High Level Bridge Newcastle

Essential cold Metallock repairs

Essential cold Metalock repairs

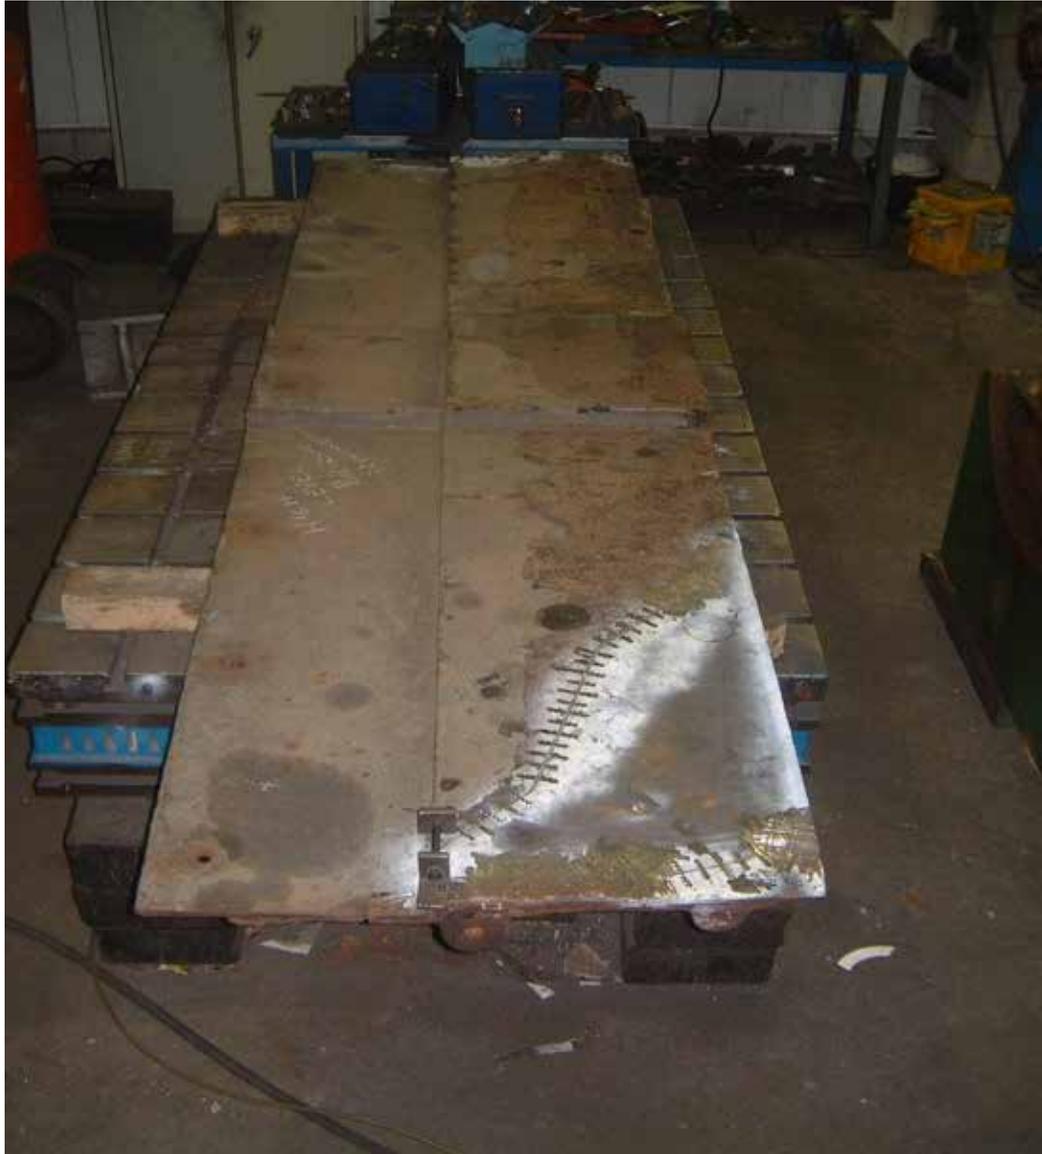
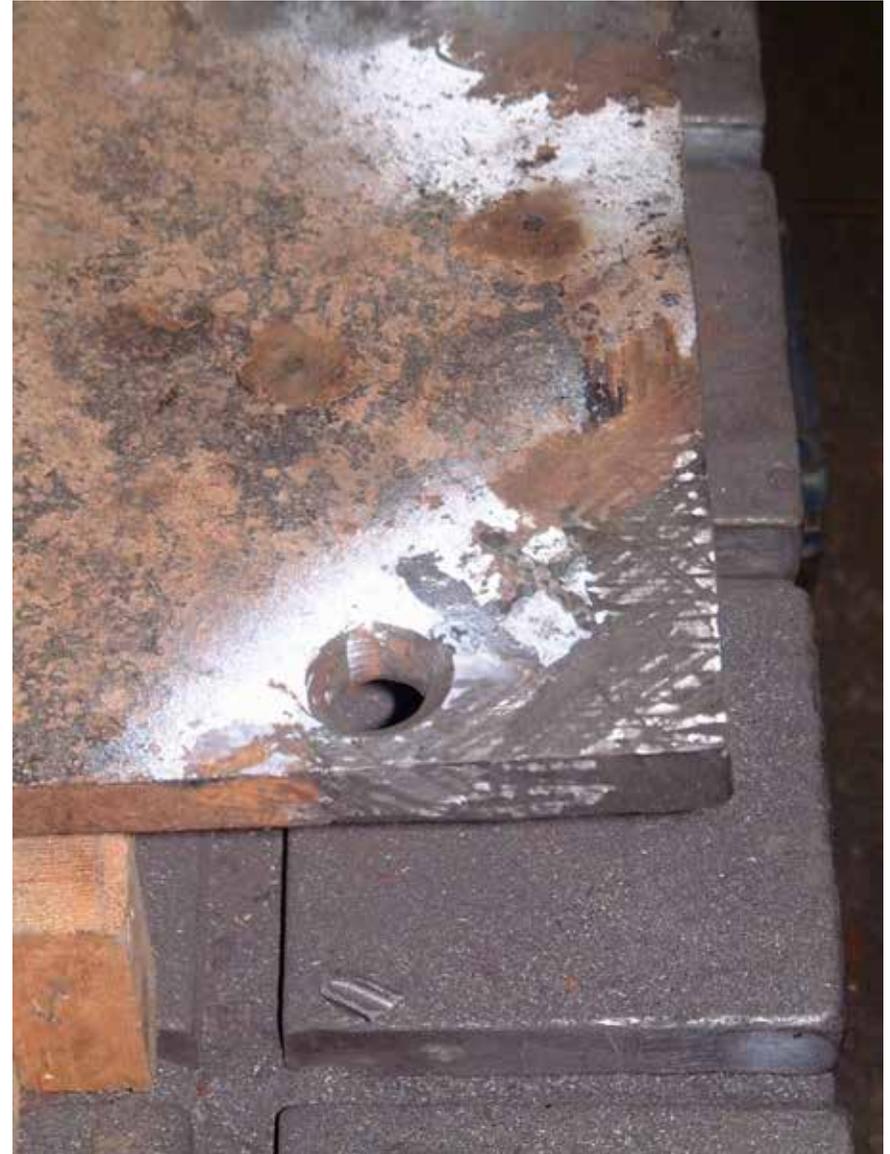
Typical damage to Fascia Panels

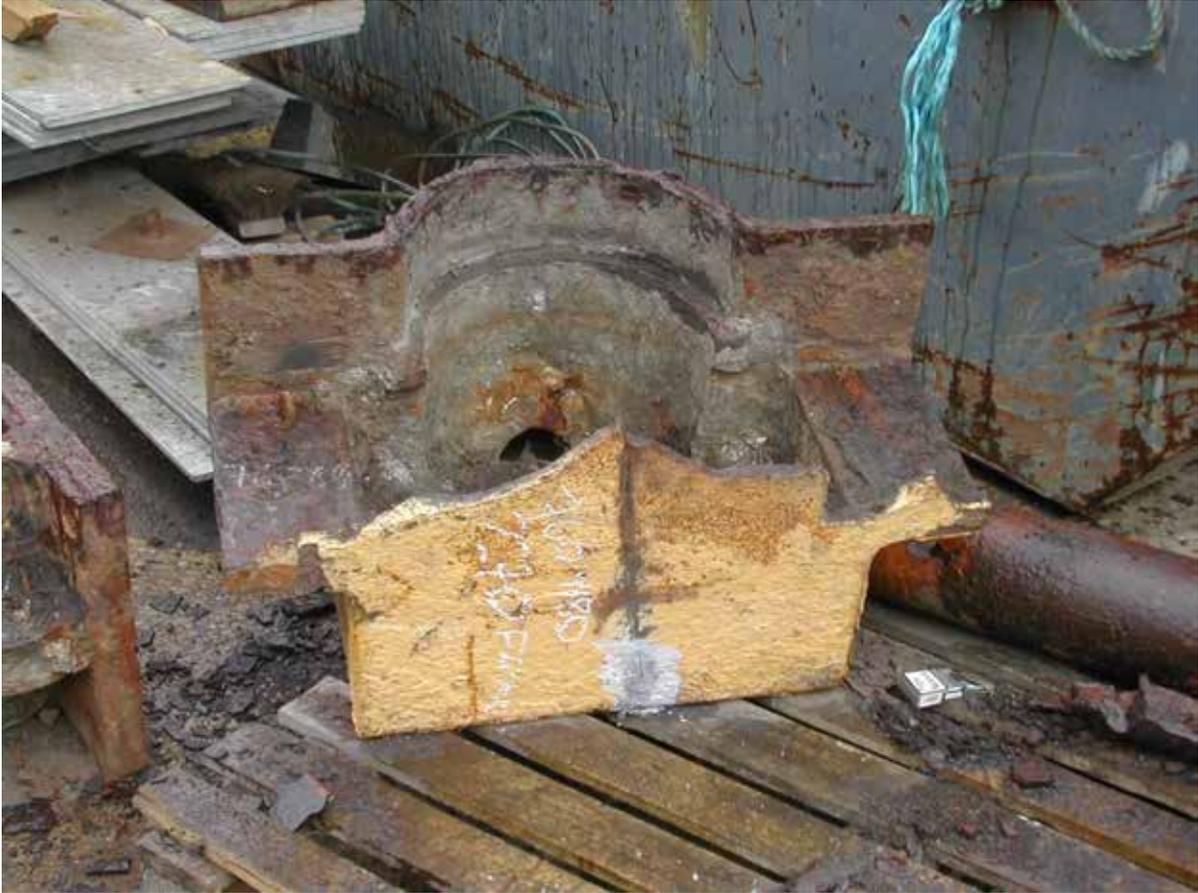
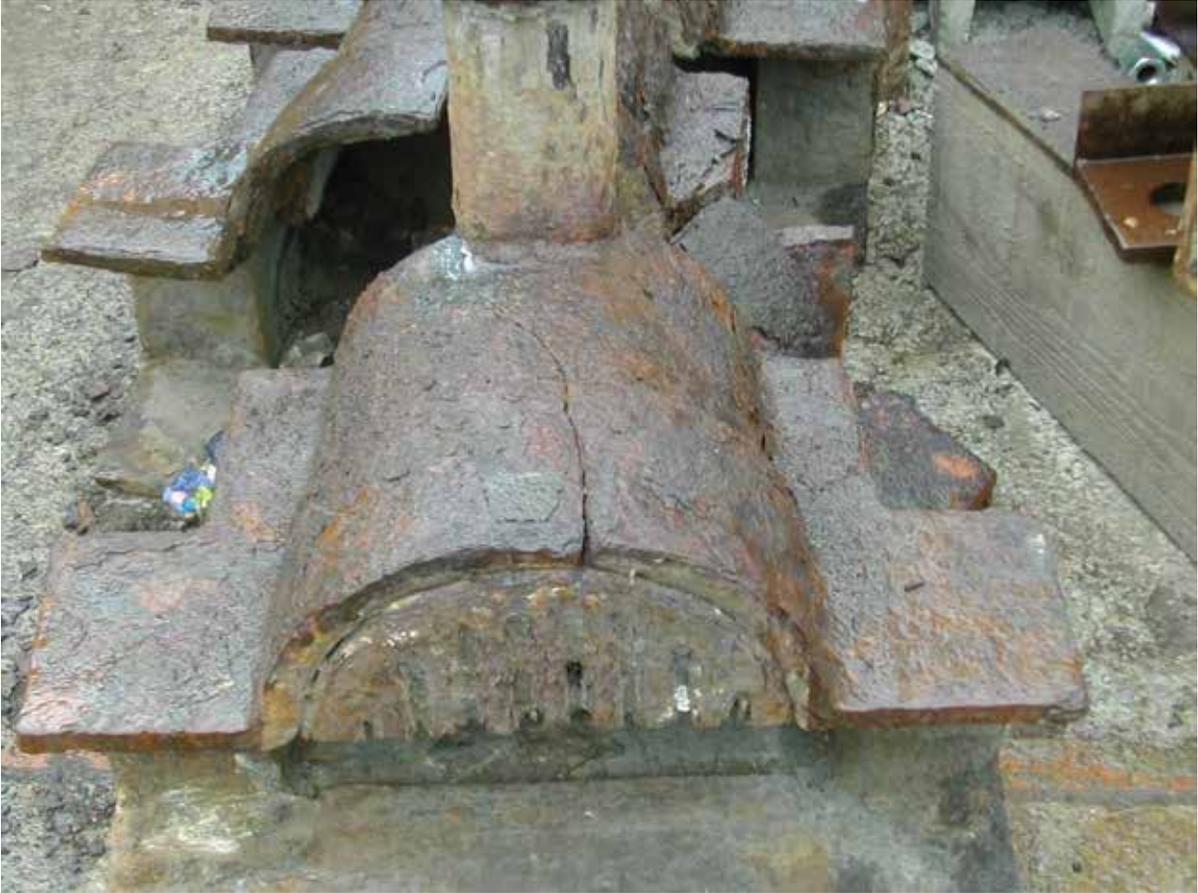
**Items still waiting
a repair decision**

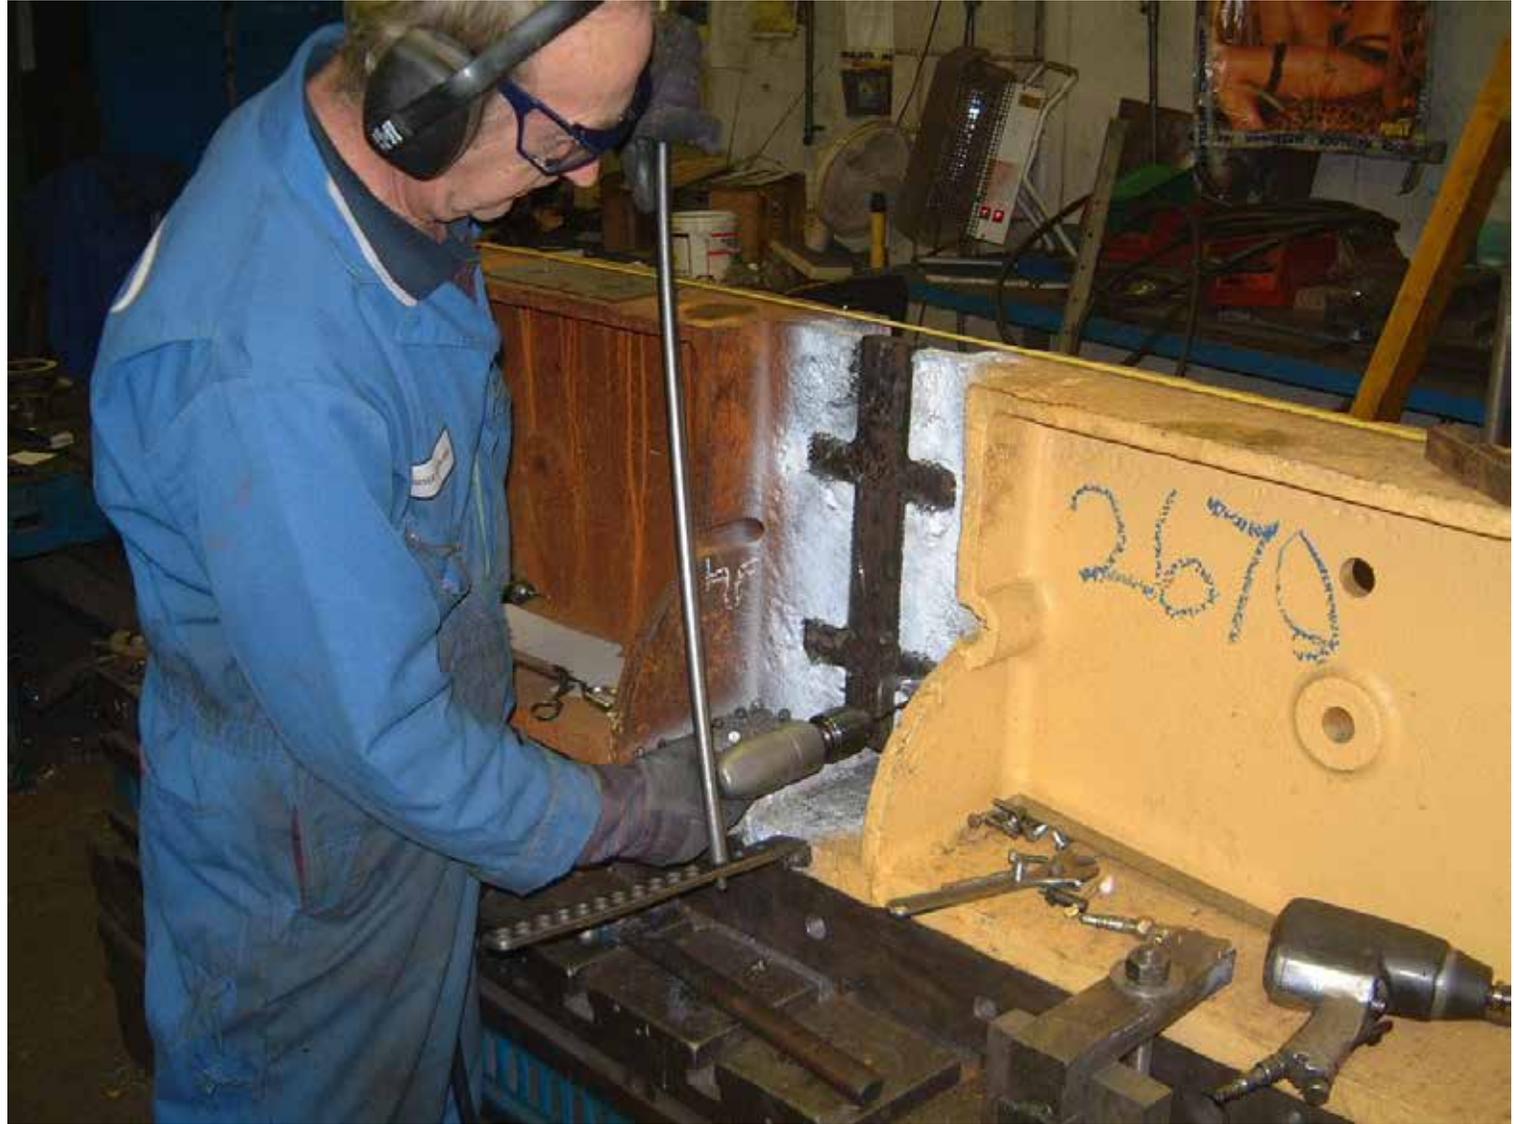
Longitudinal girder

- 140 Main Girders x 12 metres long span the Bridge
- 3 were removed and tested to destruction
- Metalock were asked to carry out repairs

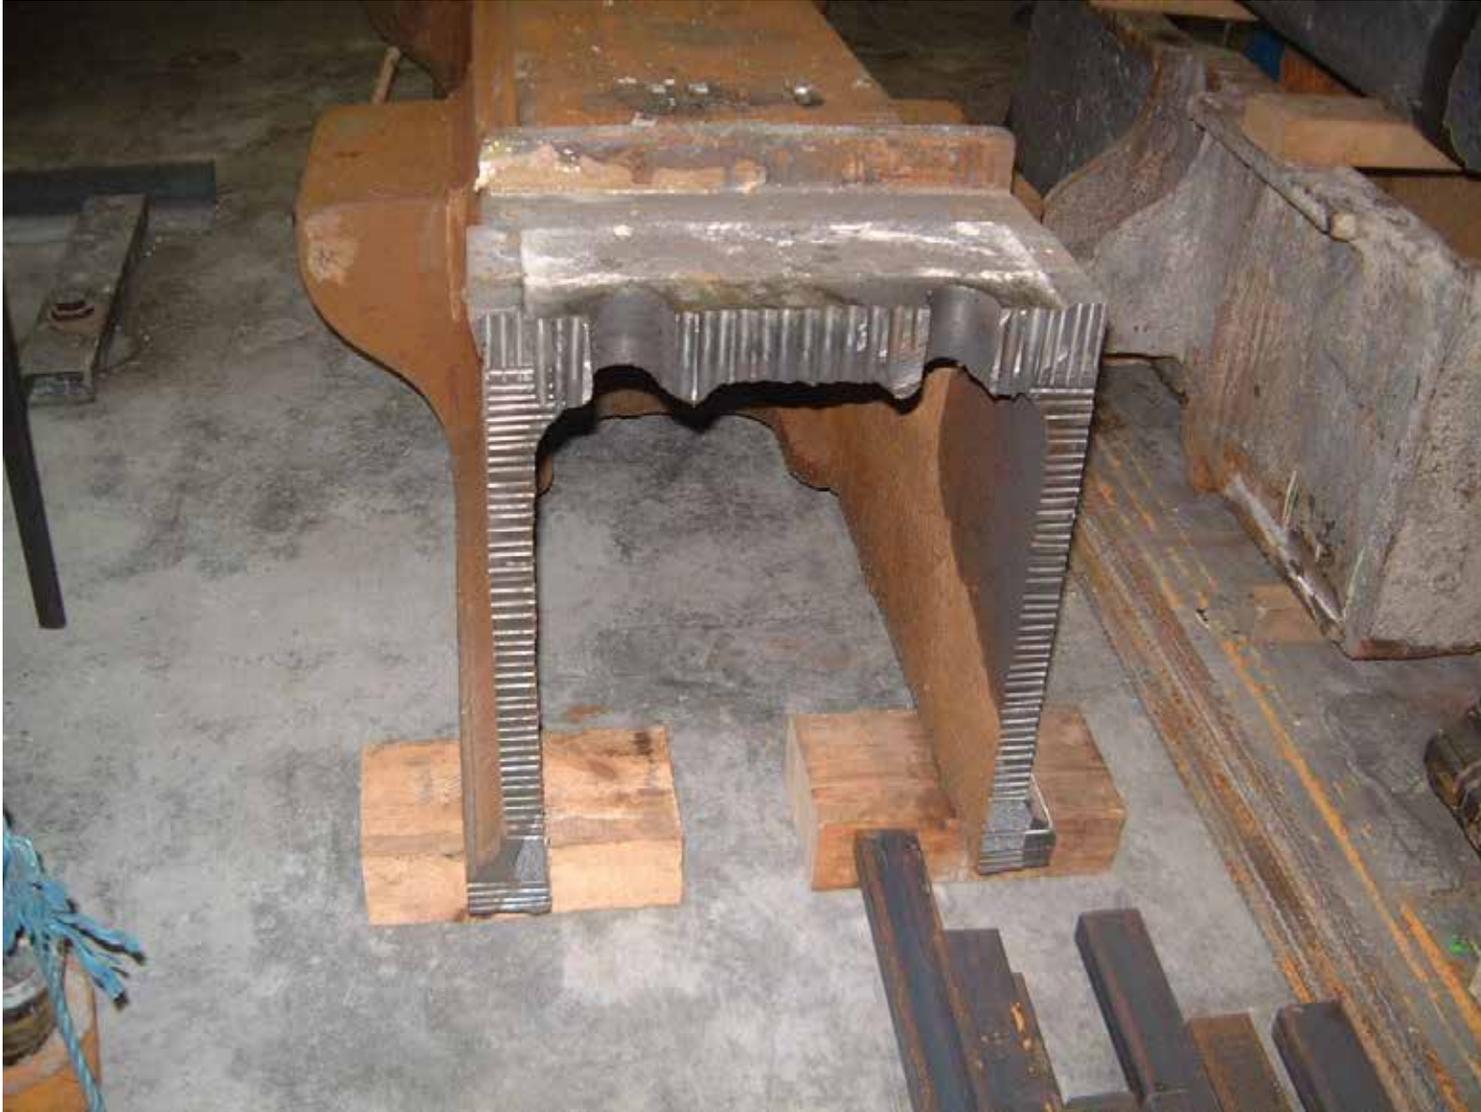
Cut into 2 piece by drilling and breaking along its weakest point.

Each Girder Section was placed into a machine at Manchester University and tested to destruction

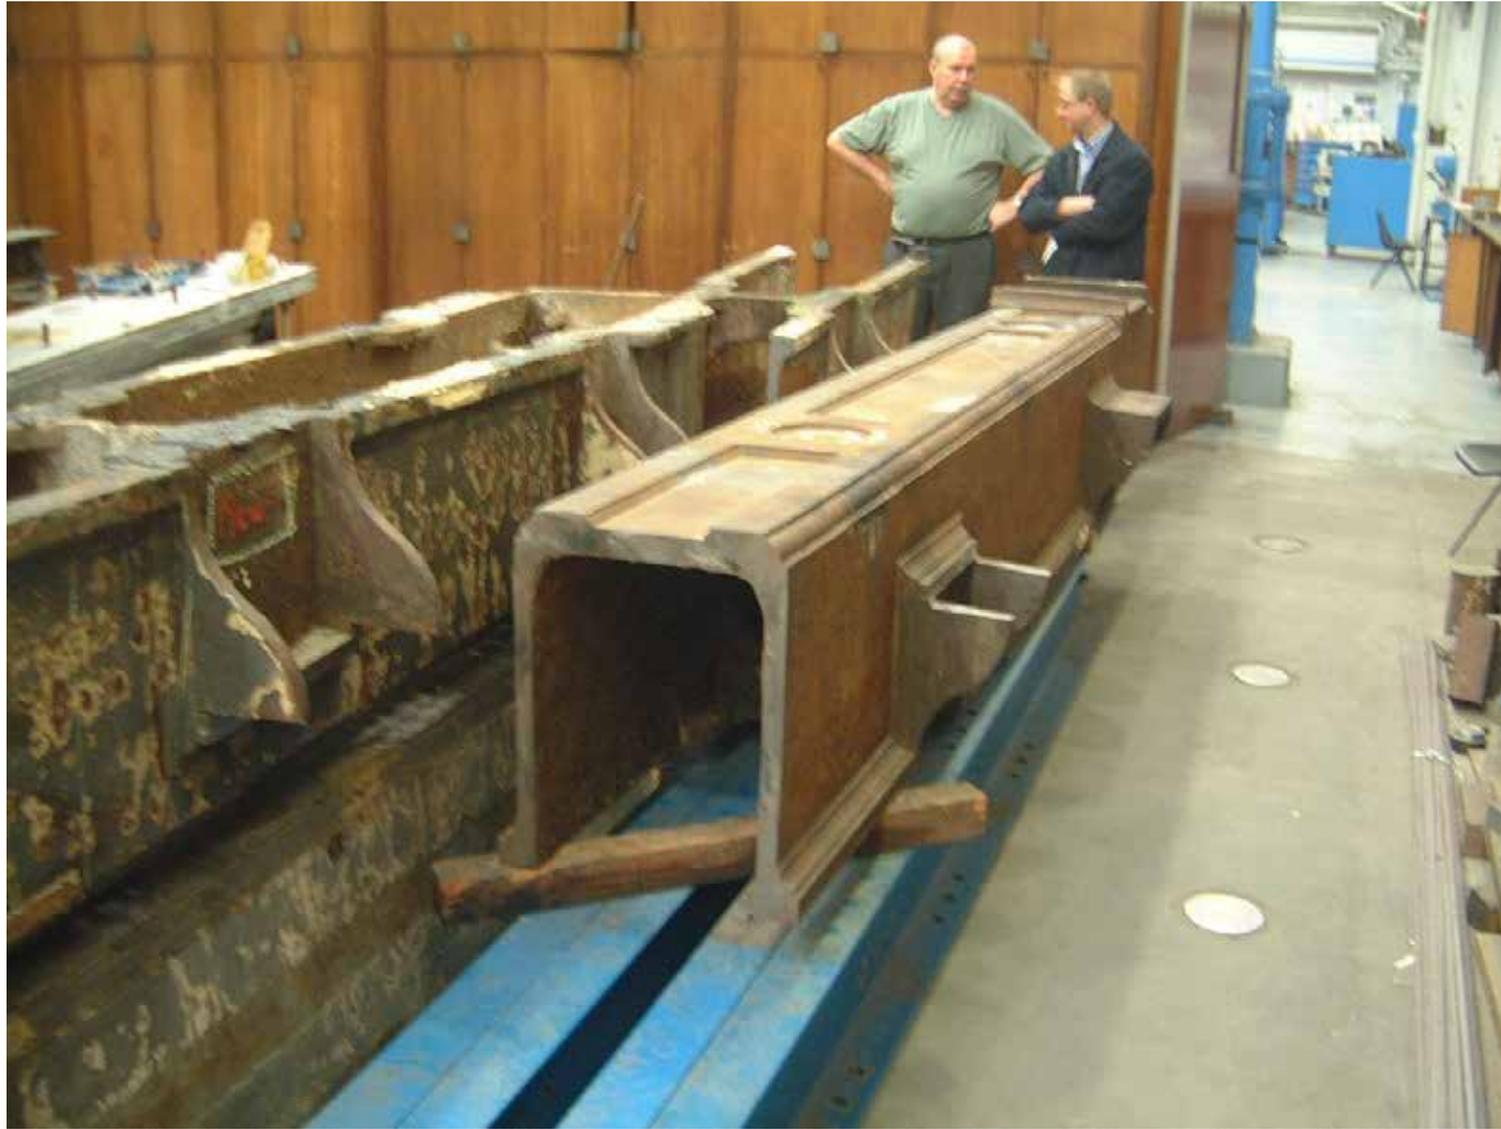
All readings were within an acceptable level with the order being given to Metalock to repair
