Engine Bearing Pocket Transplant

Ship owners James Fishers contacted Metalock Engineering UK to see if a repair was possible on their main engine bedplate.

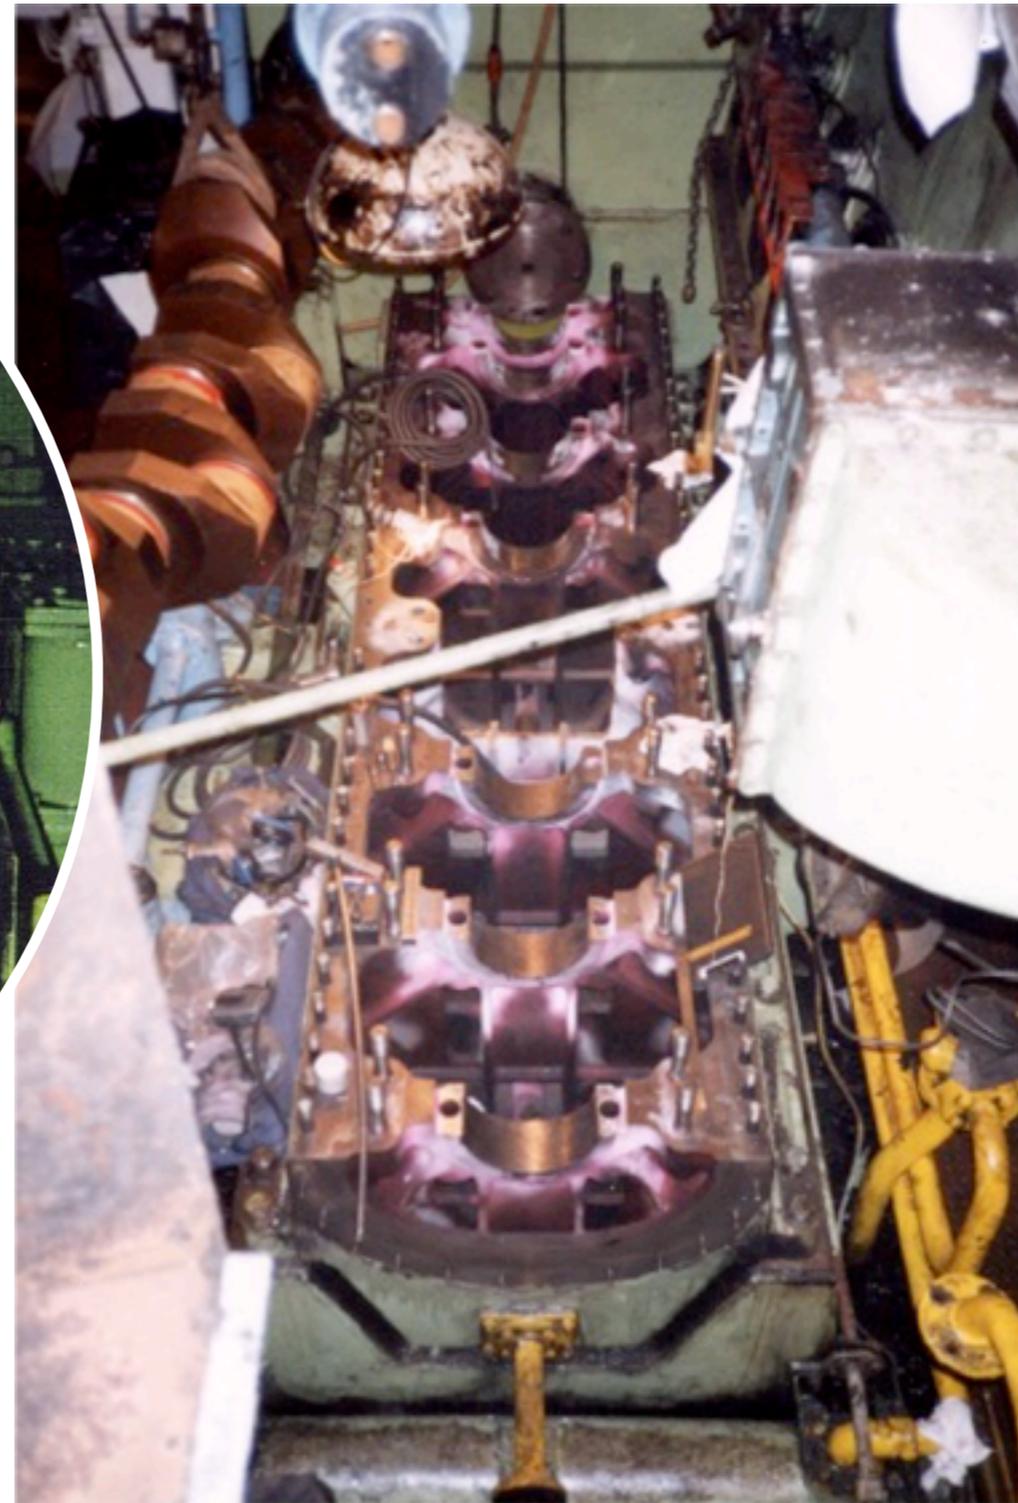
After a routine inspection cracks were found to both sides of the No.4 main bearing pocket, these were thought to have been caused by fretting of the bearing cap due to insufficient tightening of the bearing cap nuts.

Bearing pockets highlighting cracks

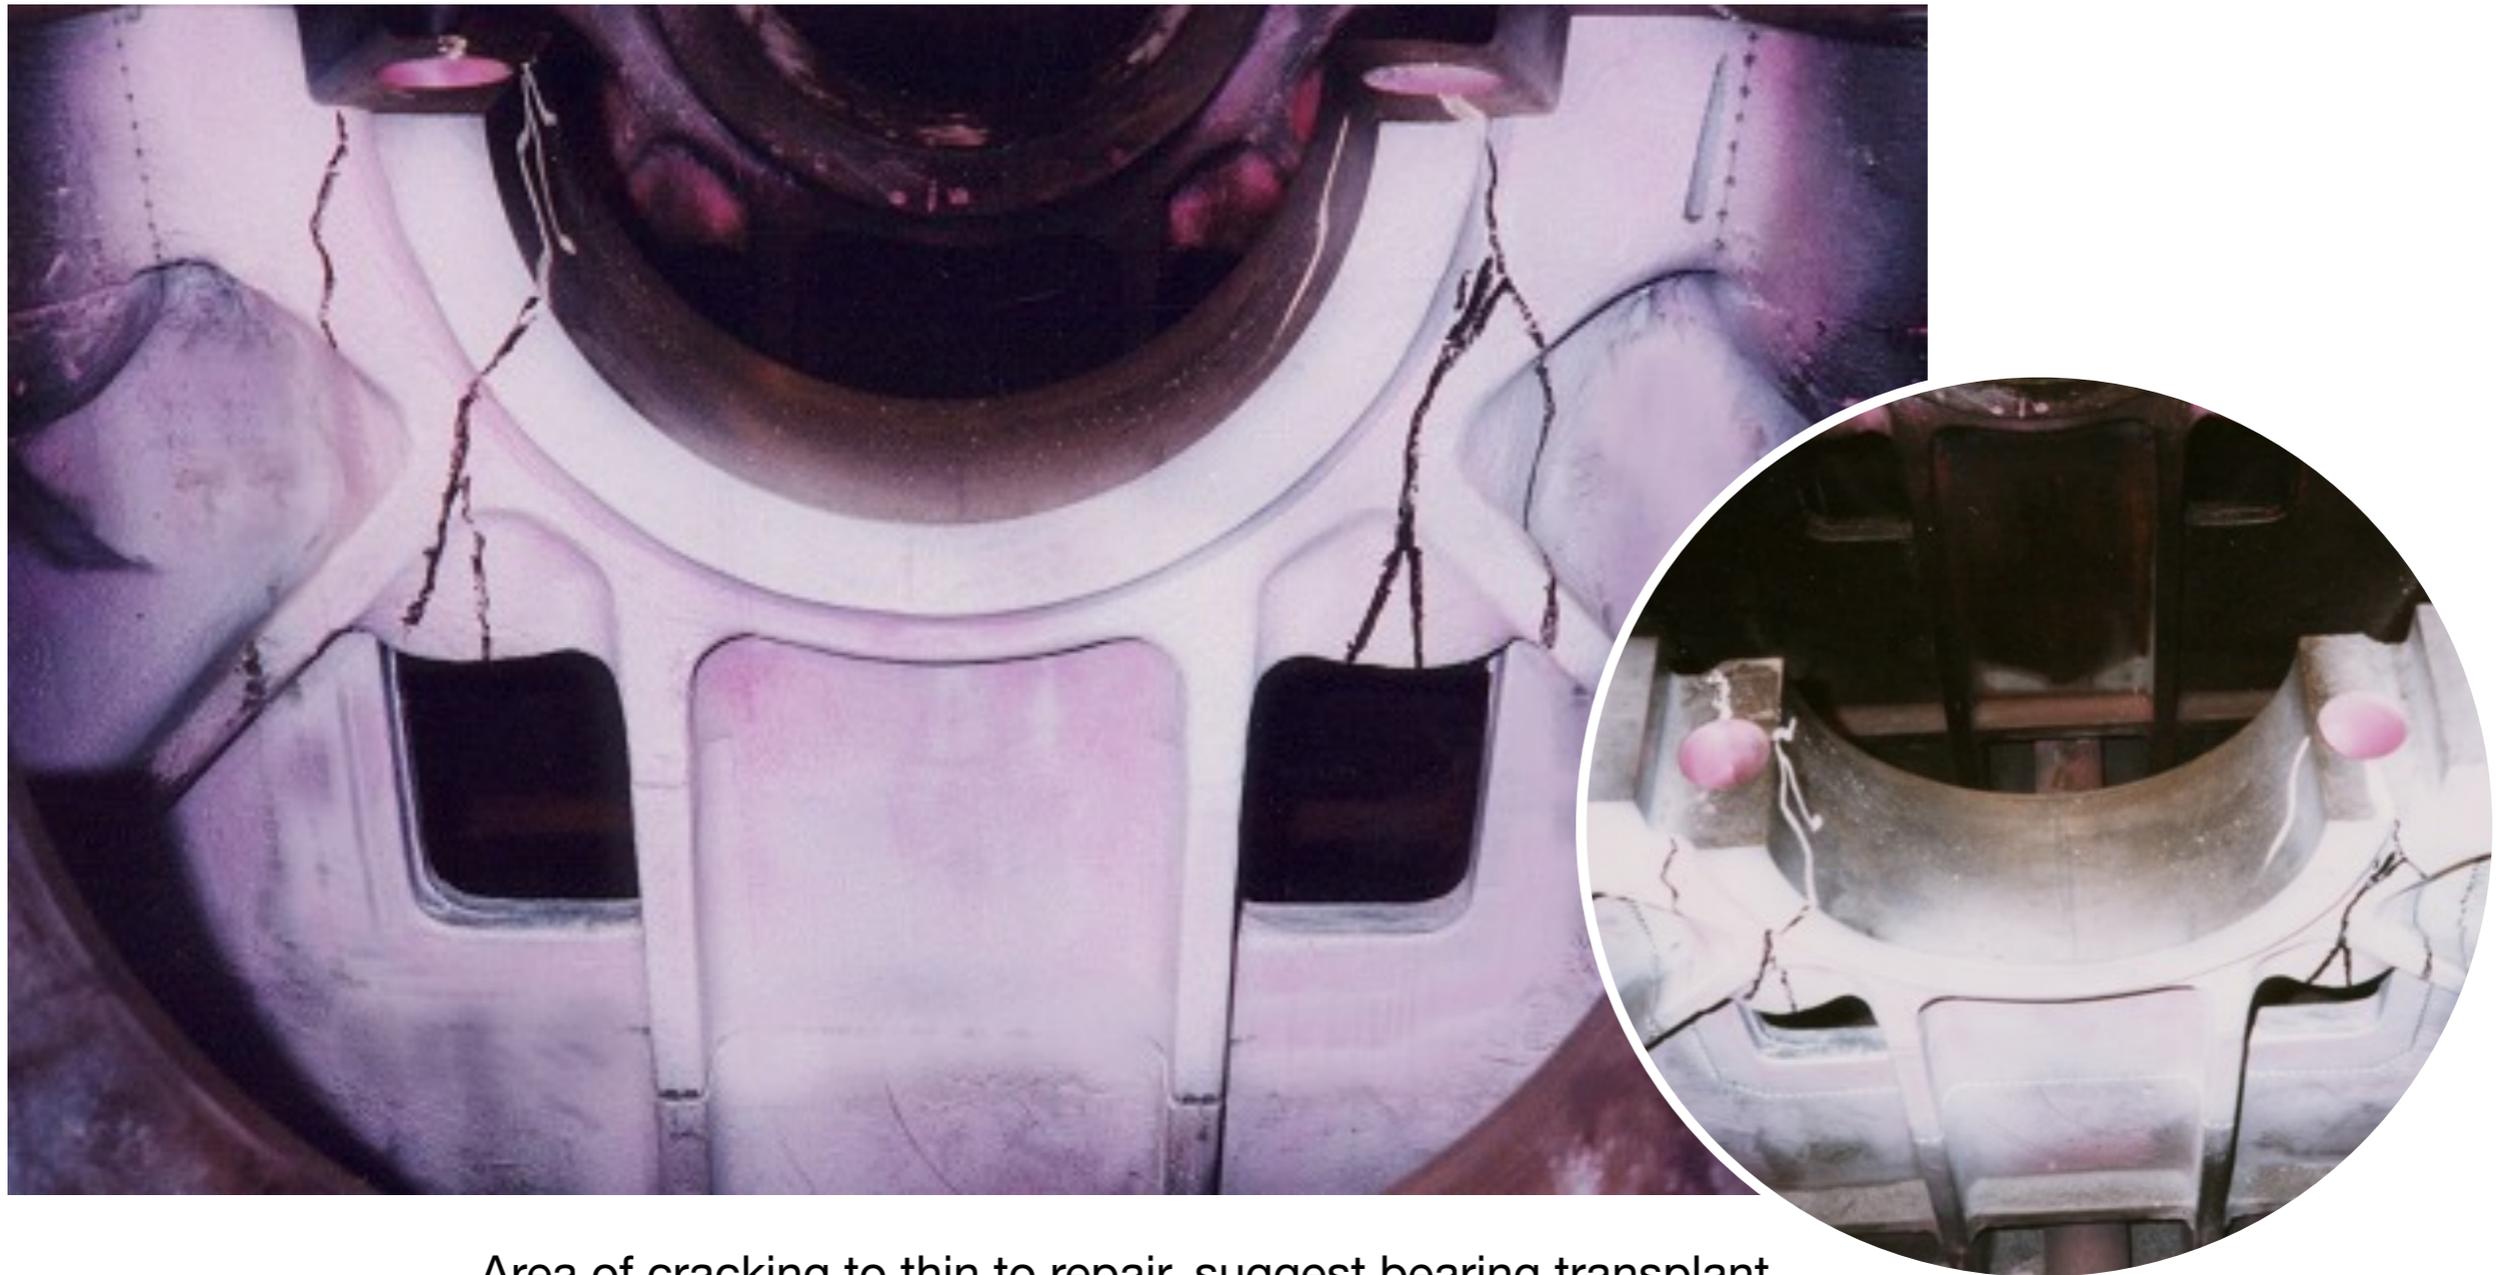
Area of cracking to thin to repair, suggest bearing transplant

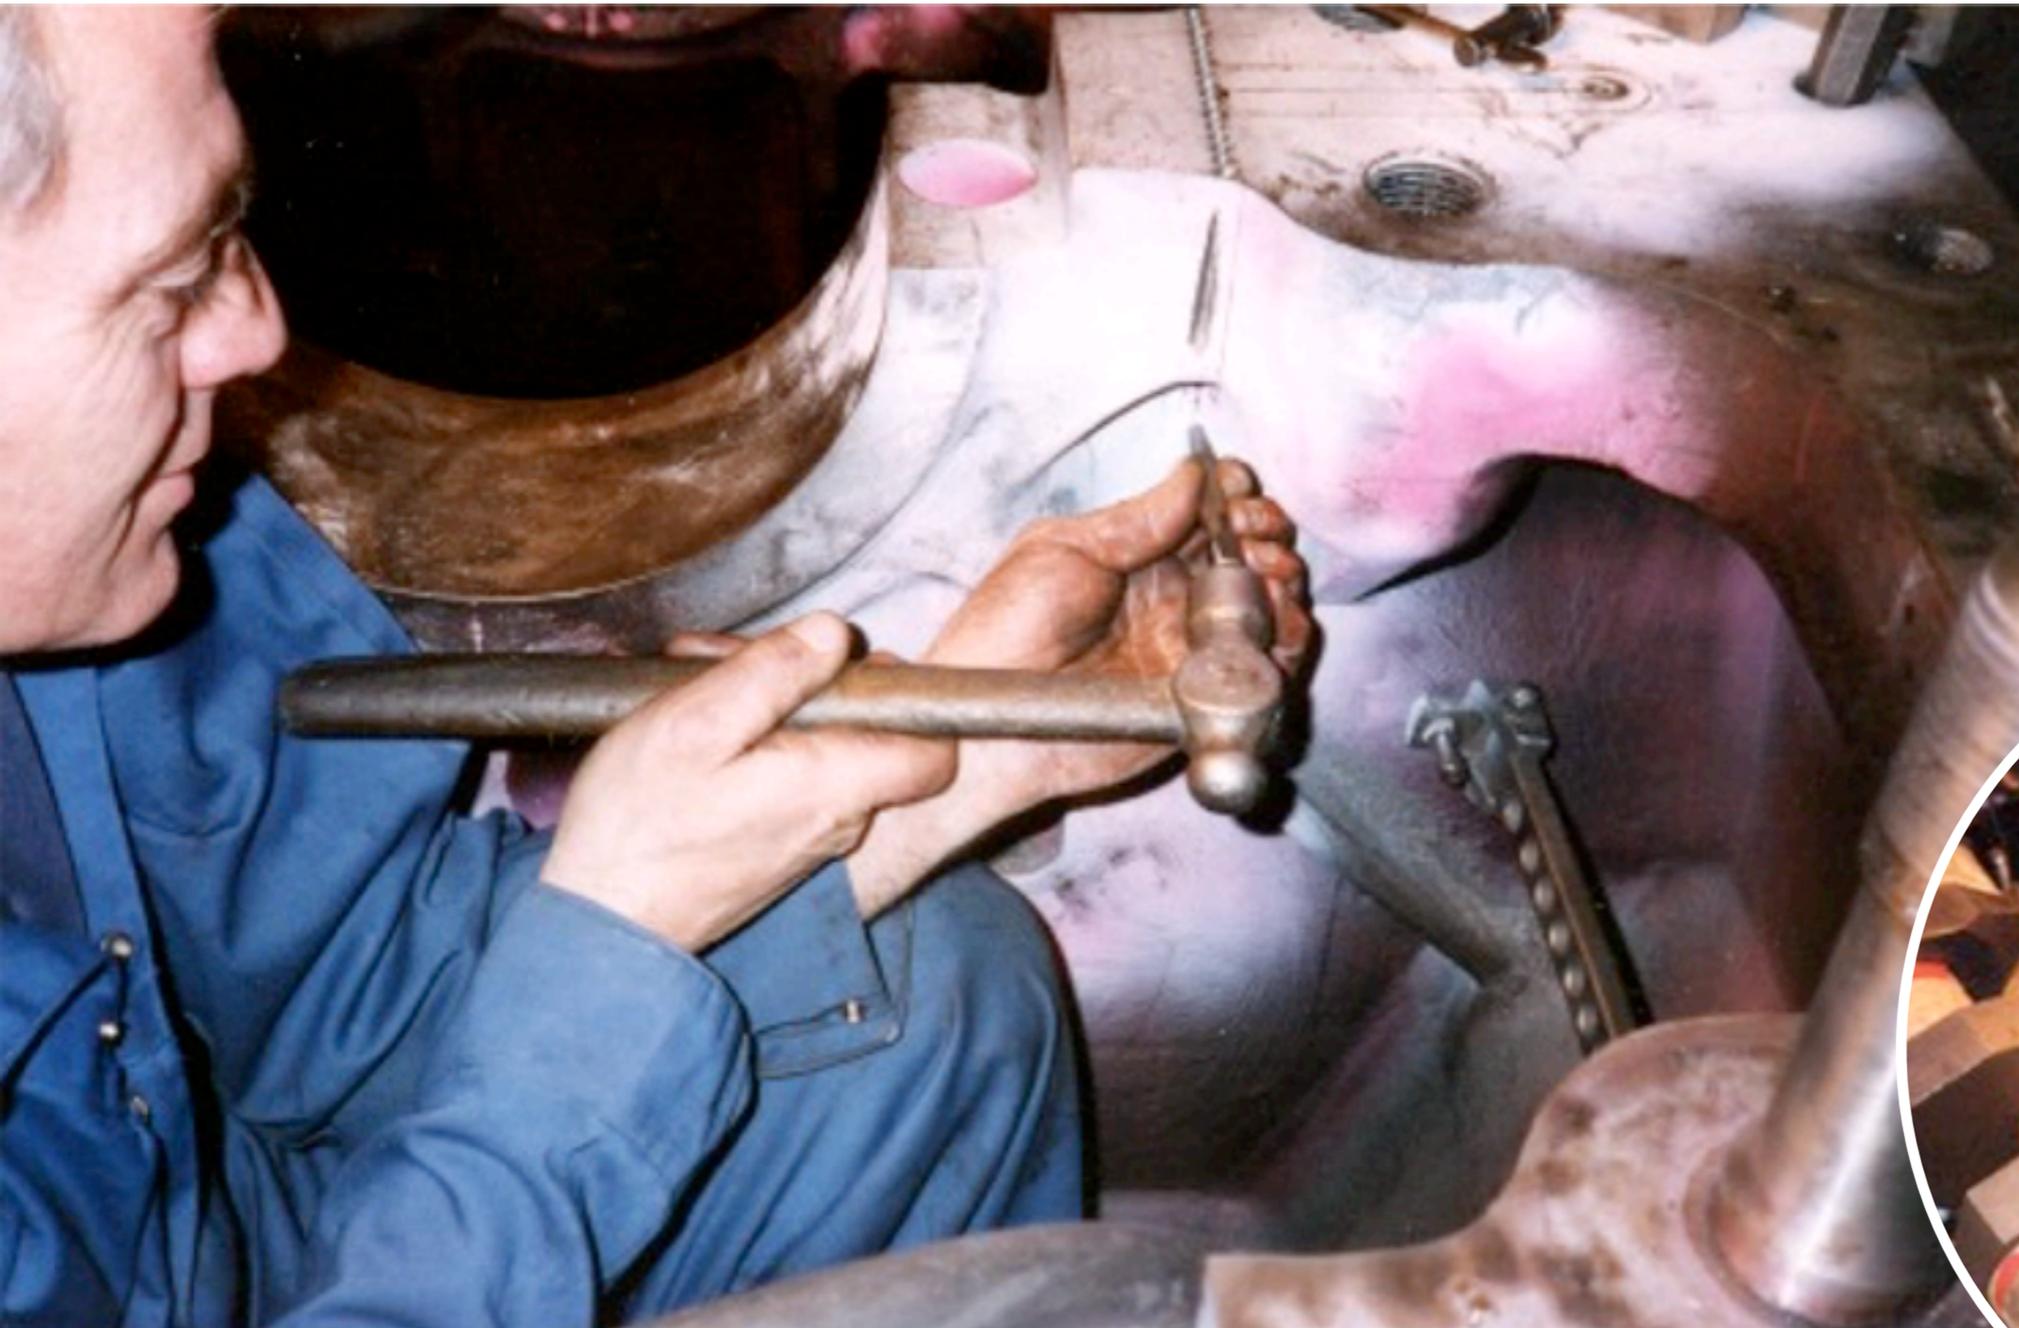
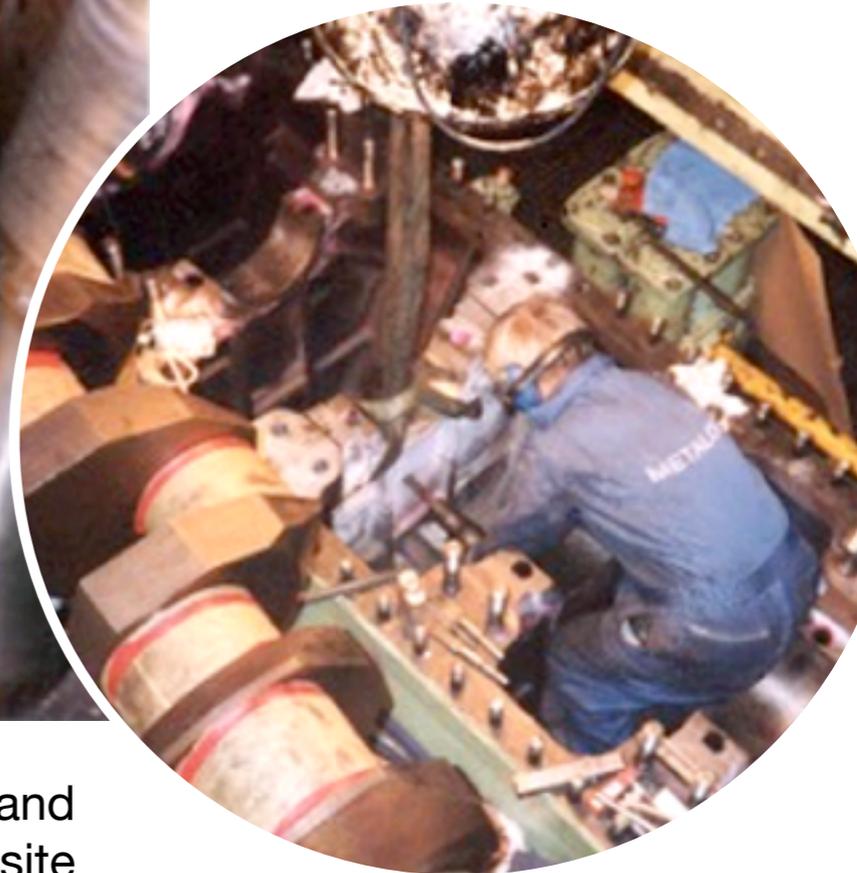
Chain drilling using a series of Metalock jigs

A repair was designed with the customers approval and the technicians were dispatched to site

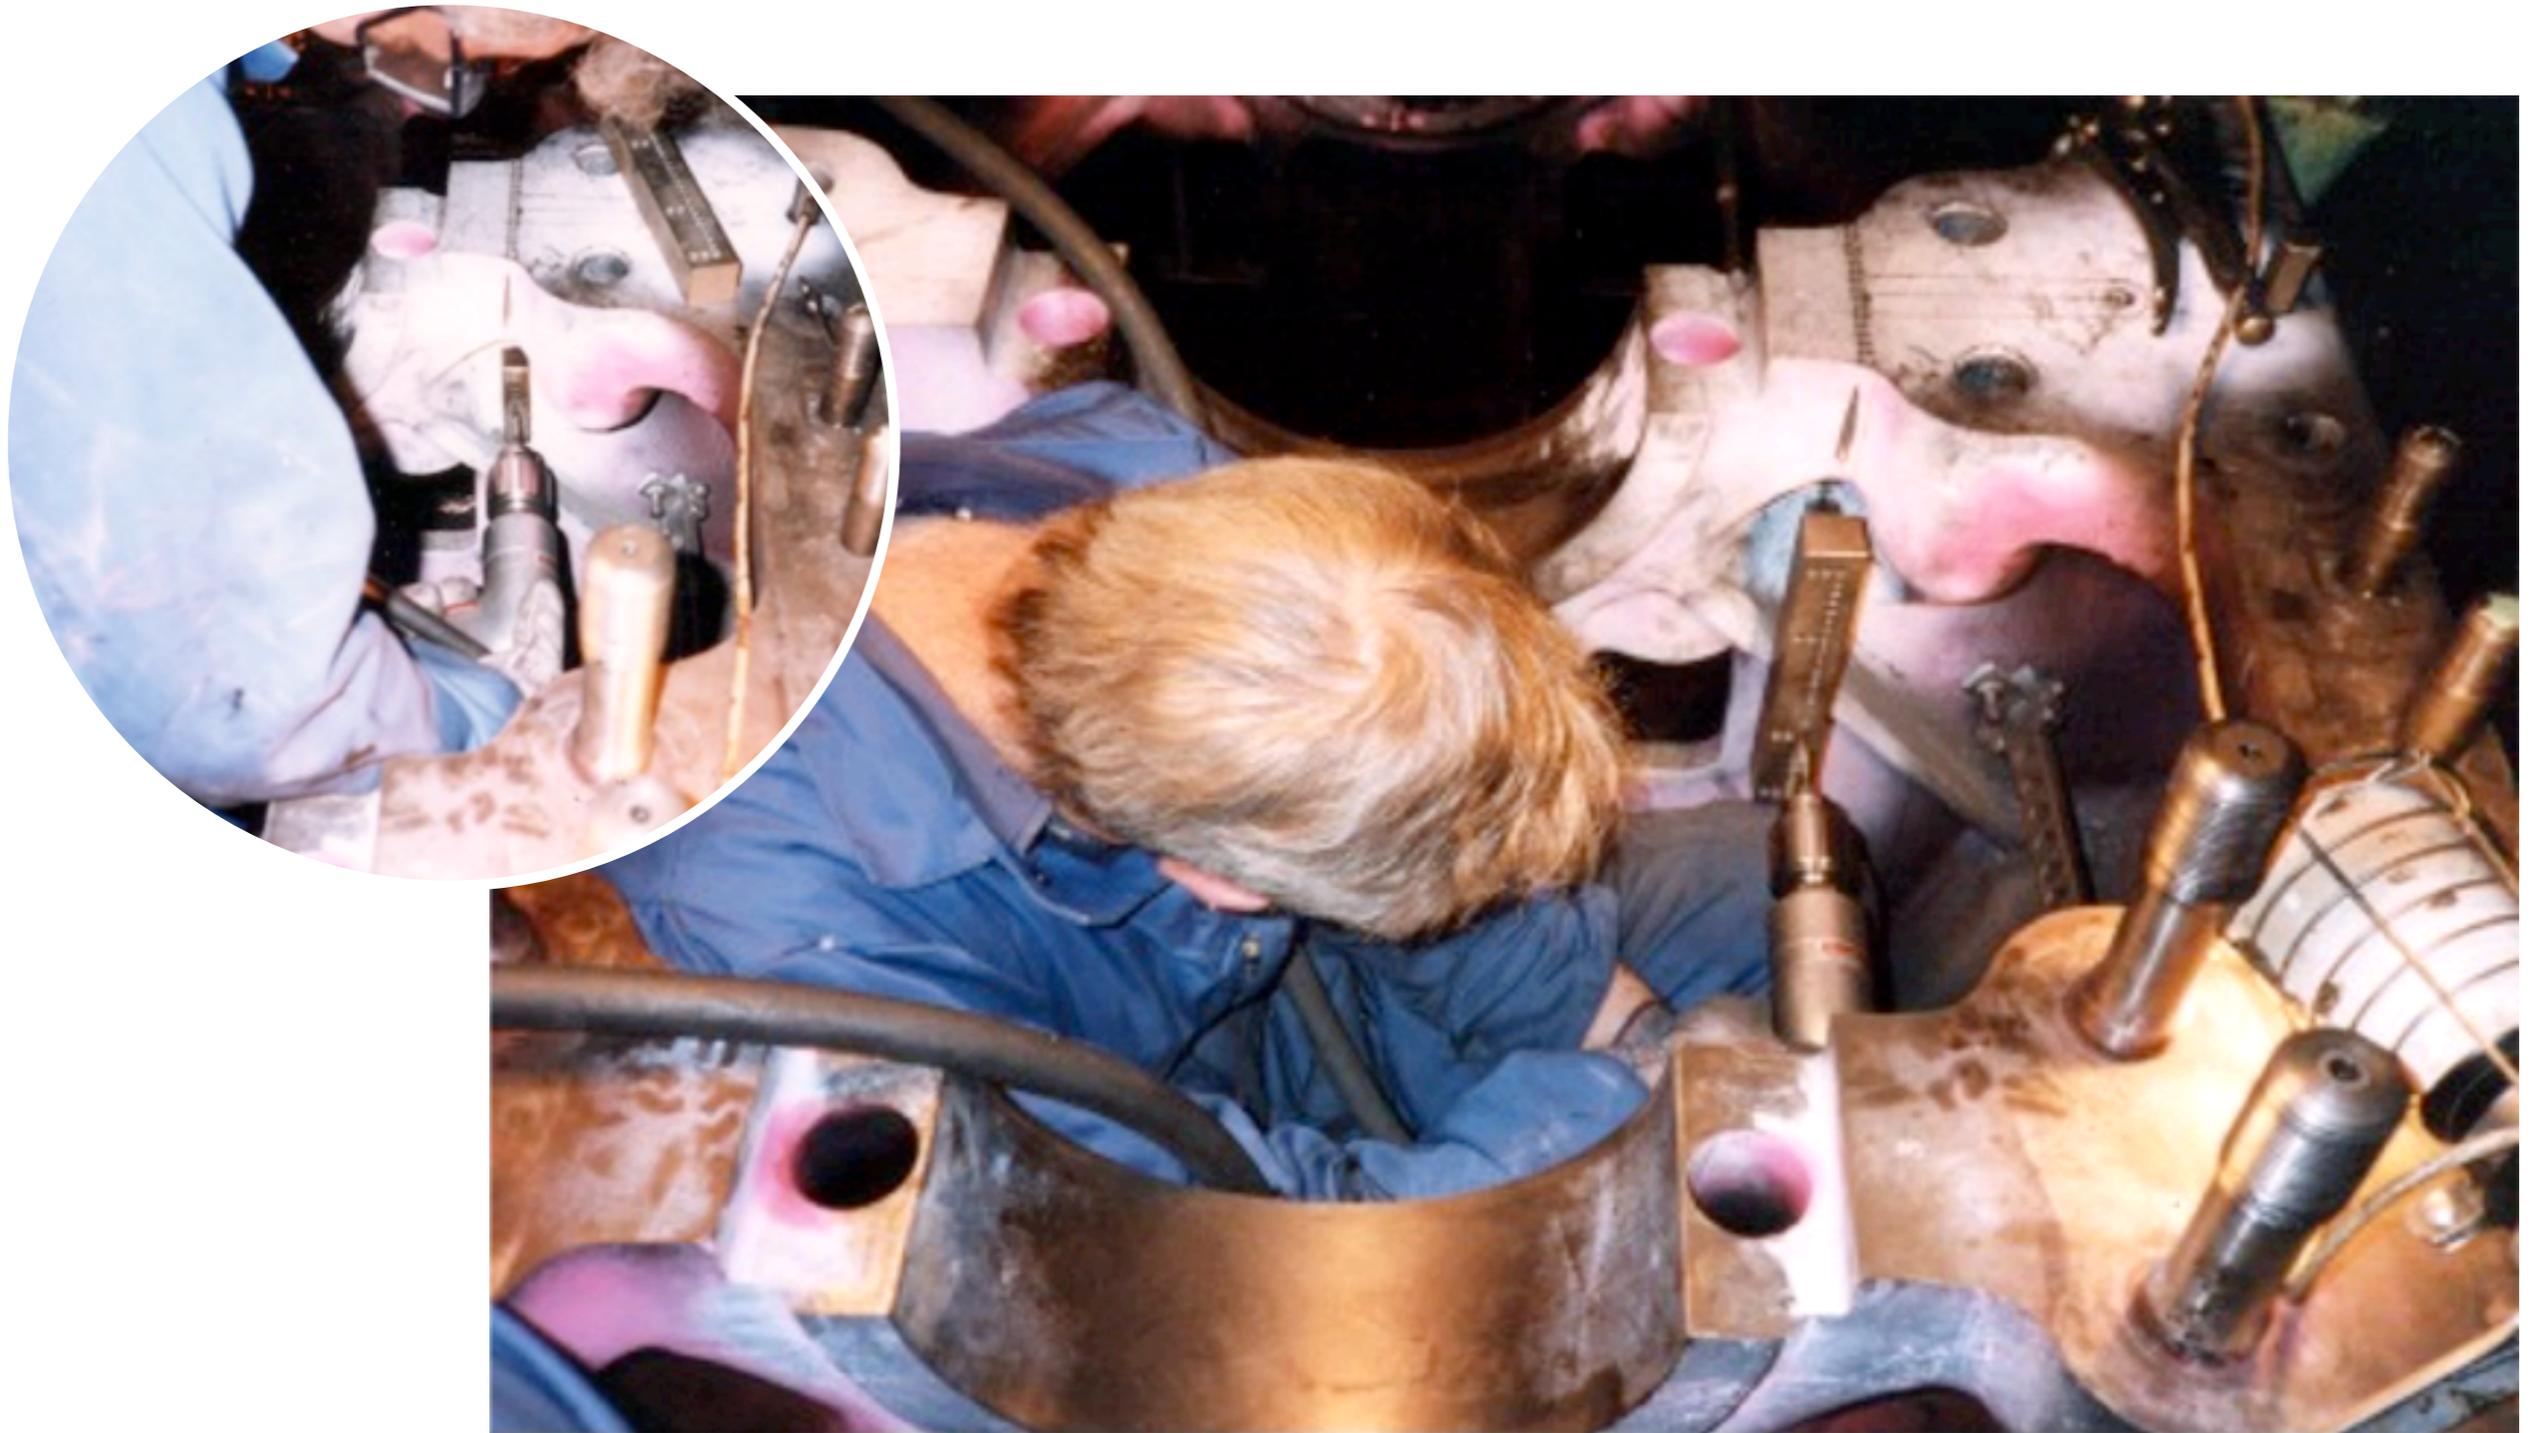
The drilling was through the full depth of the parent casting

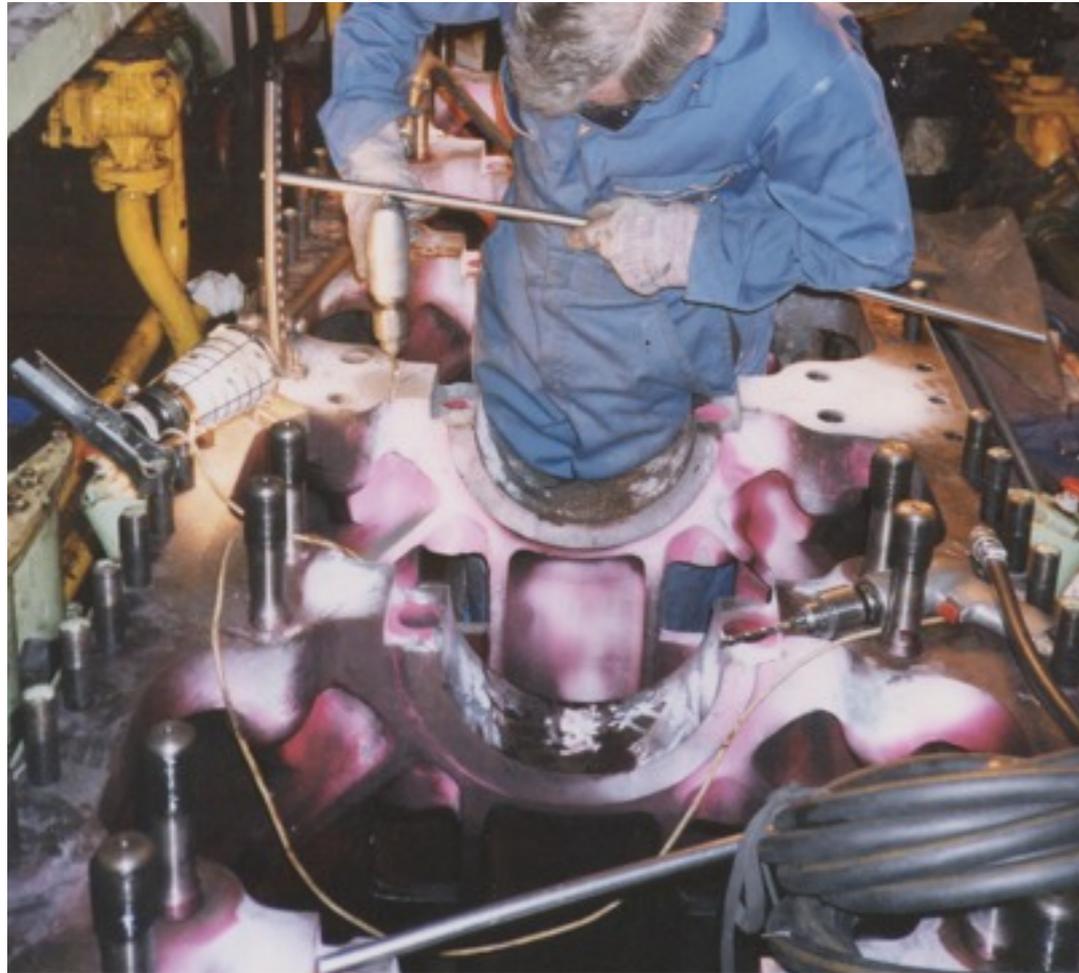
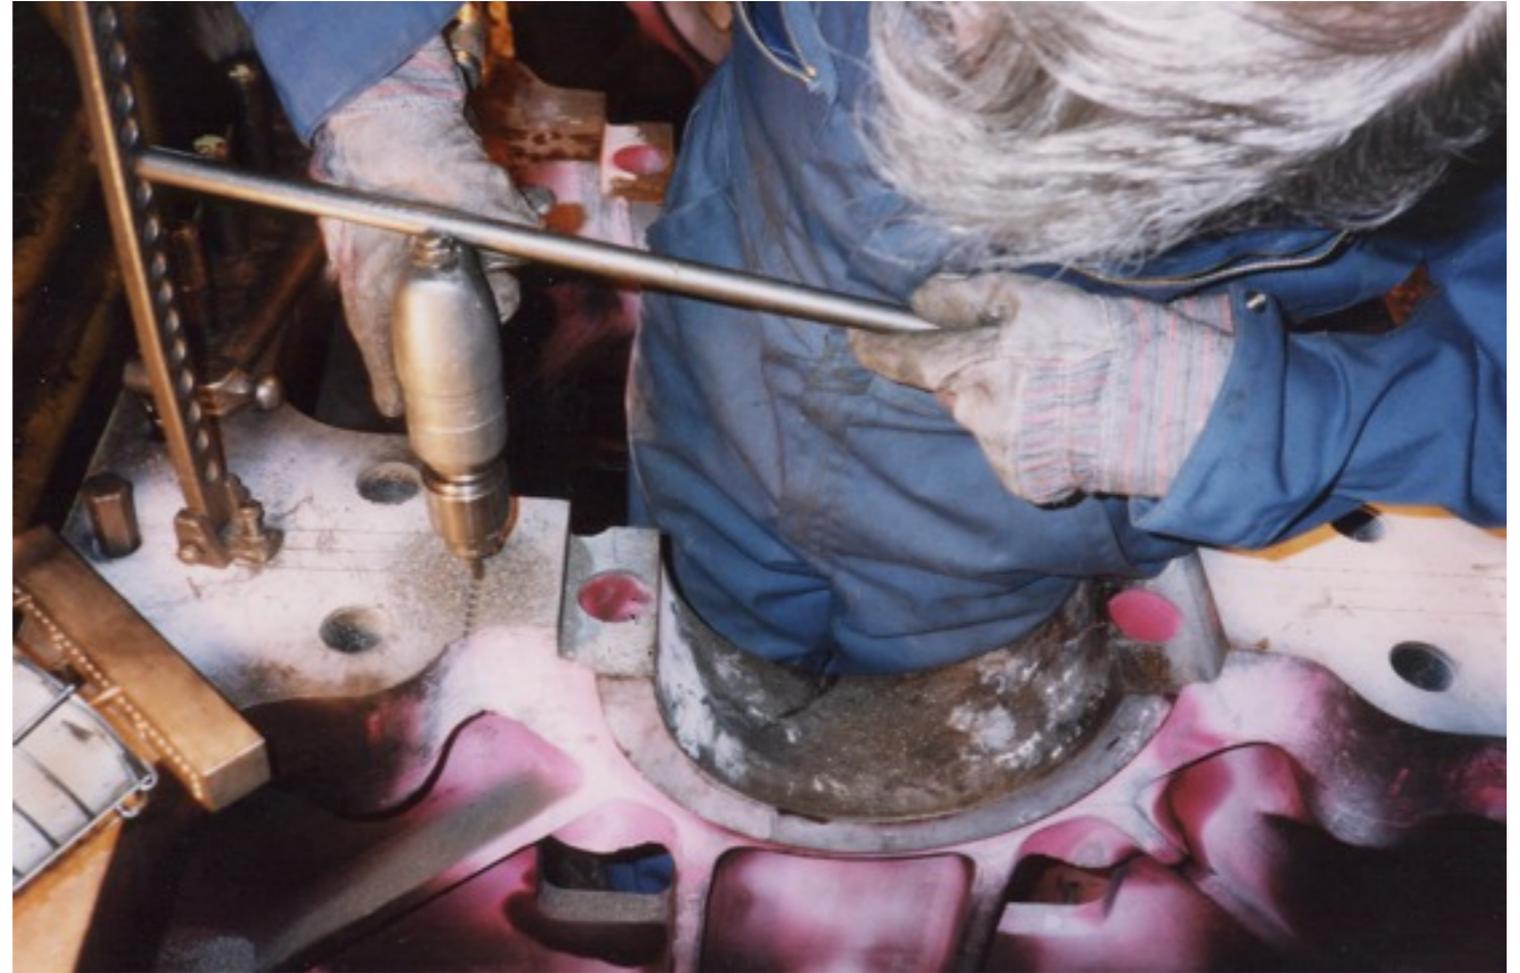
Vertical drilled holes locate side drilling

Sizing the holes ready for the removal of the bearing pocket

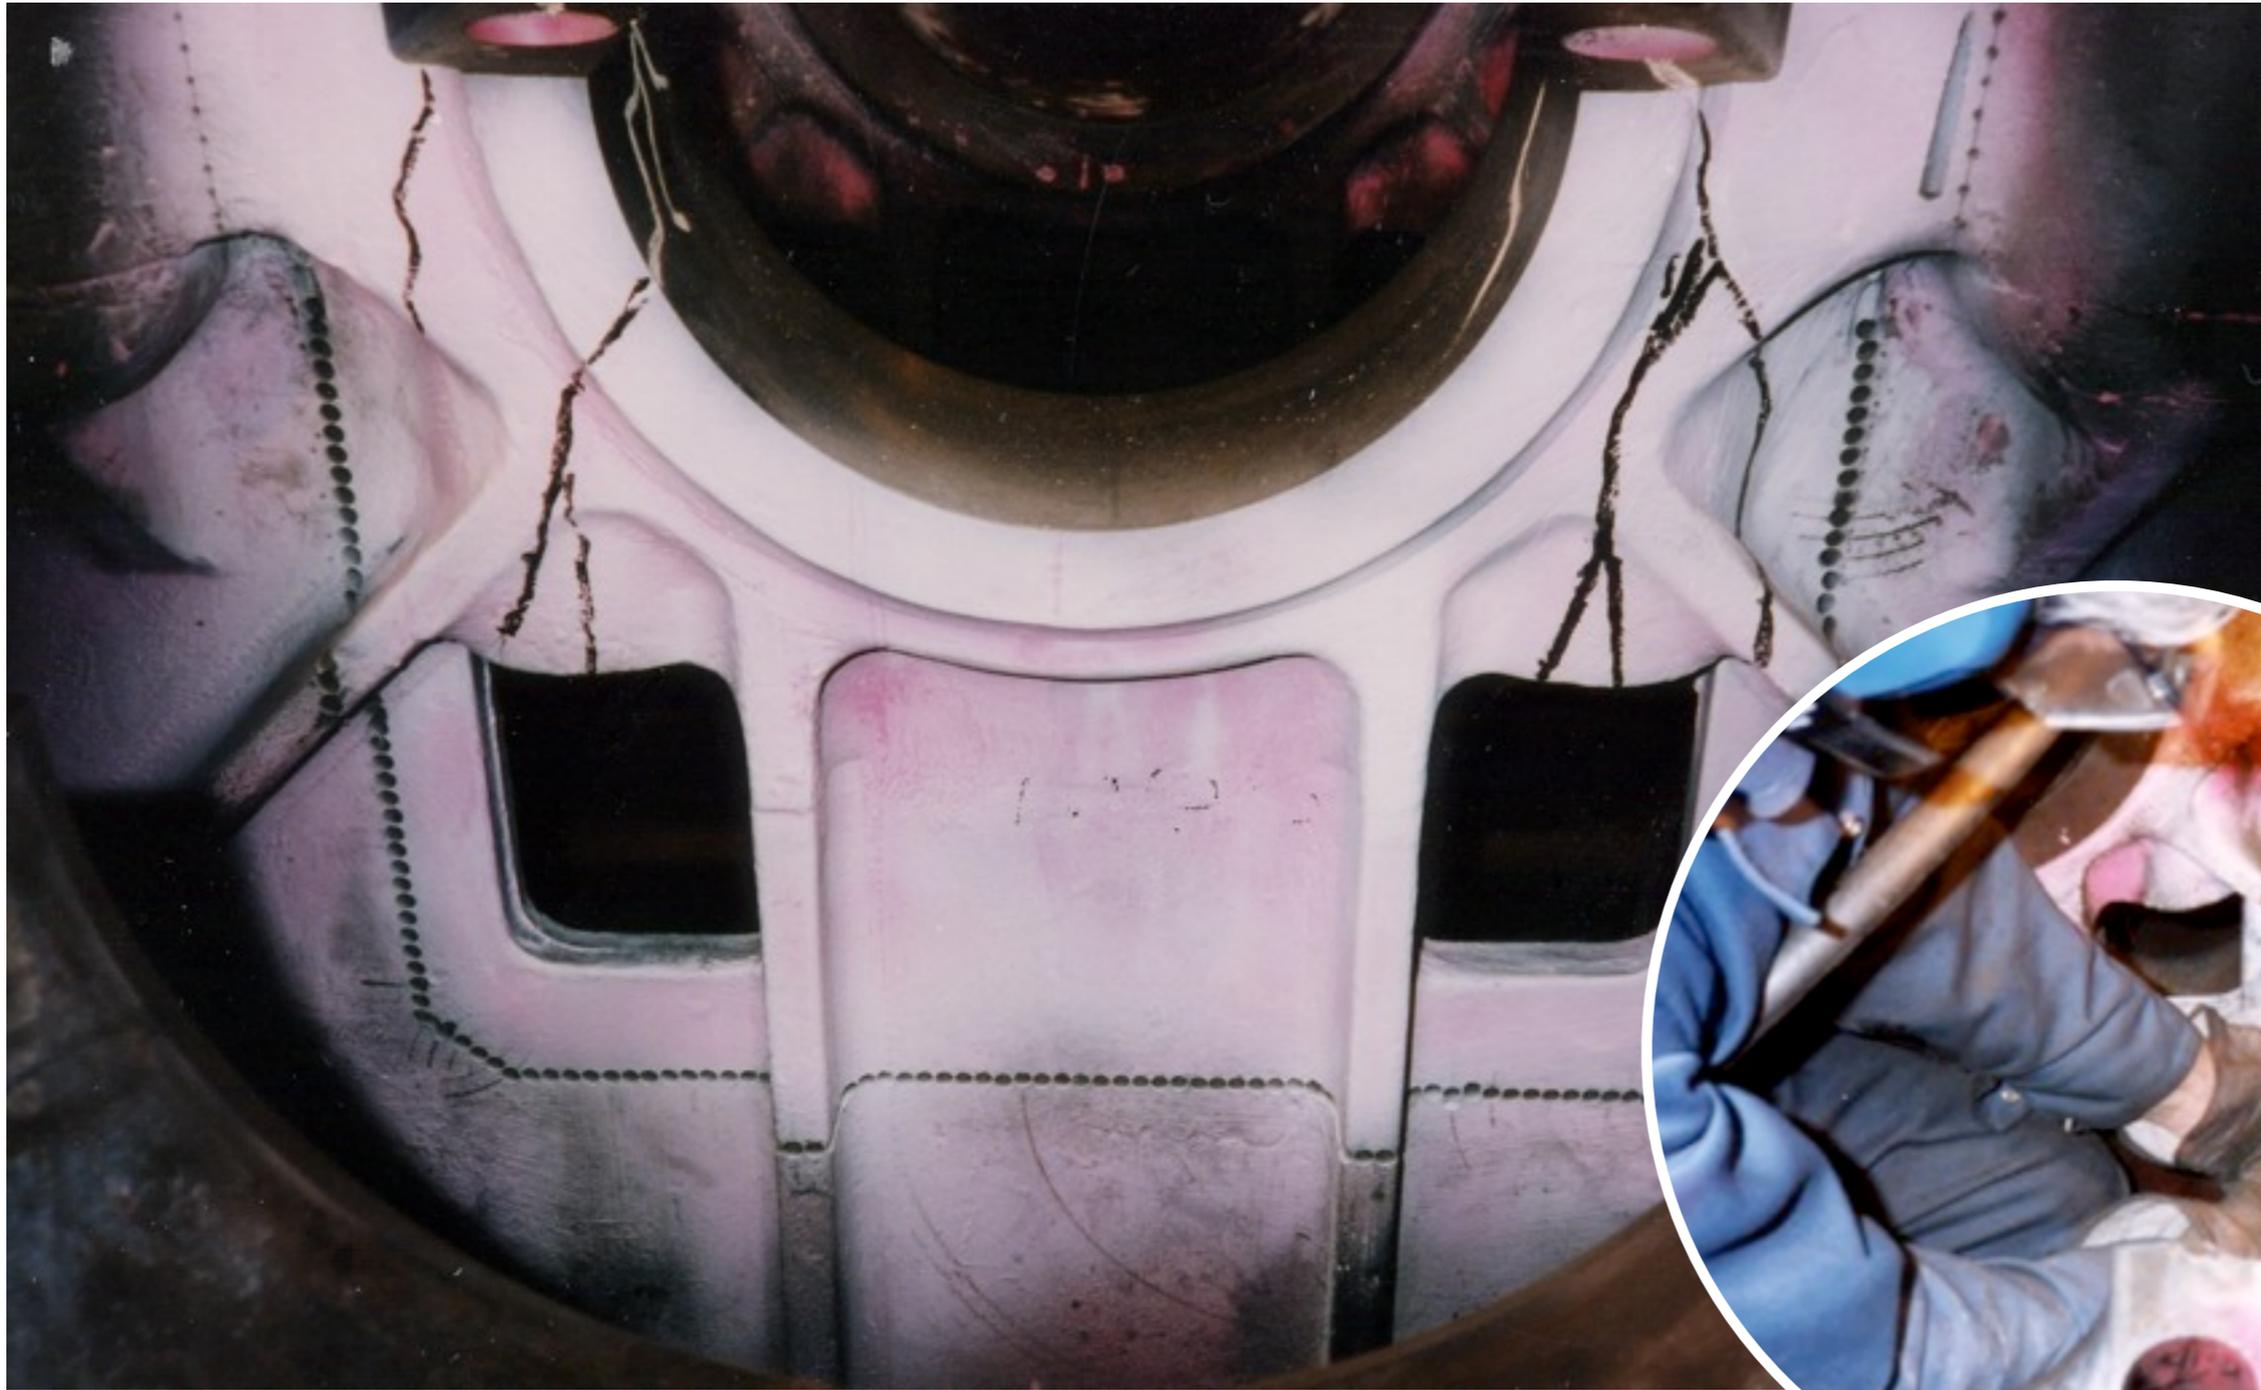
Holes drilled showing the full extent of area to be removed

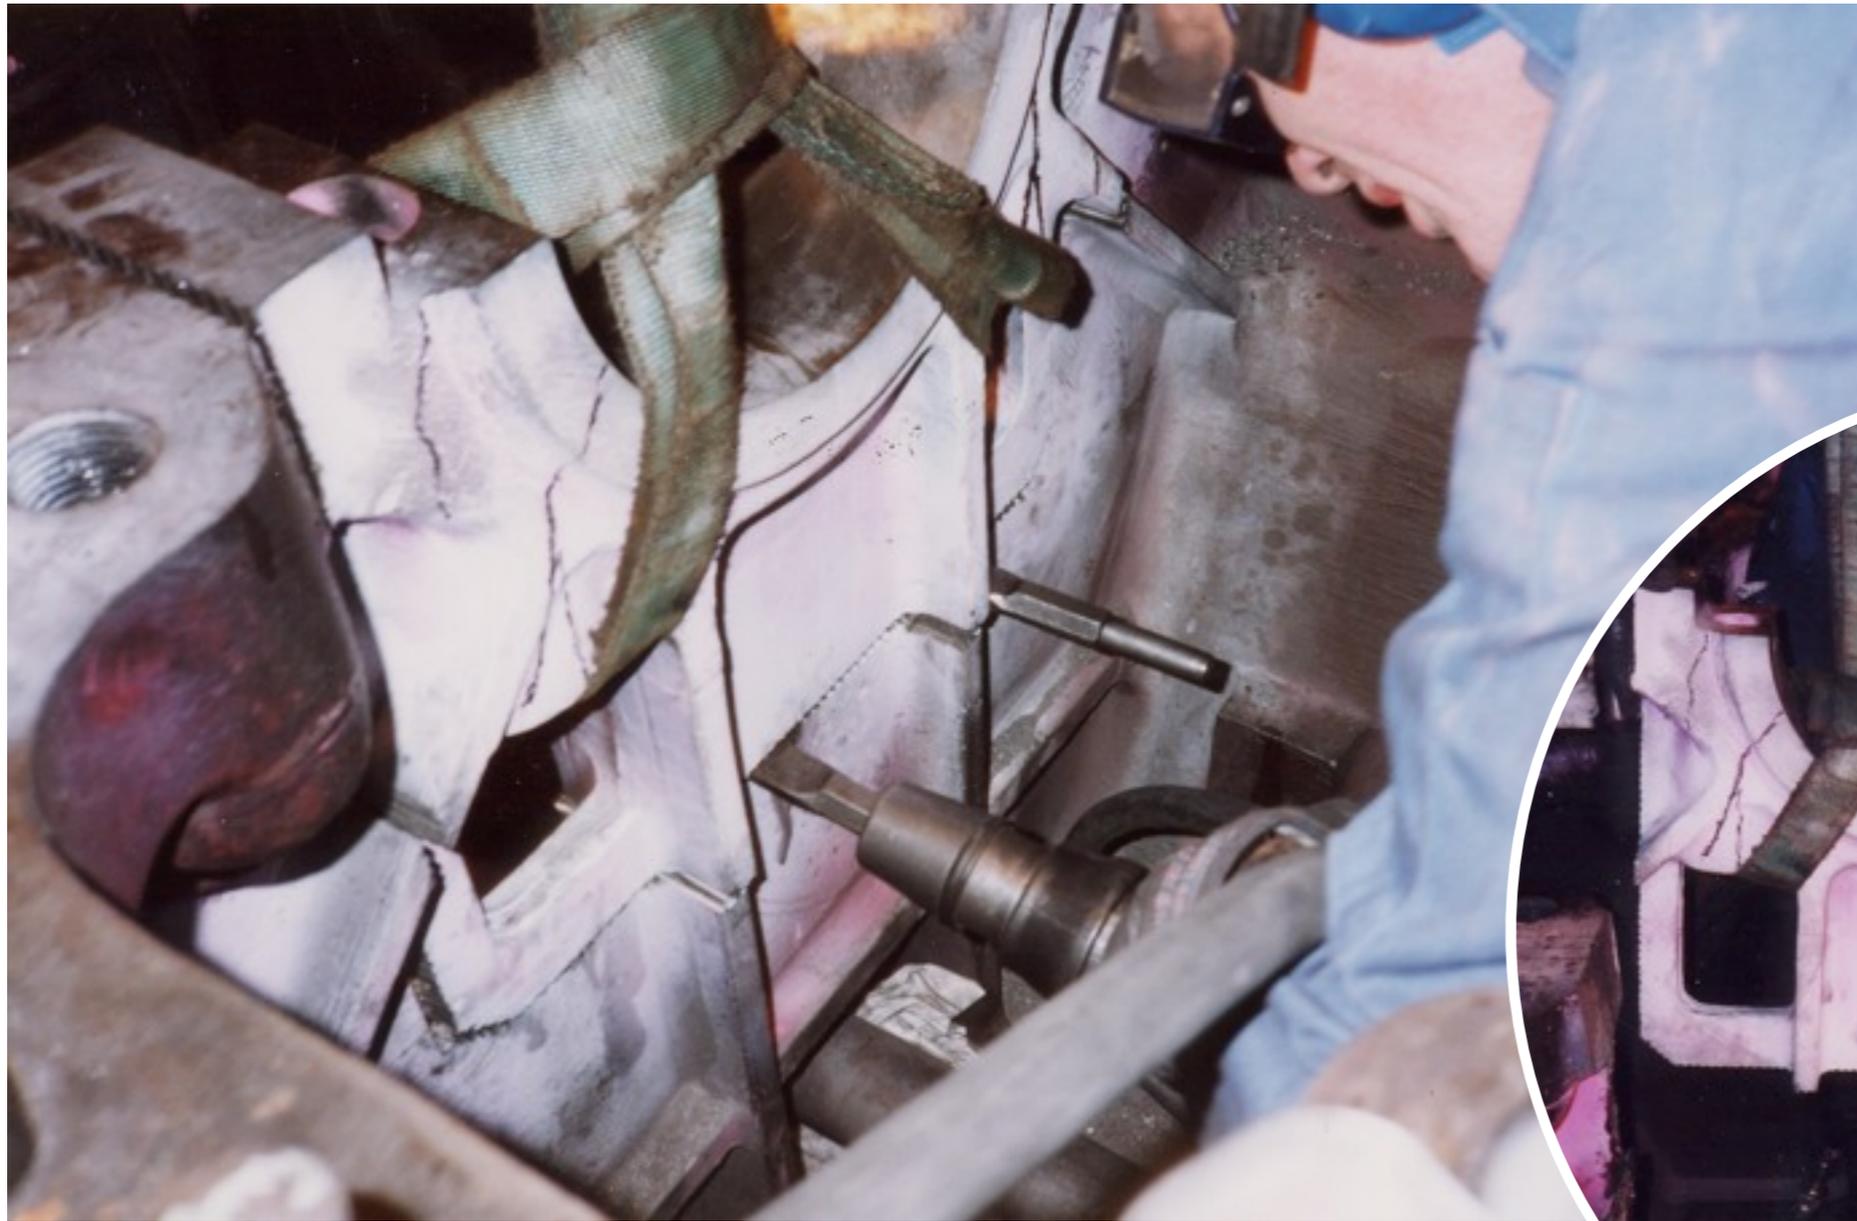
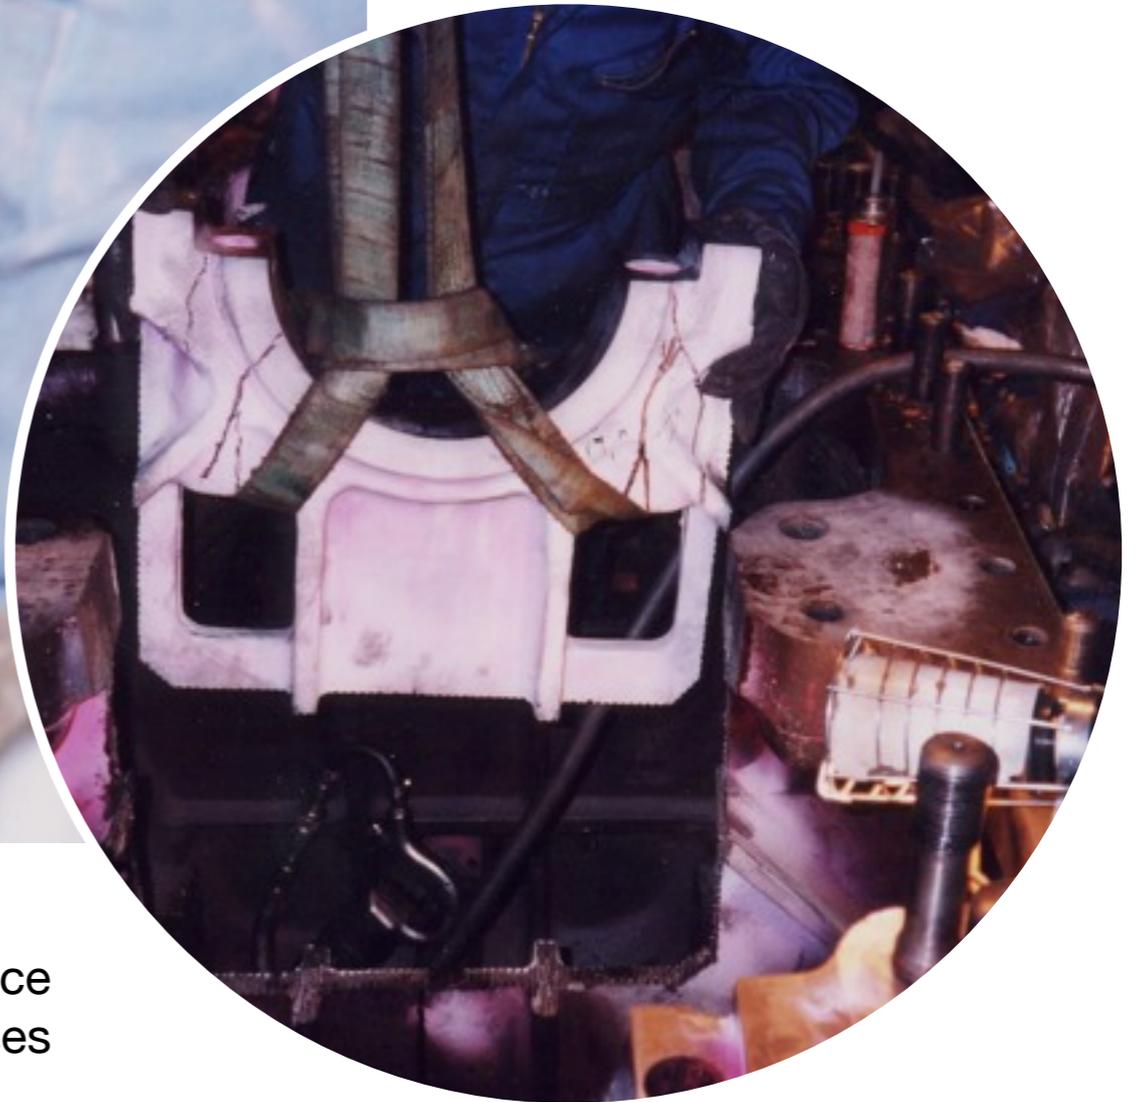
Driving a wedge into the sized holes to break the seal

Removing the bearing pocket in one piece
to be used for dimensional purposes
