Engine Bearing Pocket Transplant

Ship owners James Fishers contacted Metalock Engineering UK to see if a repair was possible on their main engine bedplate.

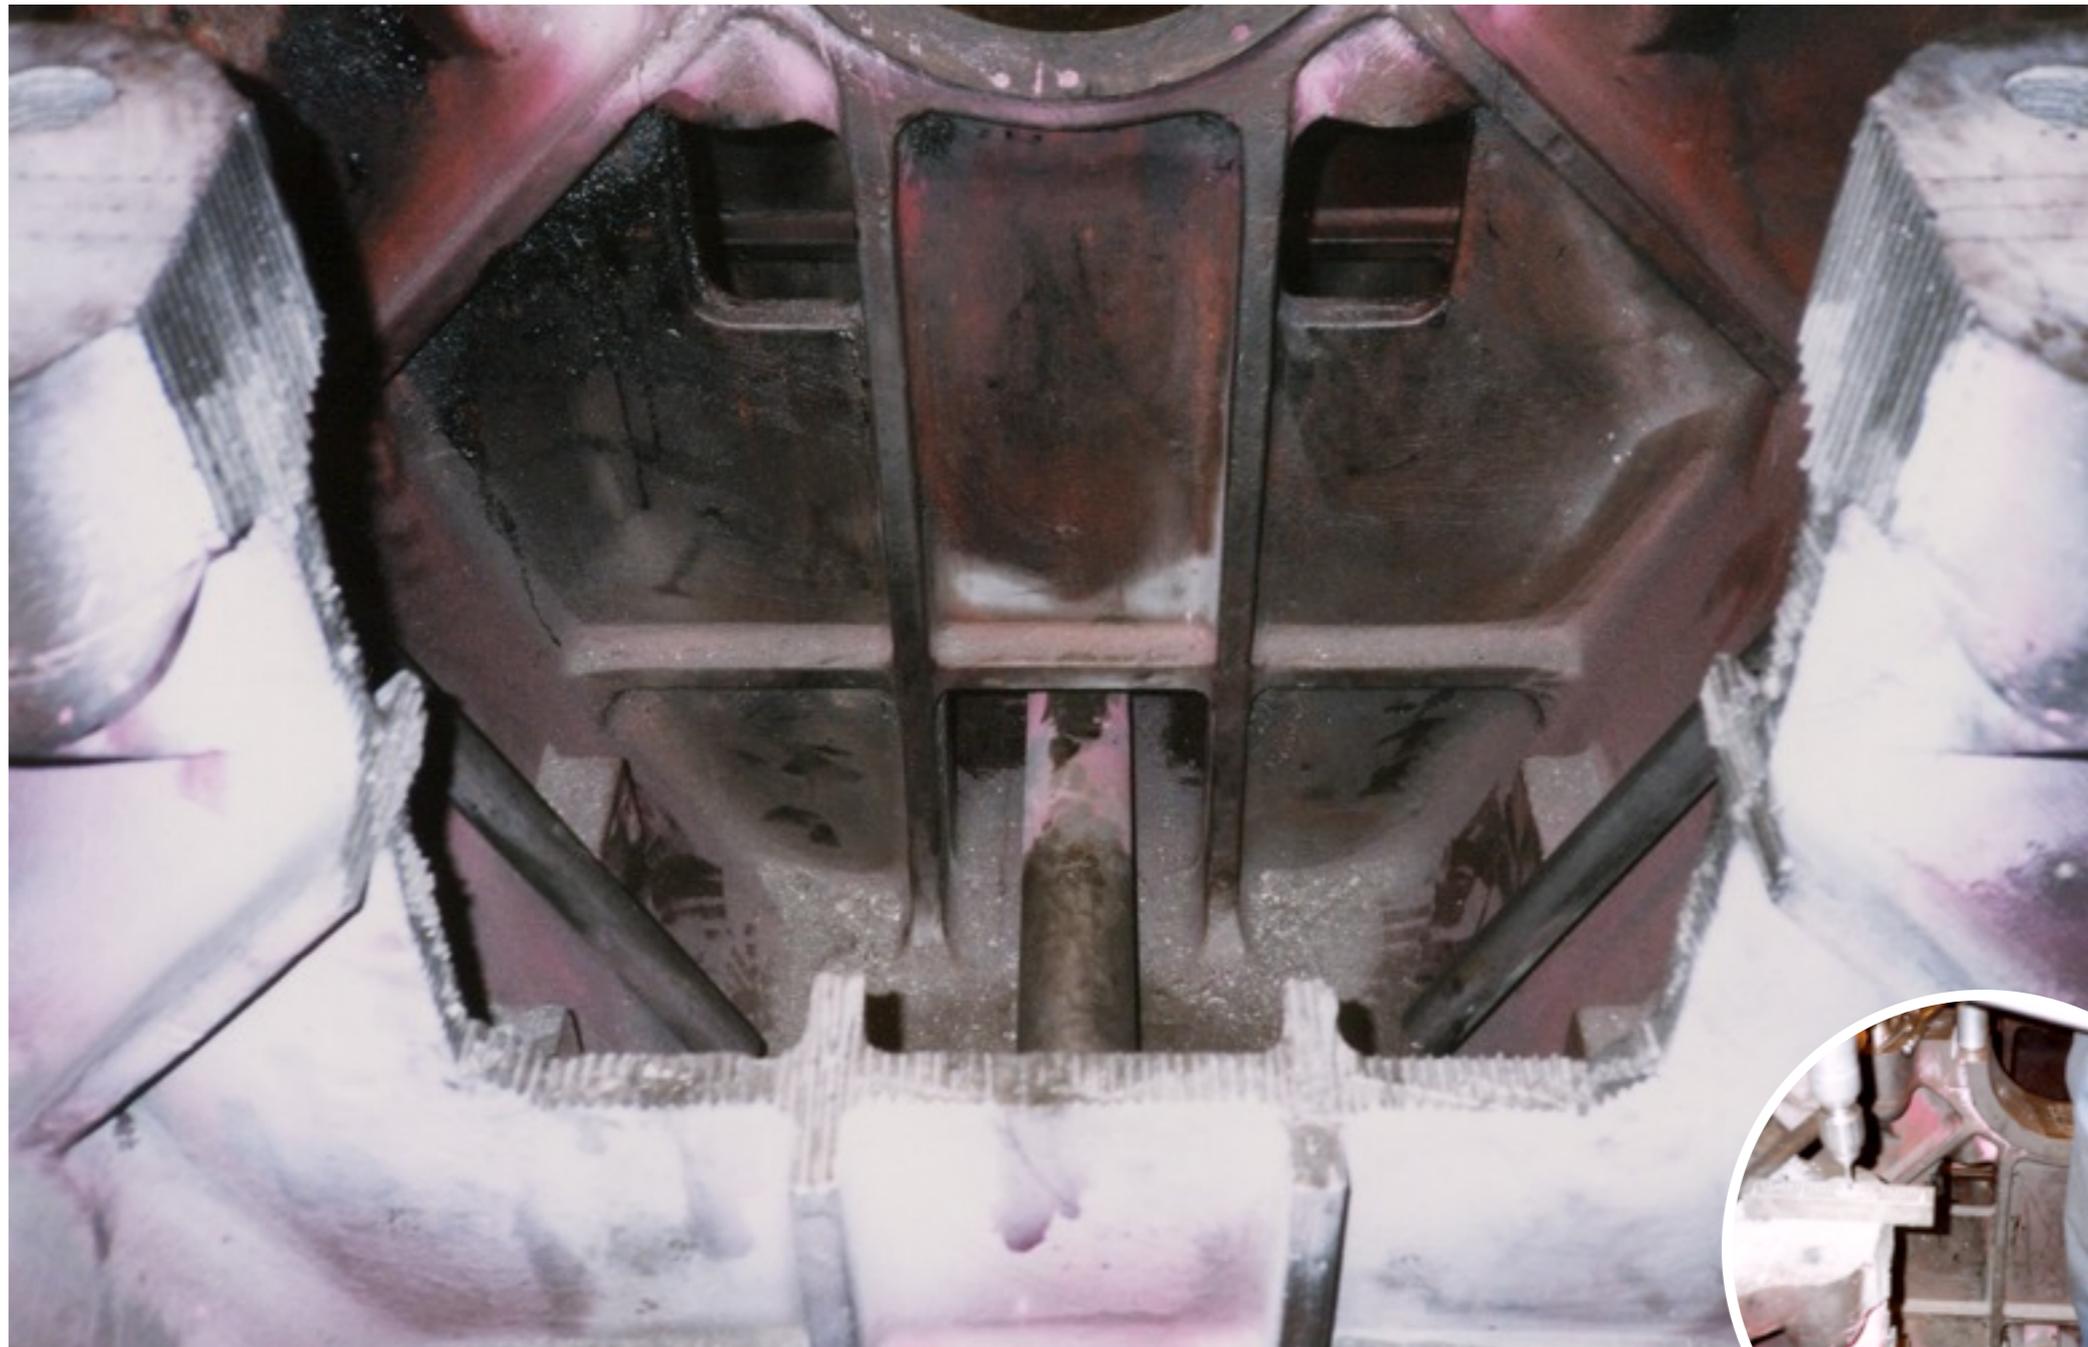
Aperture of bearing pocket ready to be cleaned up

Drilling between the Bearing Cap joint face to take fixed Masterlocks

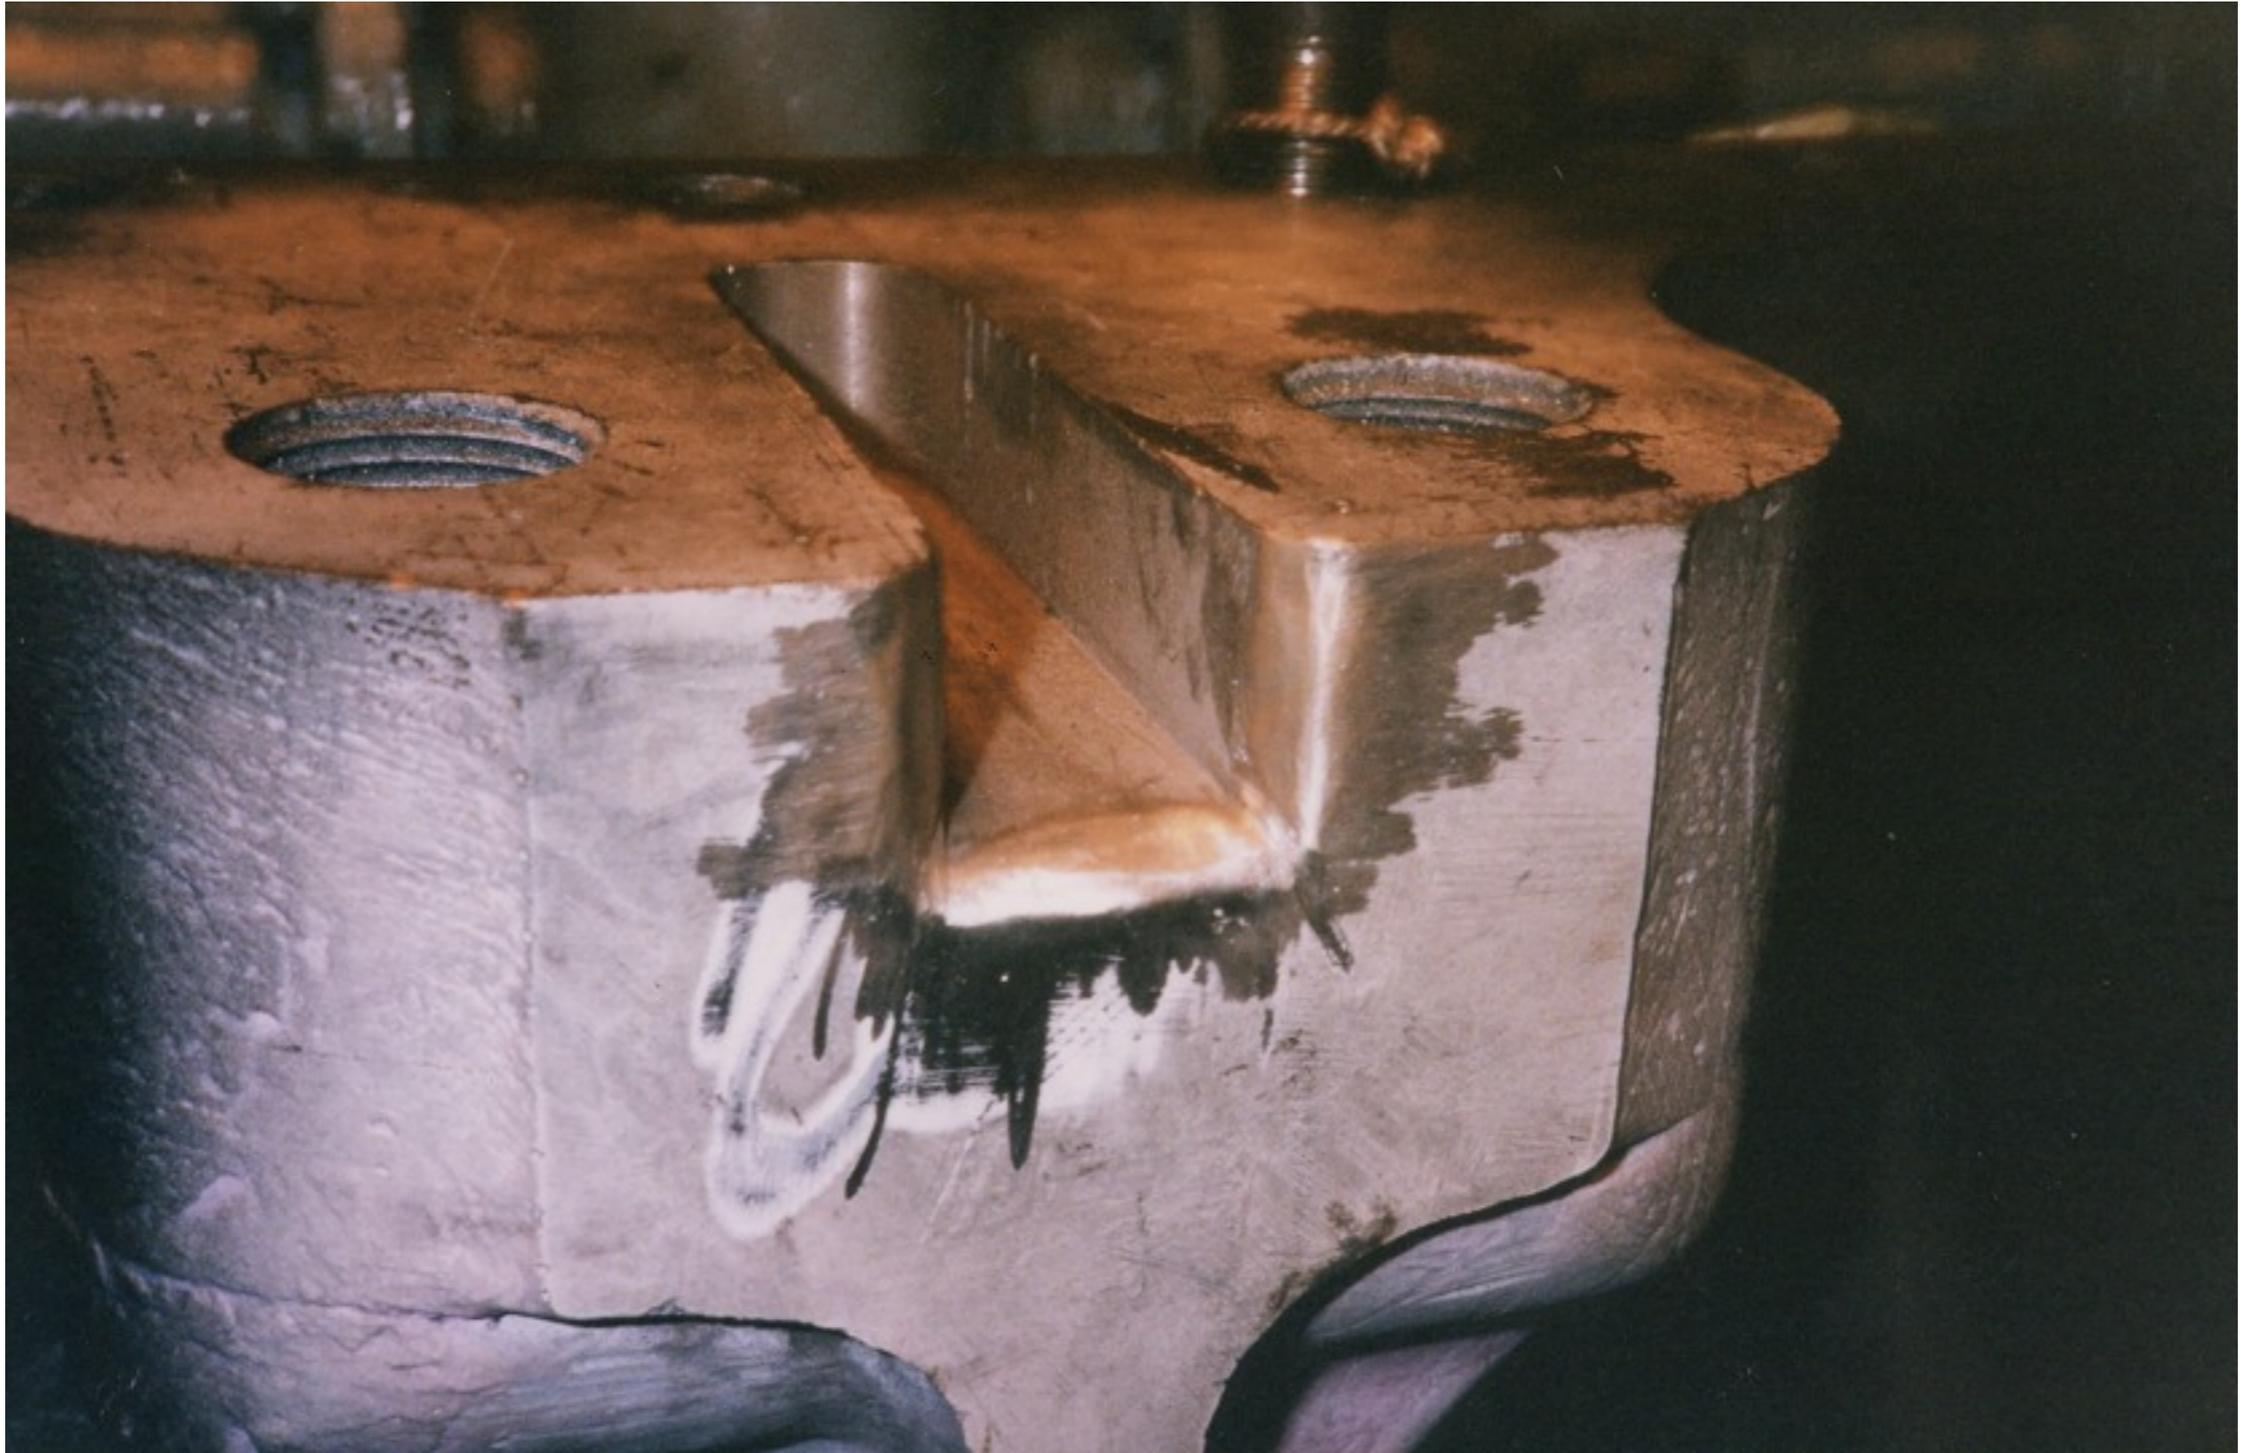
All sharp edges removed to eliminate stress raisers

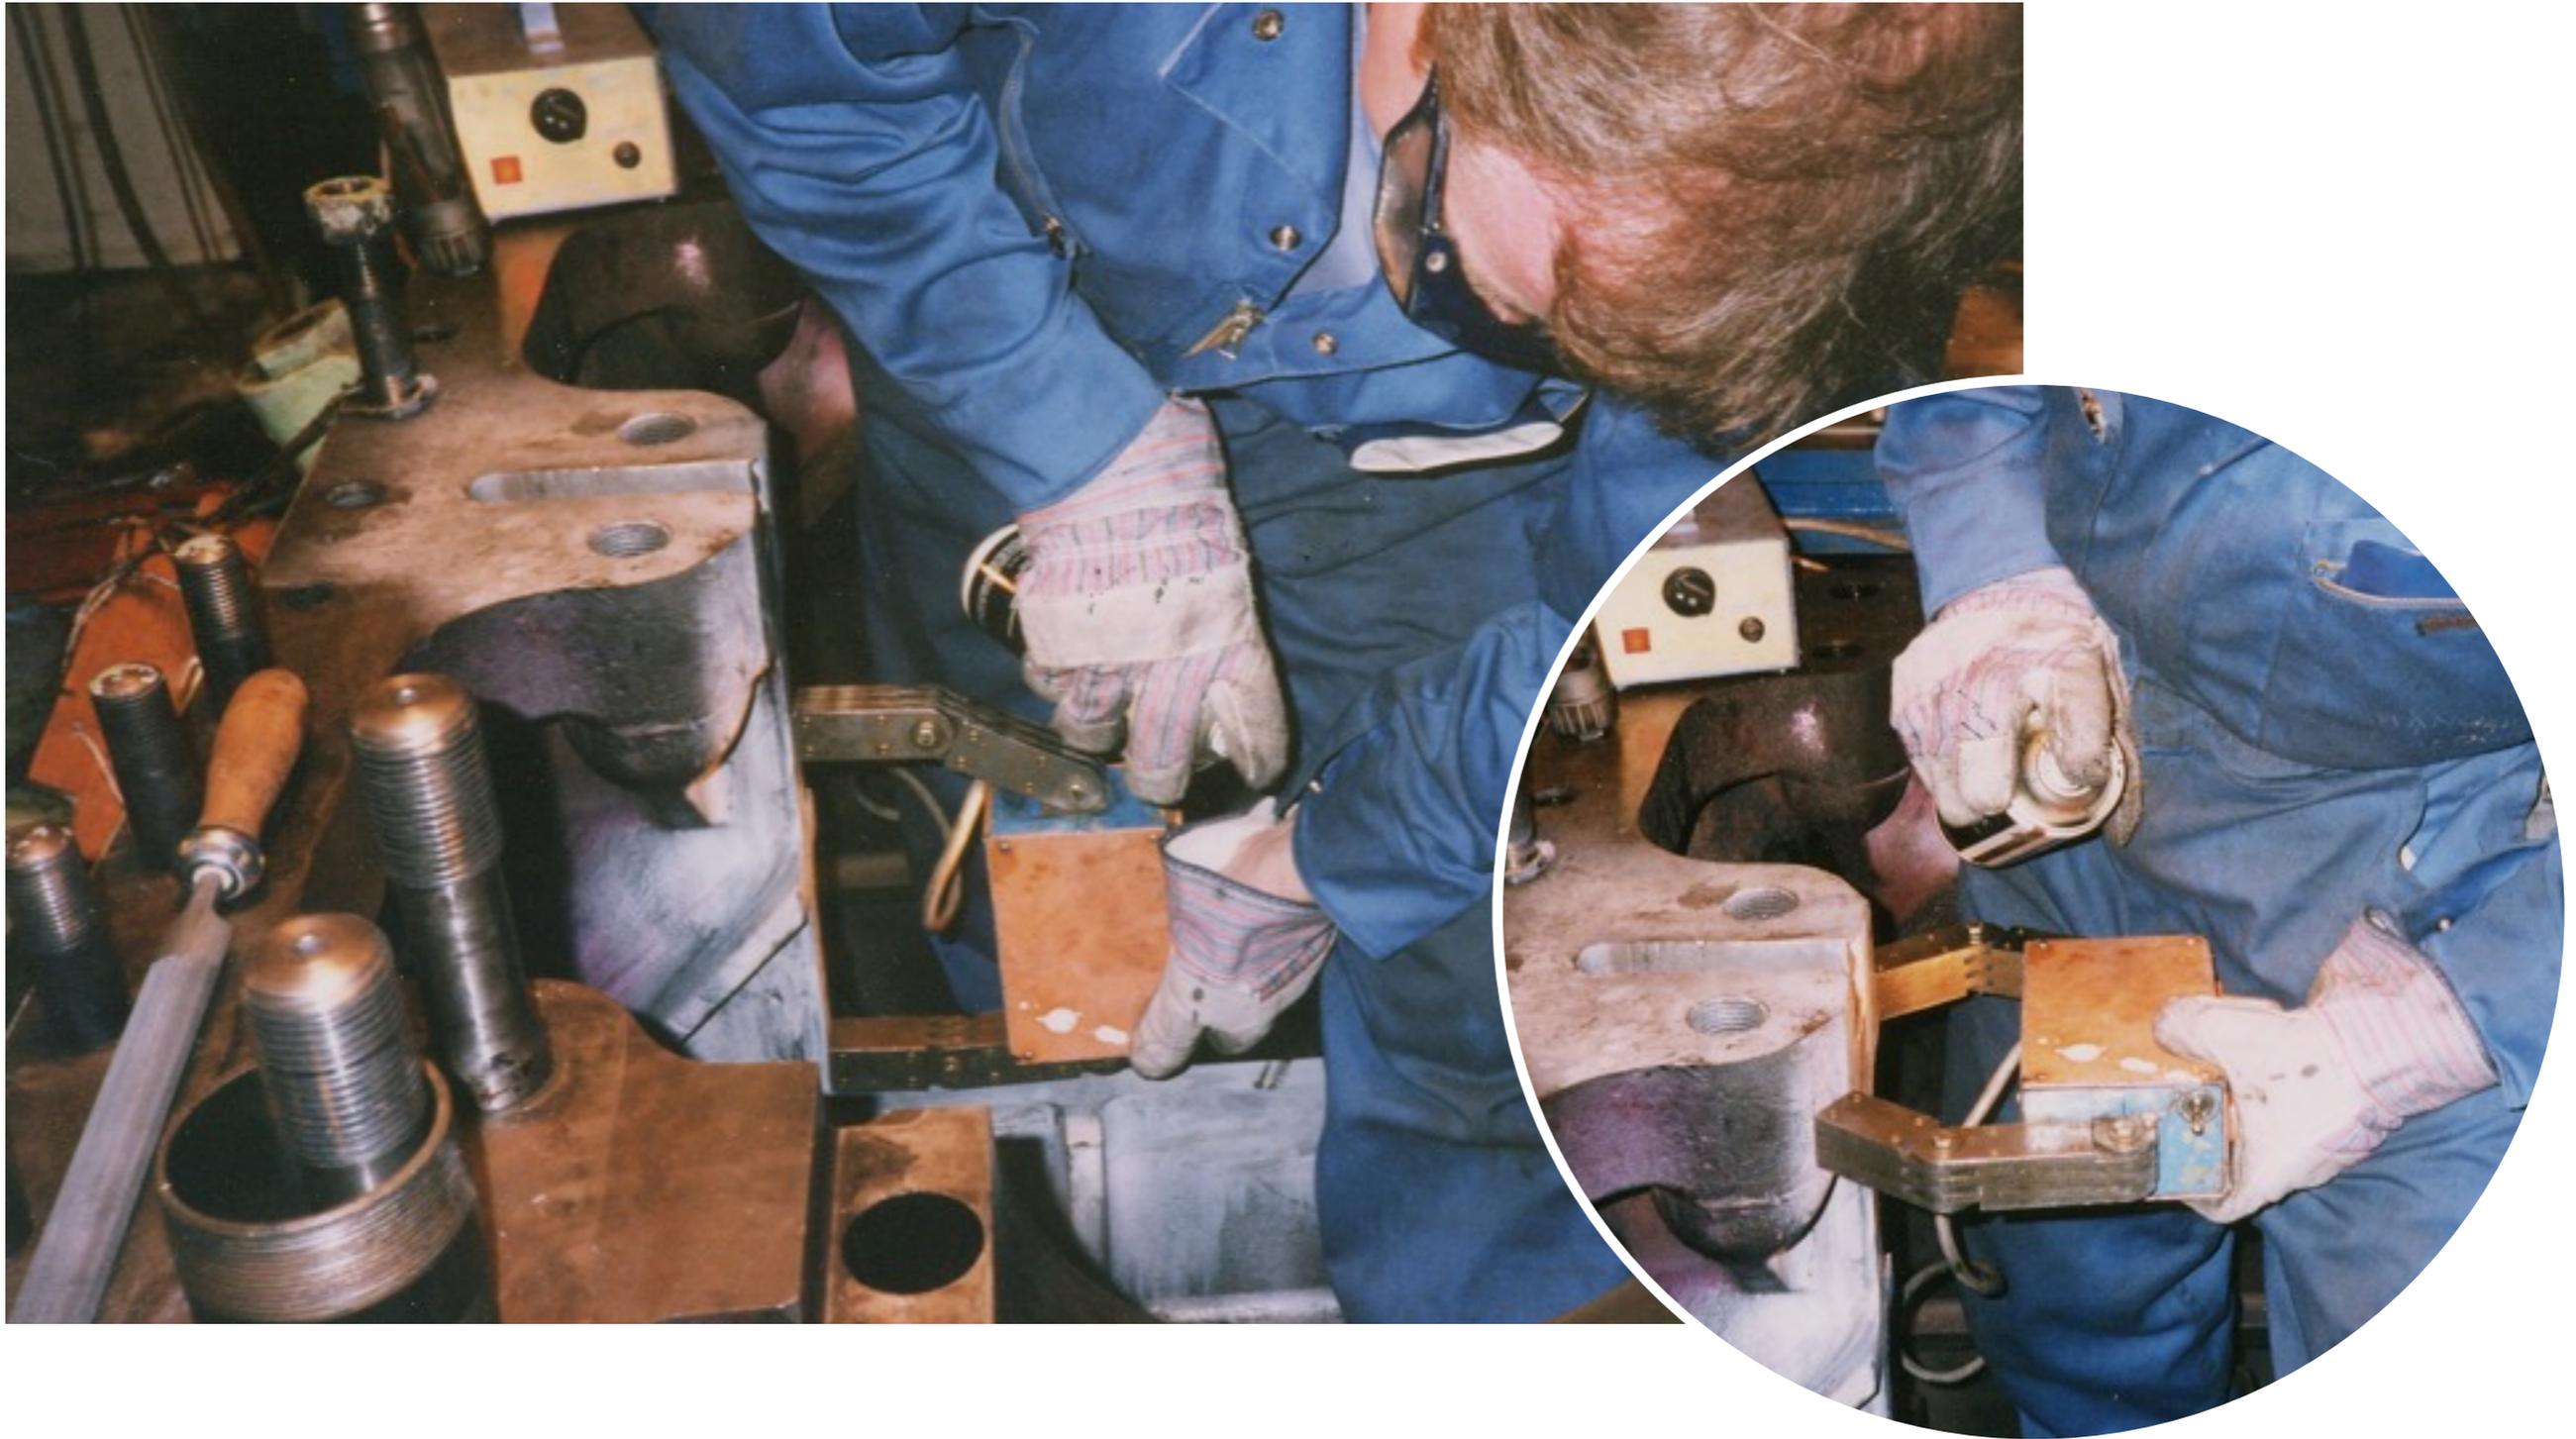
Non-destructive testing carried out to ensure all cracks have been removed

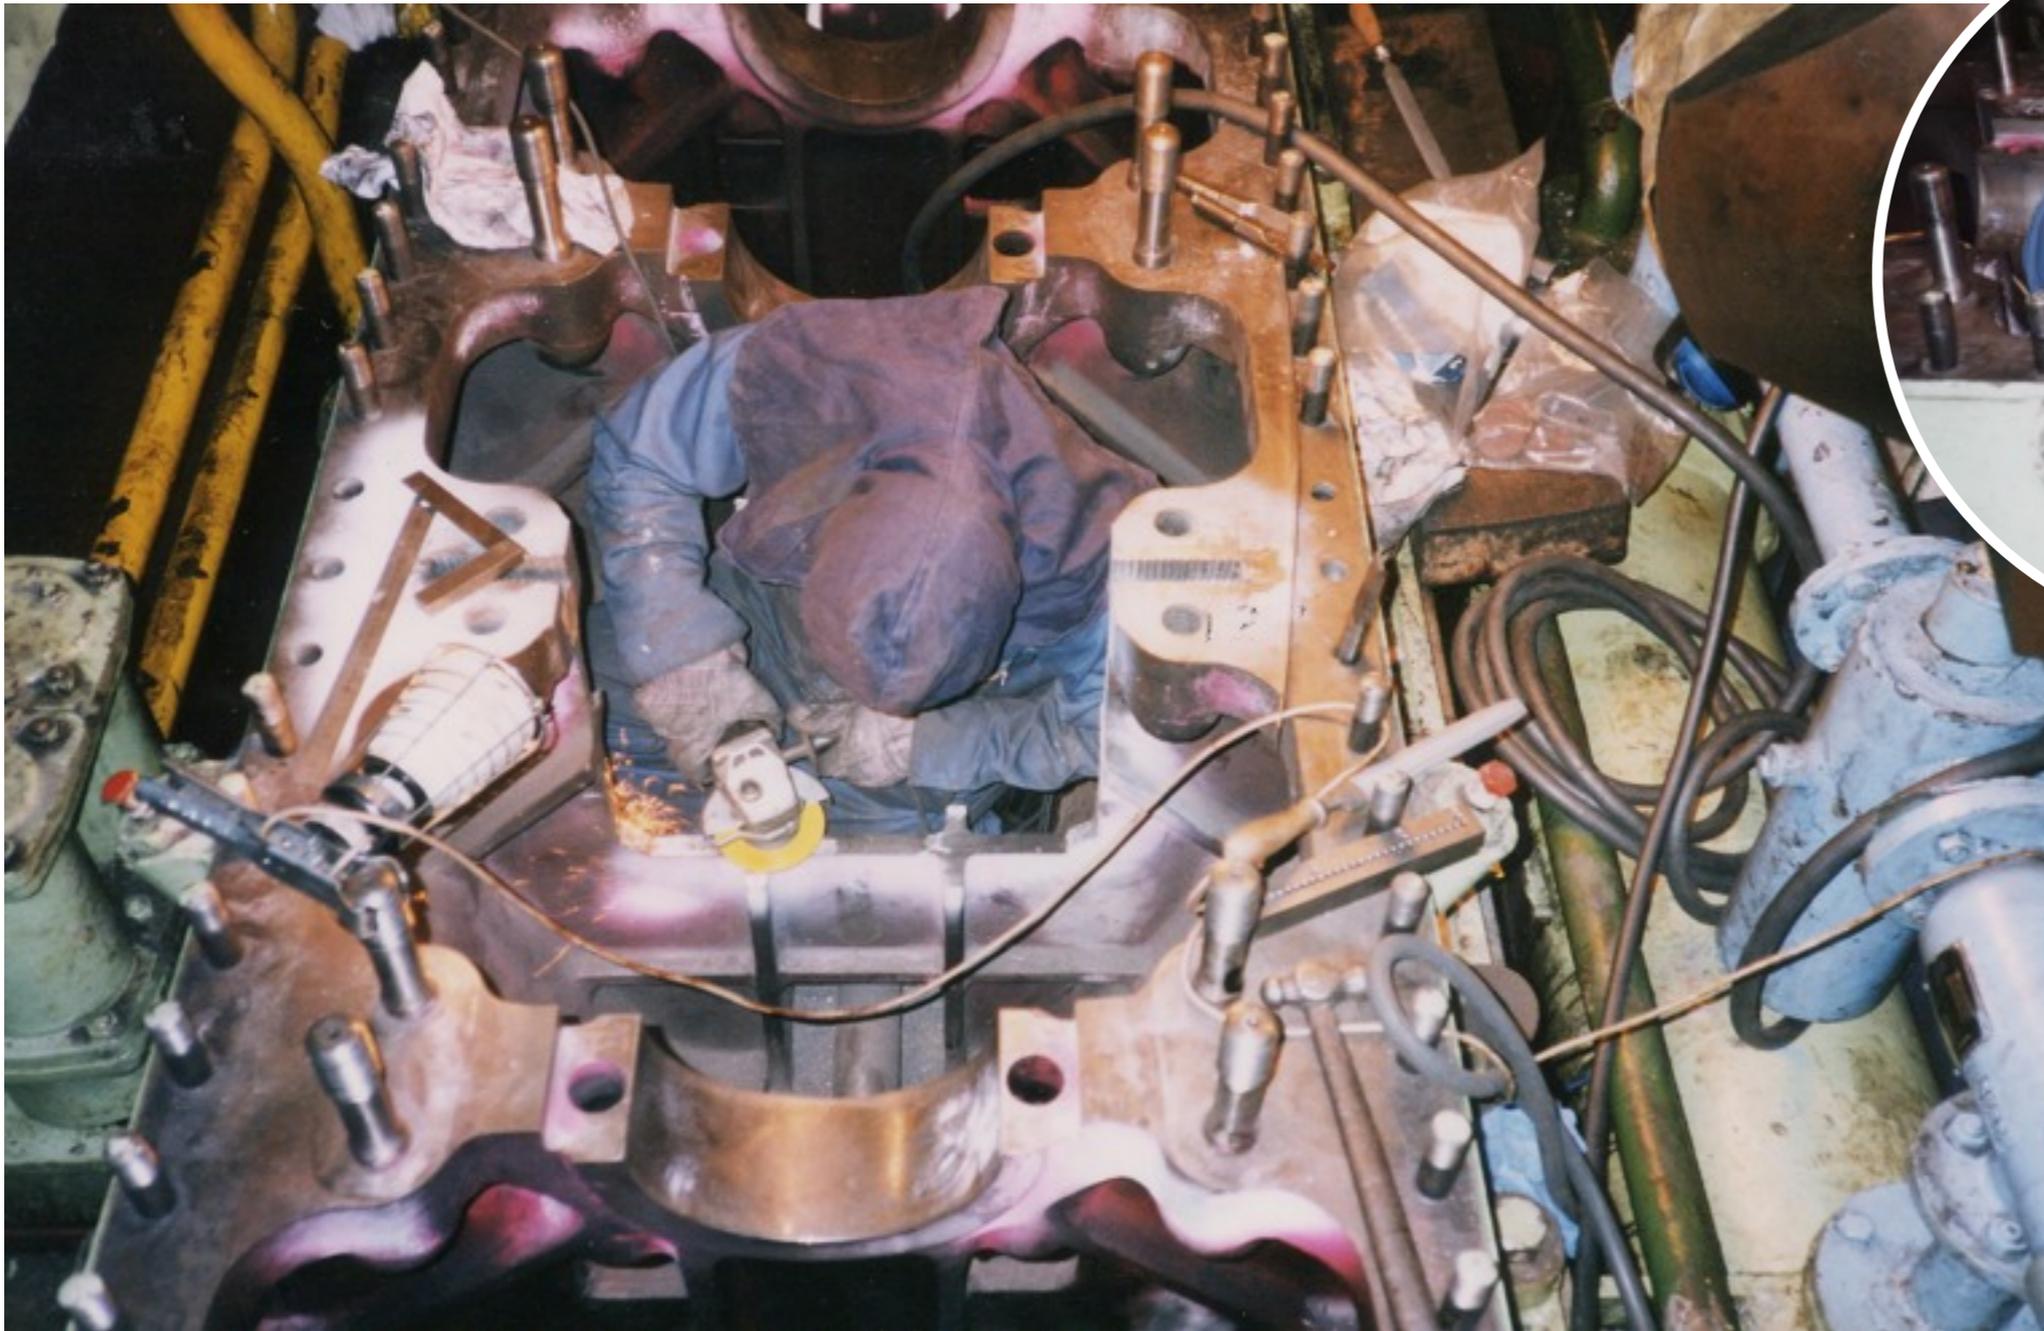
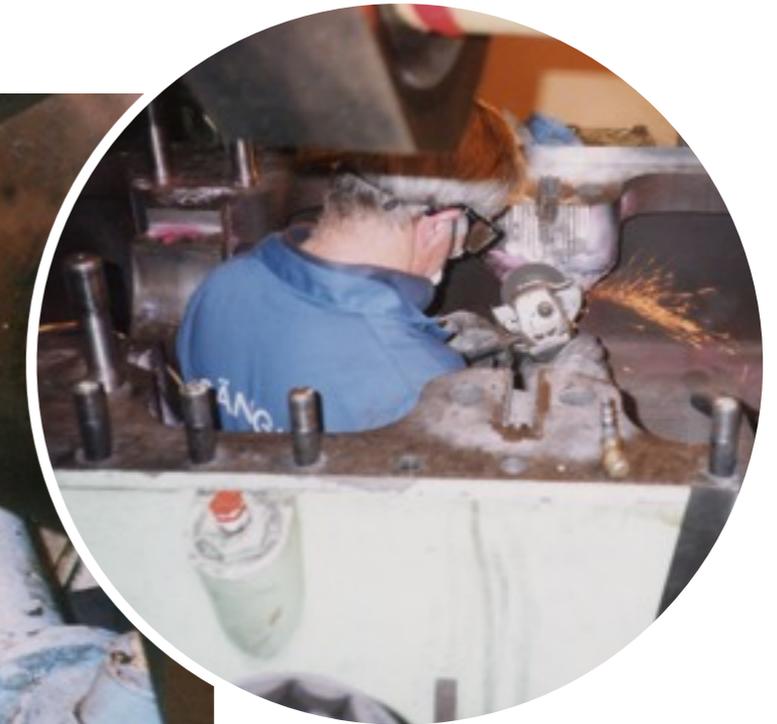
All faces hand dressed to accurate dimensions

Tools used

- Hand Grinders
- Files
- Tape Measures
- Set Square
- Inside Micrometer

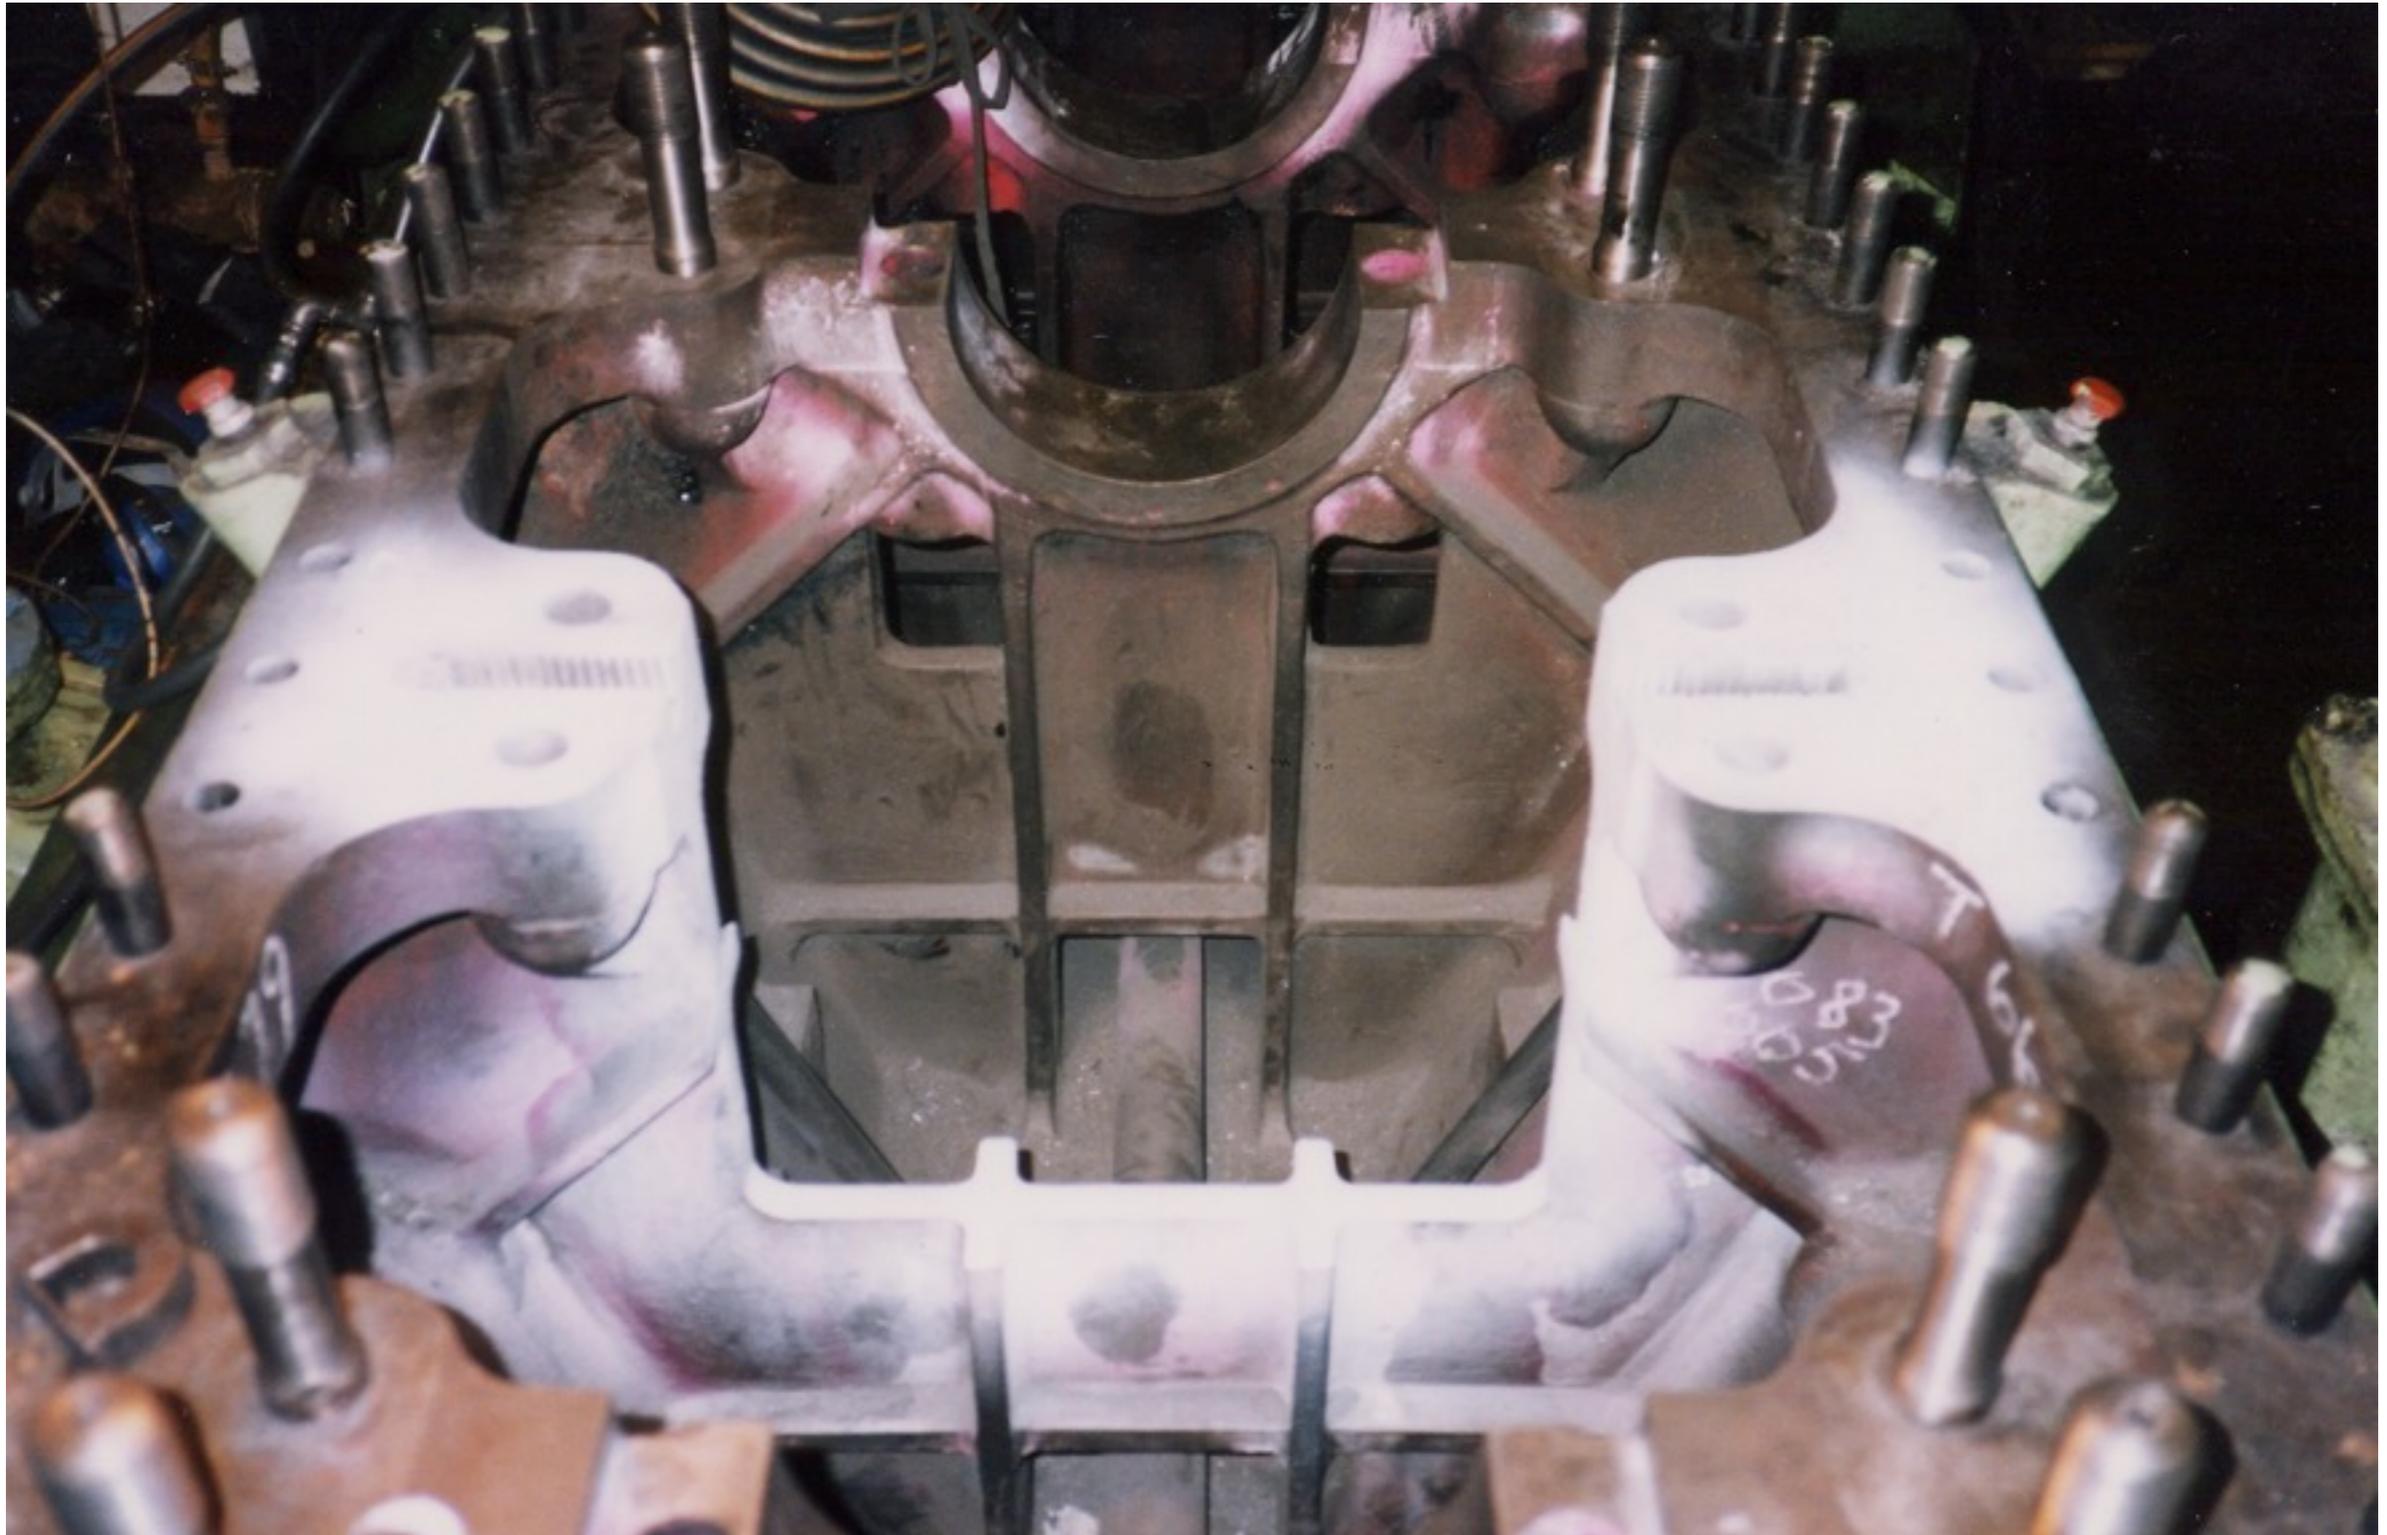
Completion of hand dressing

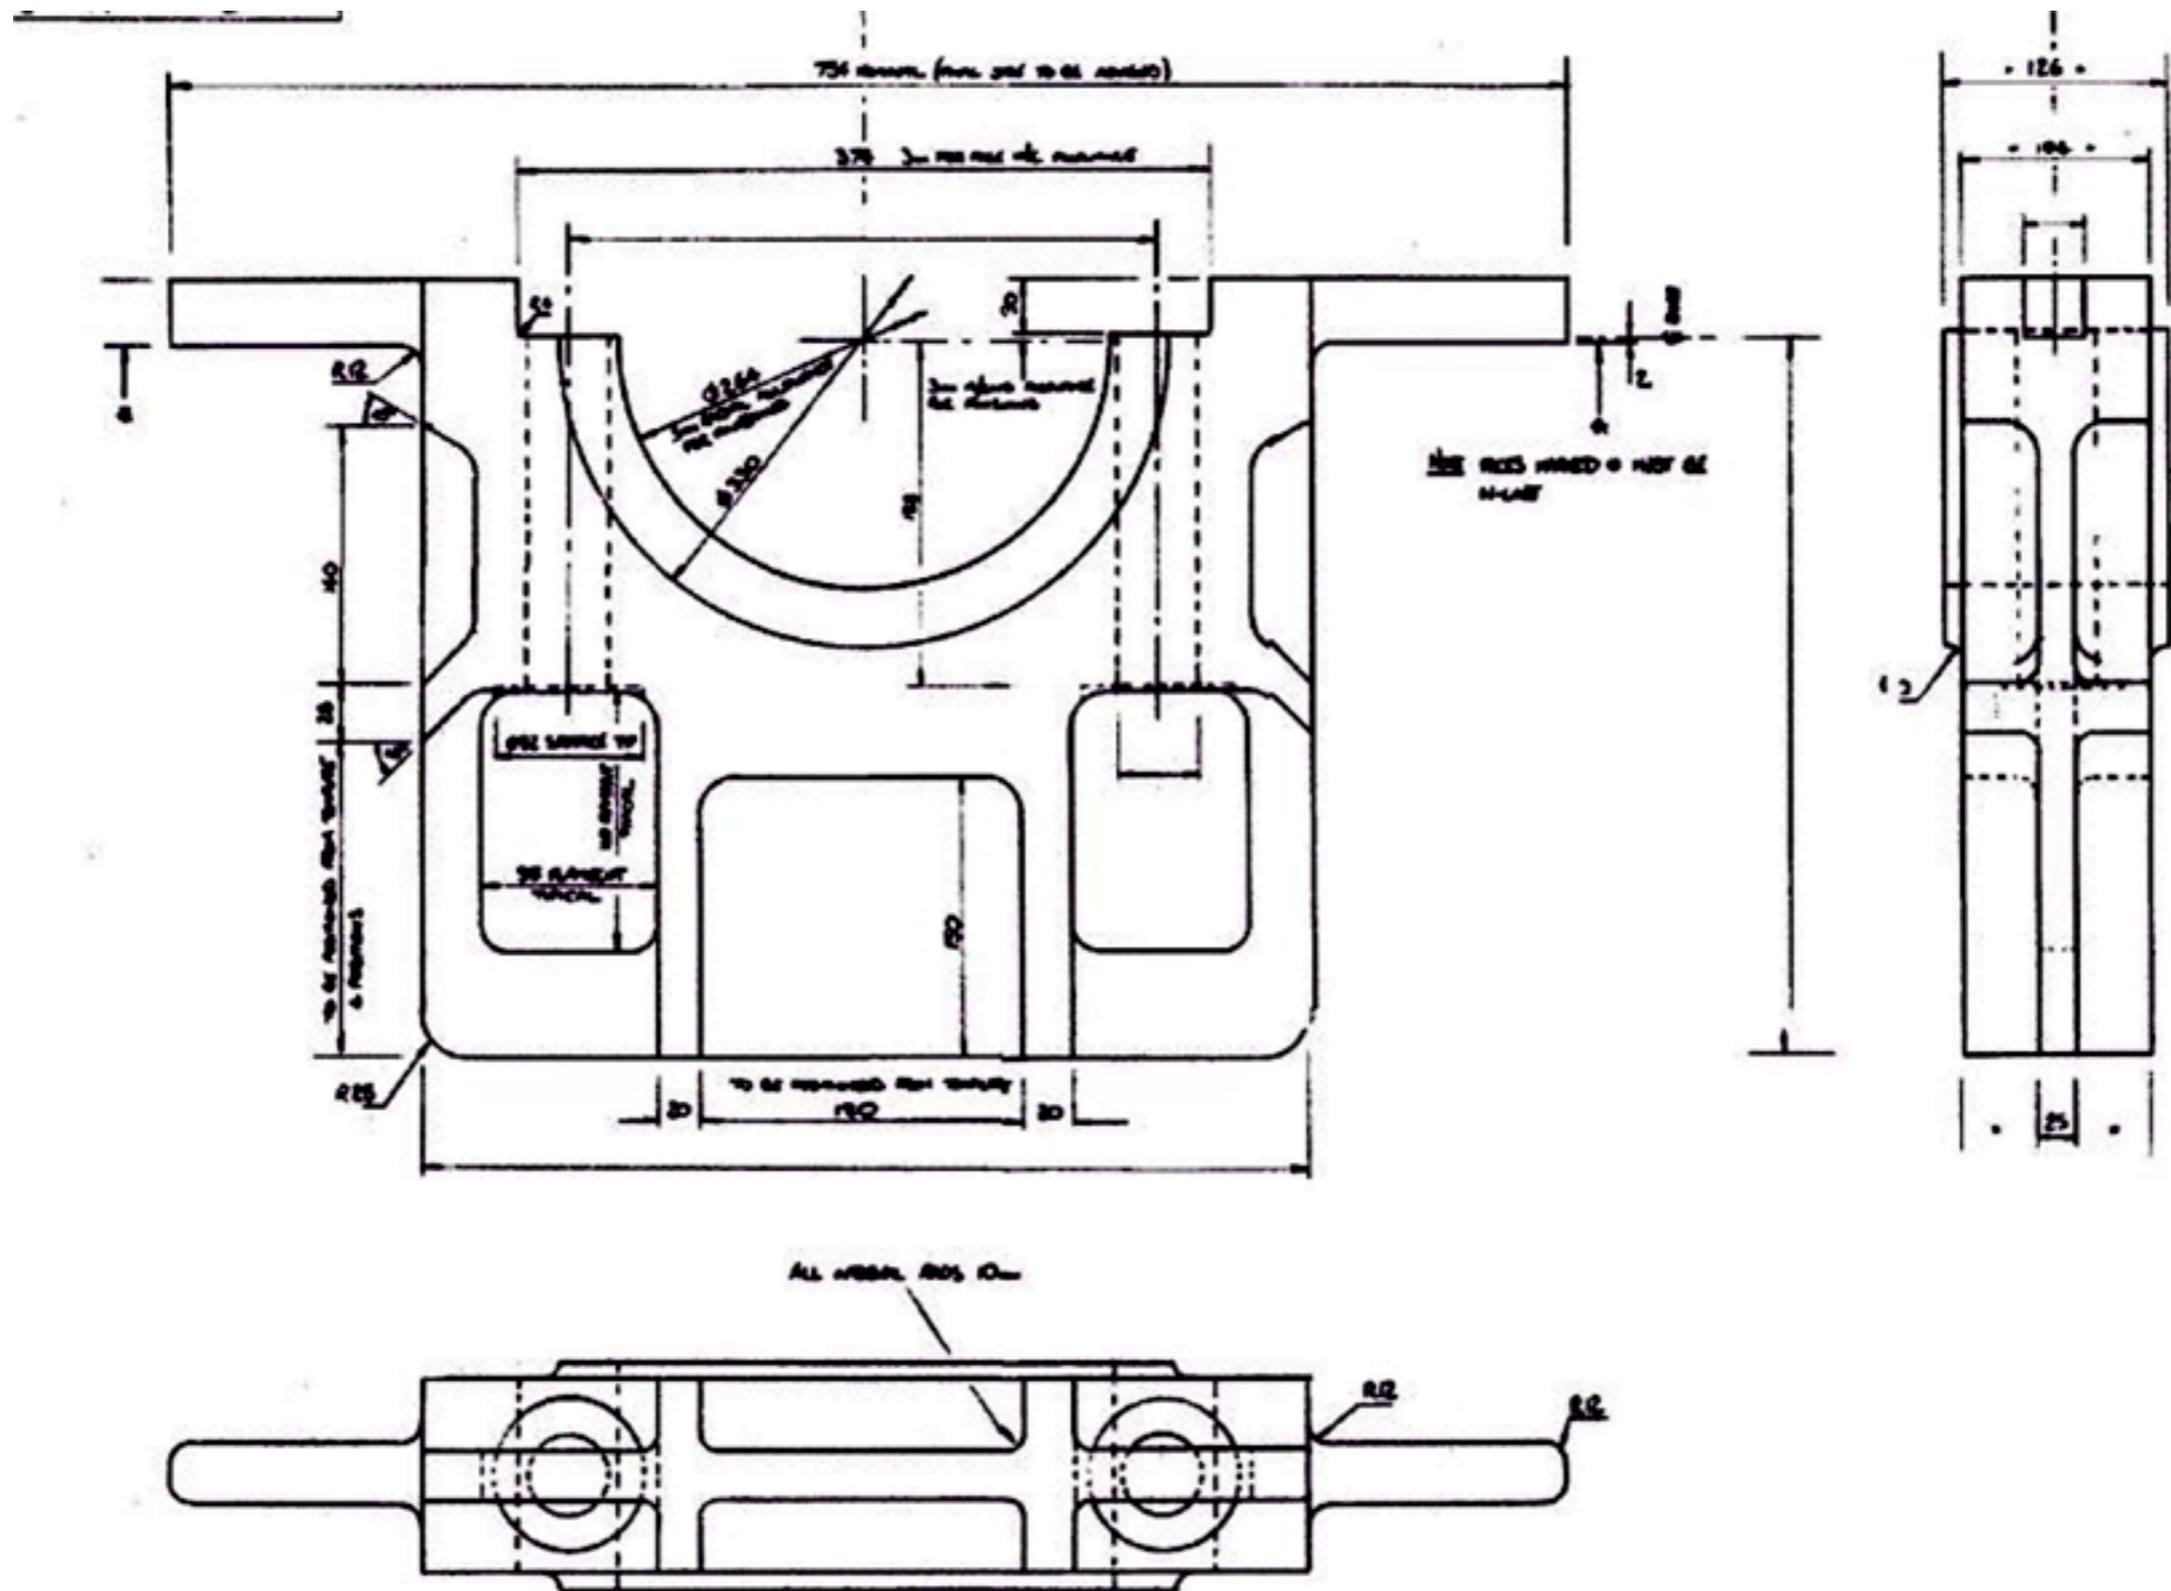
Dimensions taken and transferred to a drawing
