Engine Bearing Pocket Transplant

Ship owners James Fishers contacted Metalock Engineering UK to see if a repair was possible on their main engine bedplate.

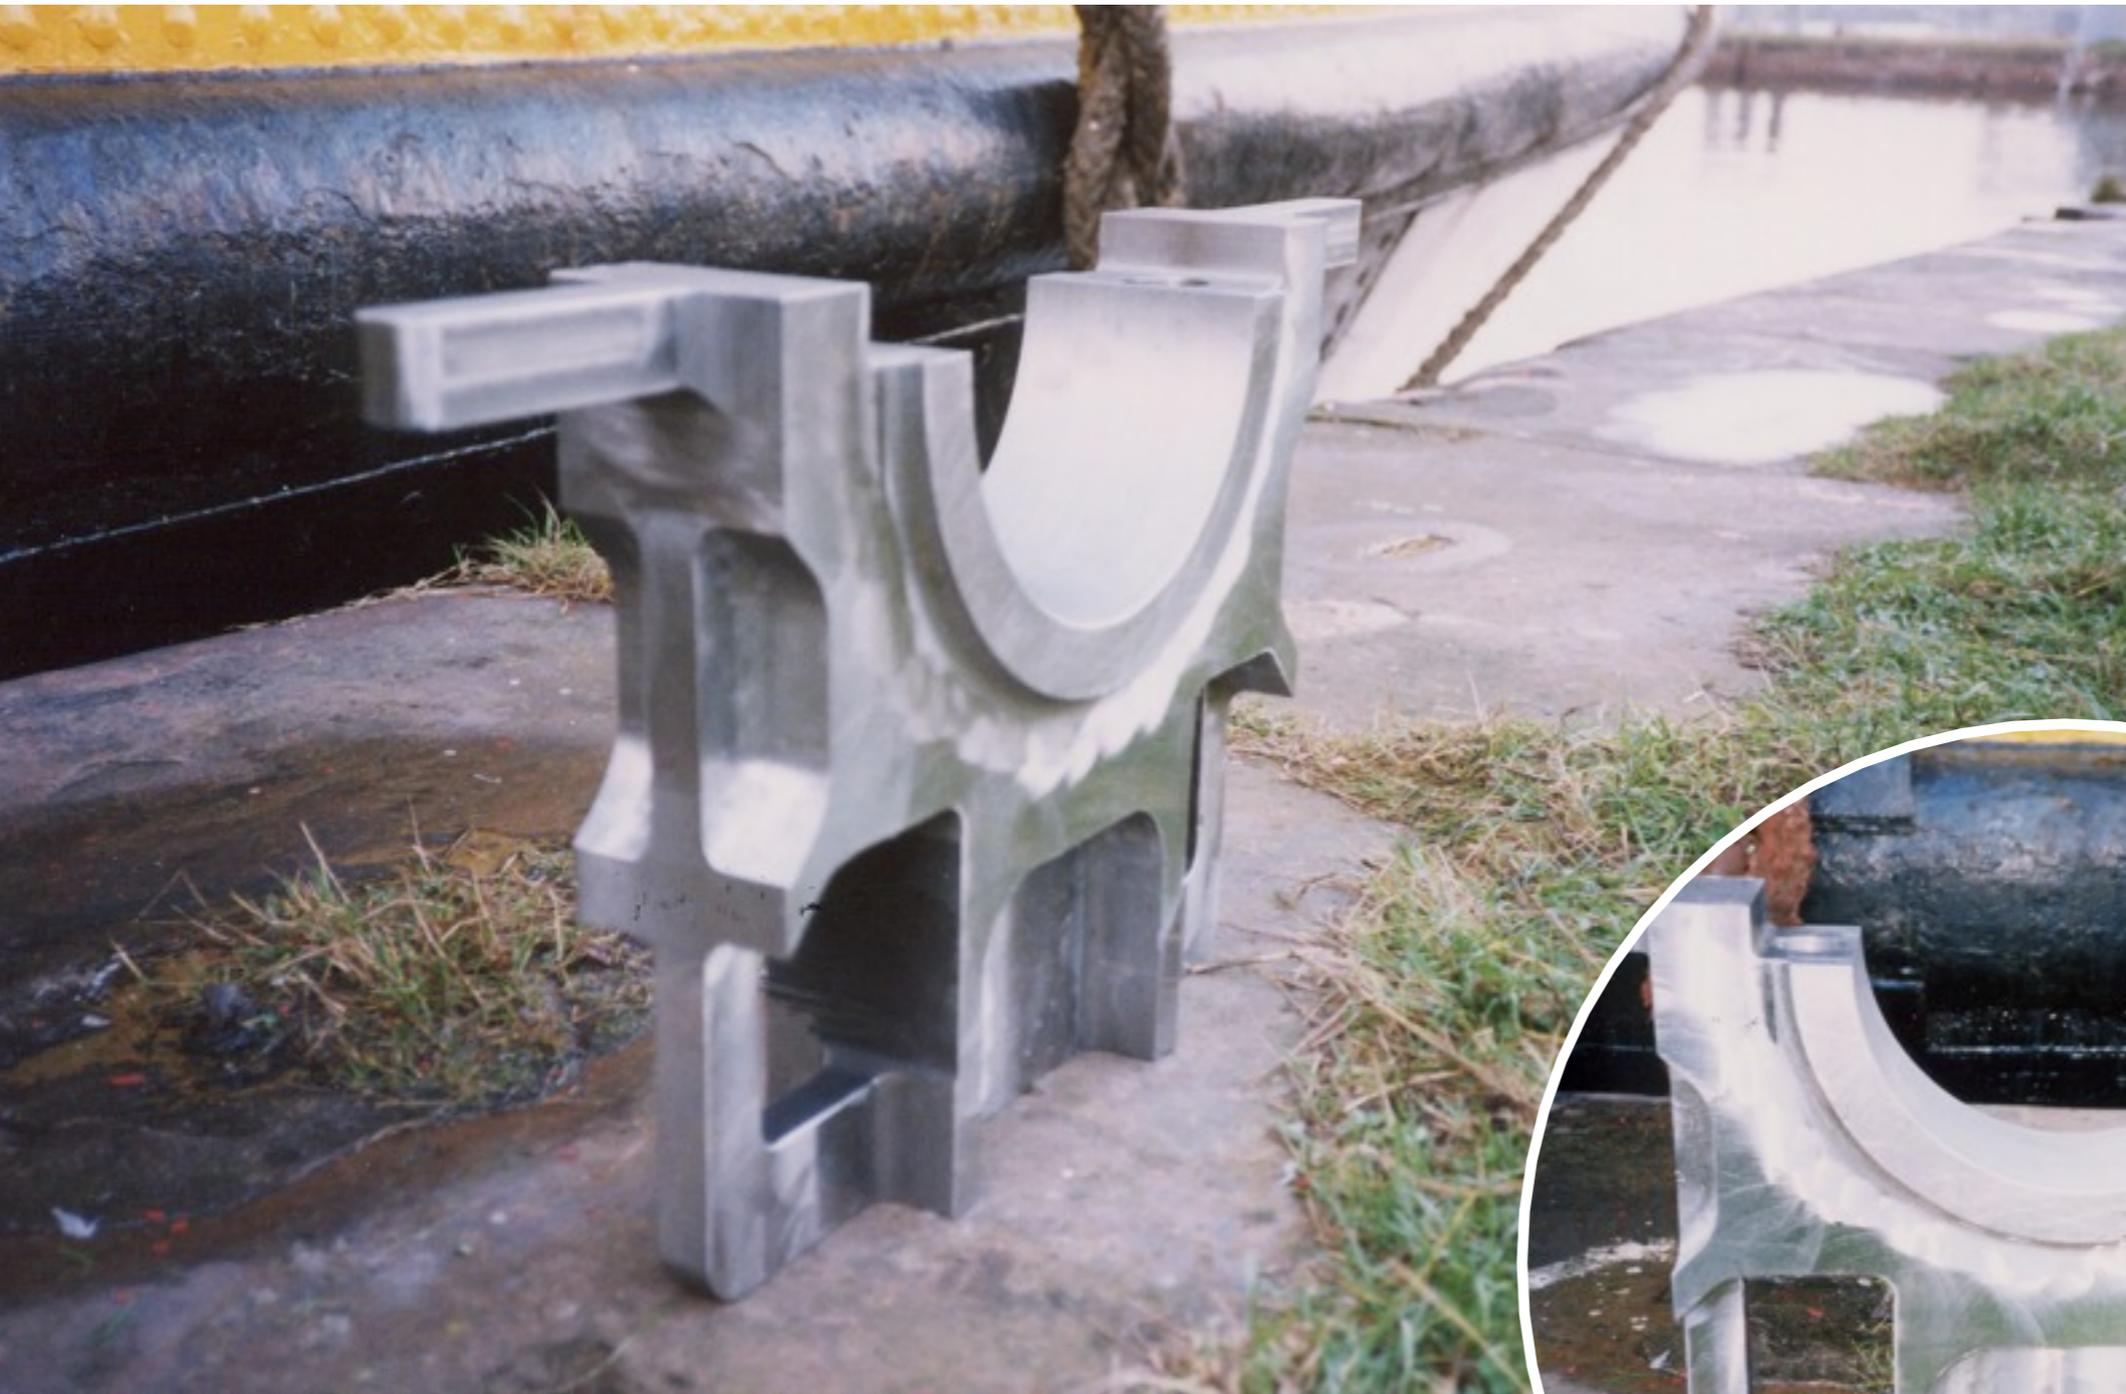
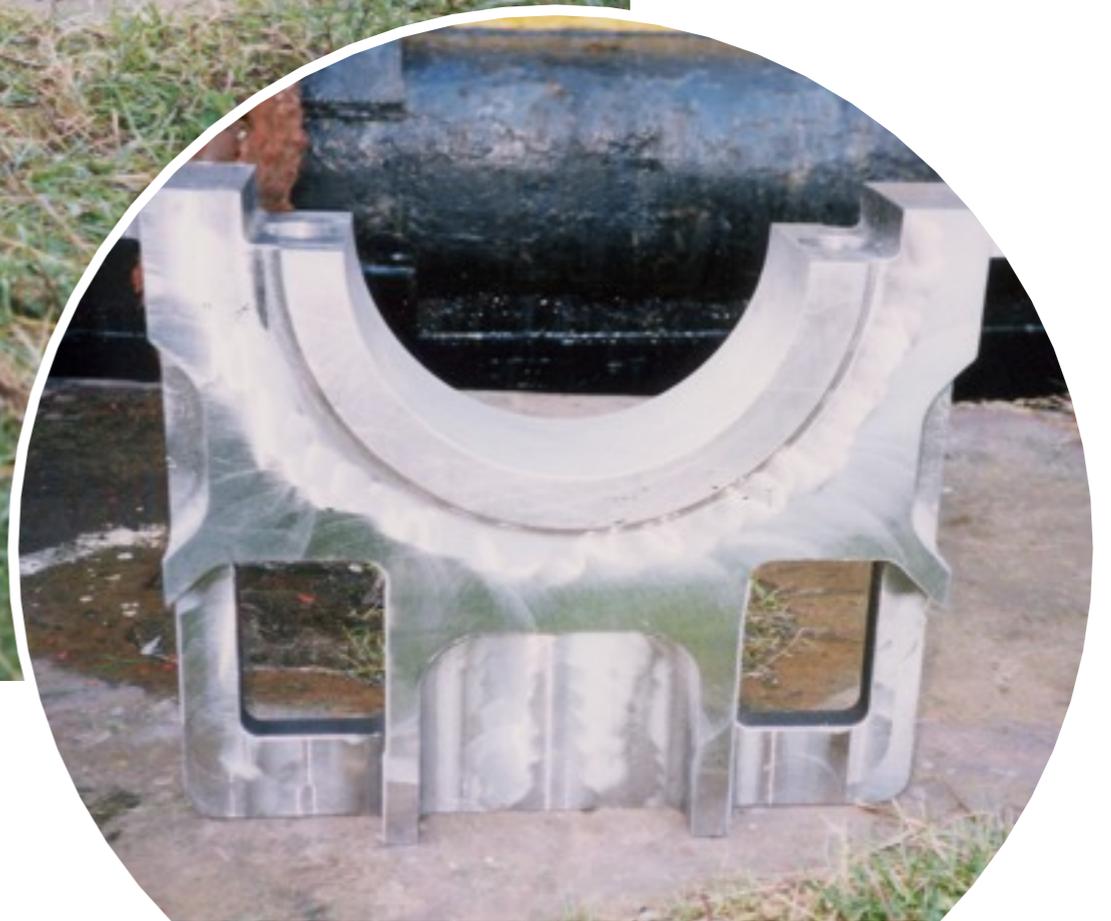
Steel insert manufactured from a solid ingot

Insert showing attached Masterlocks to help spread the load

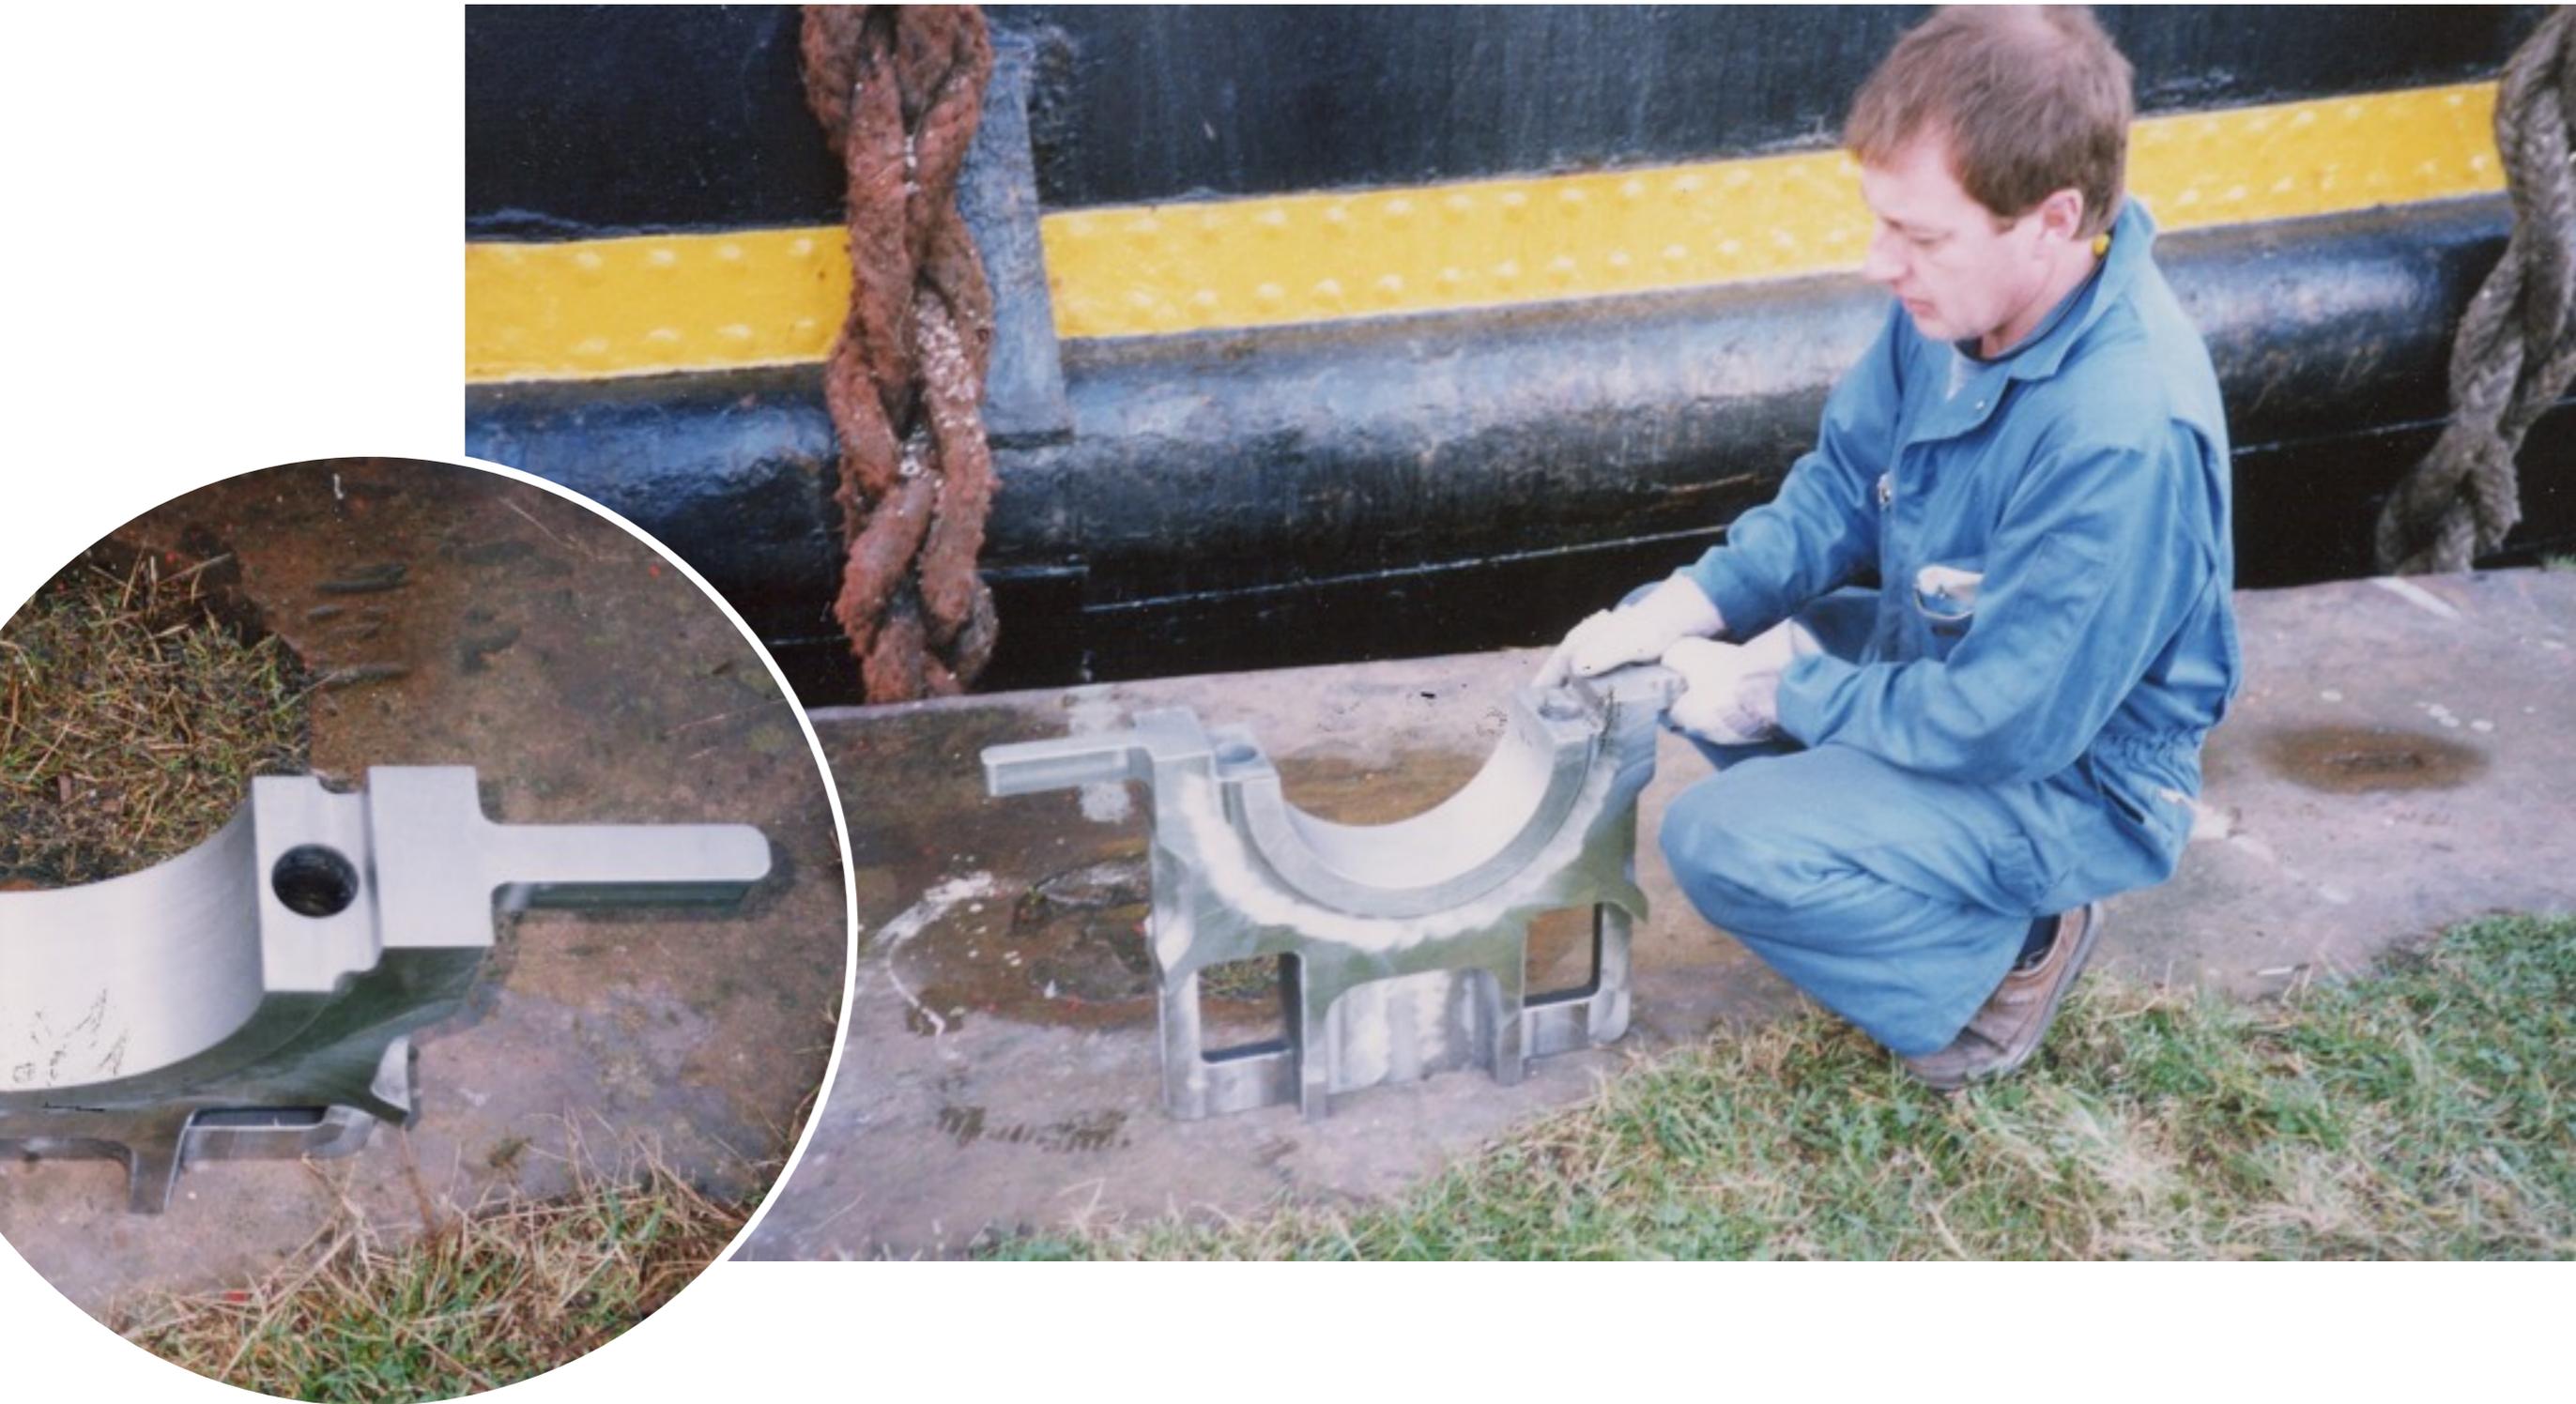
Bearing Cap bolt holes drilled at manufacturing stage

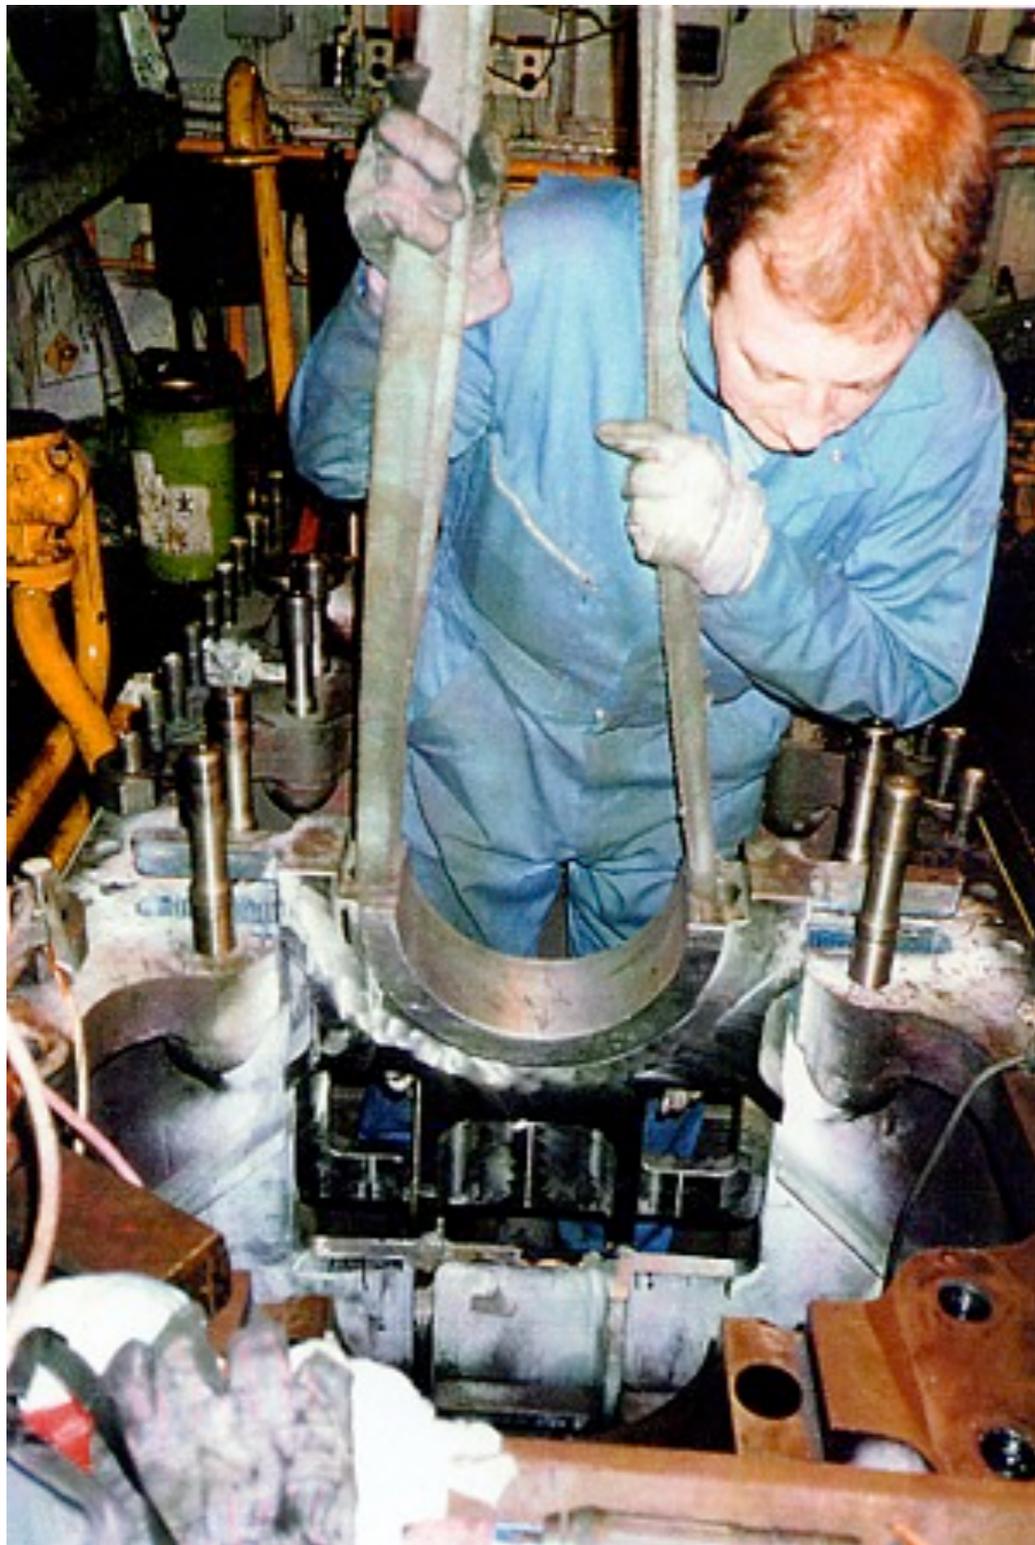
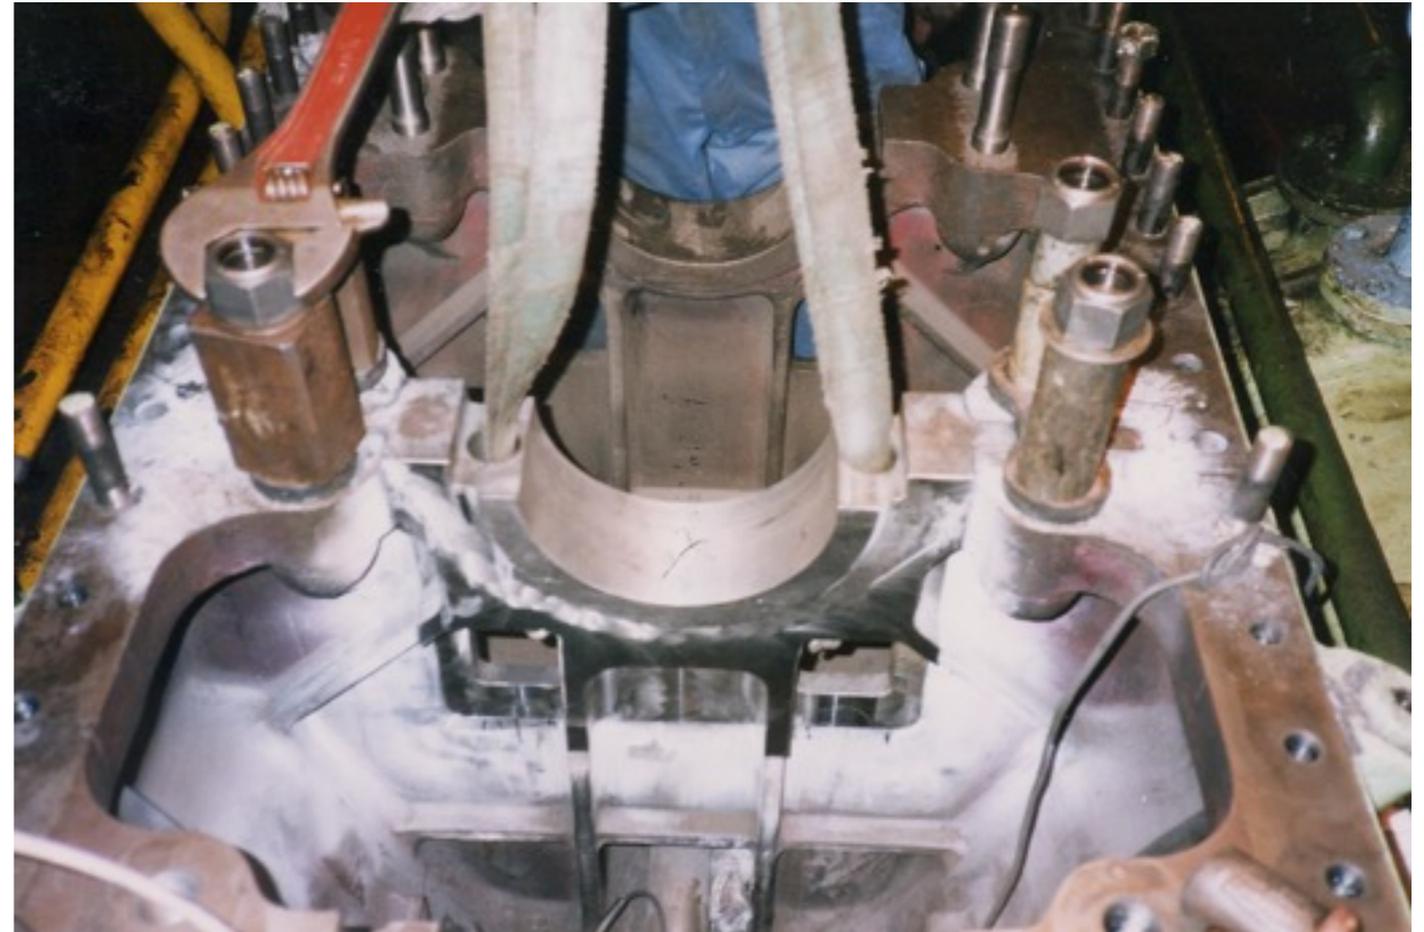
Insert being lowered into the prepared aperture making sure all the ribs are inline

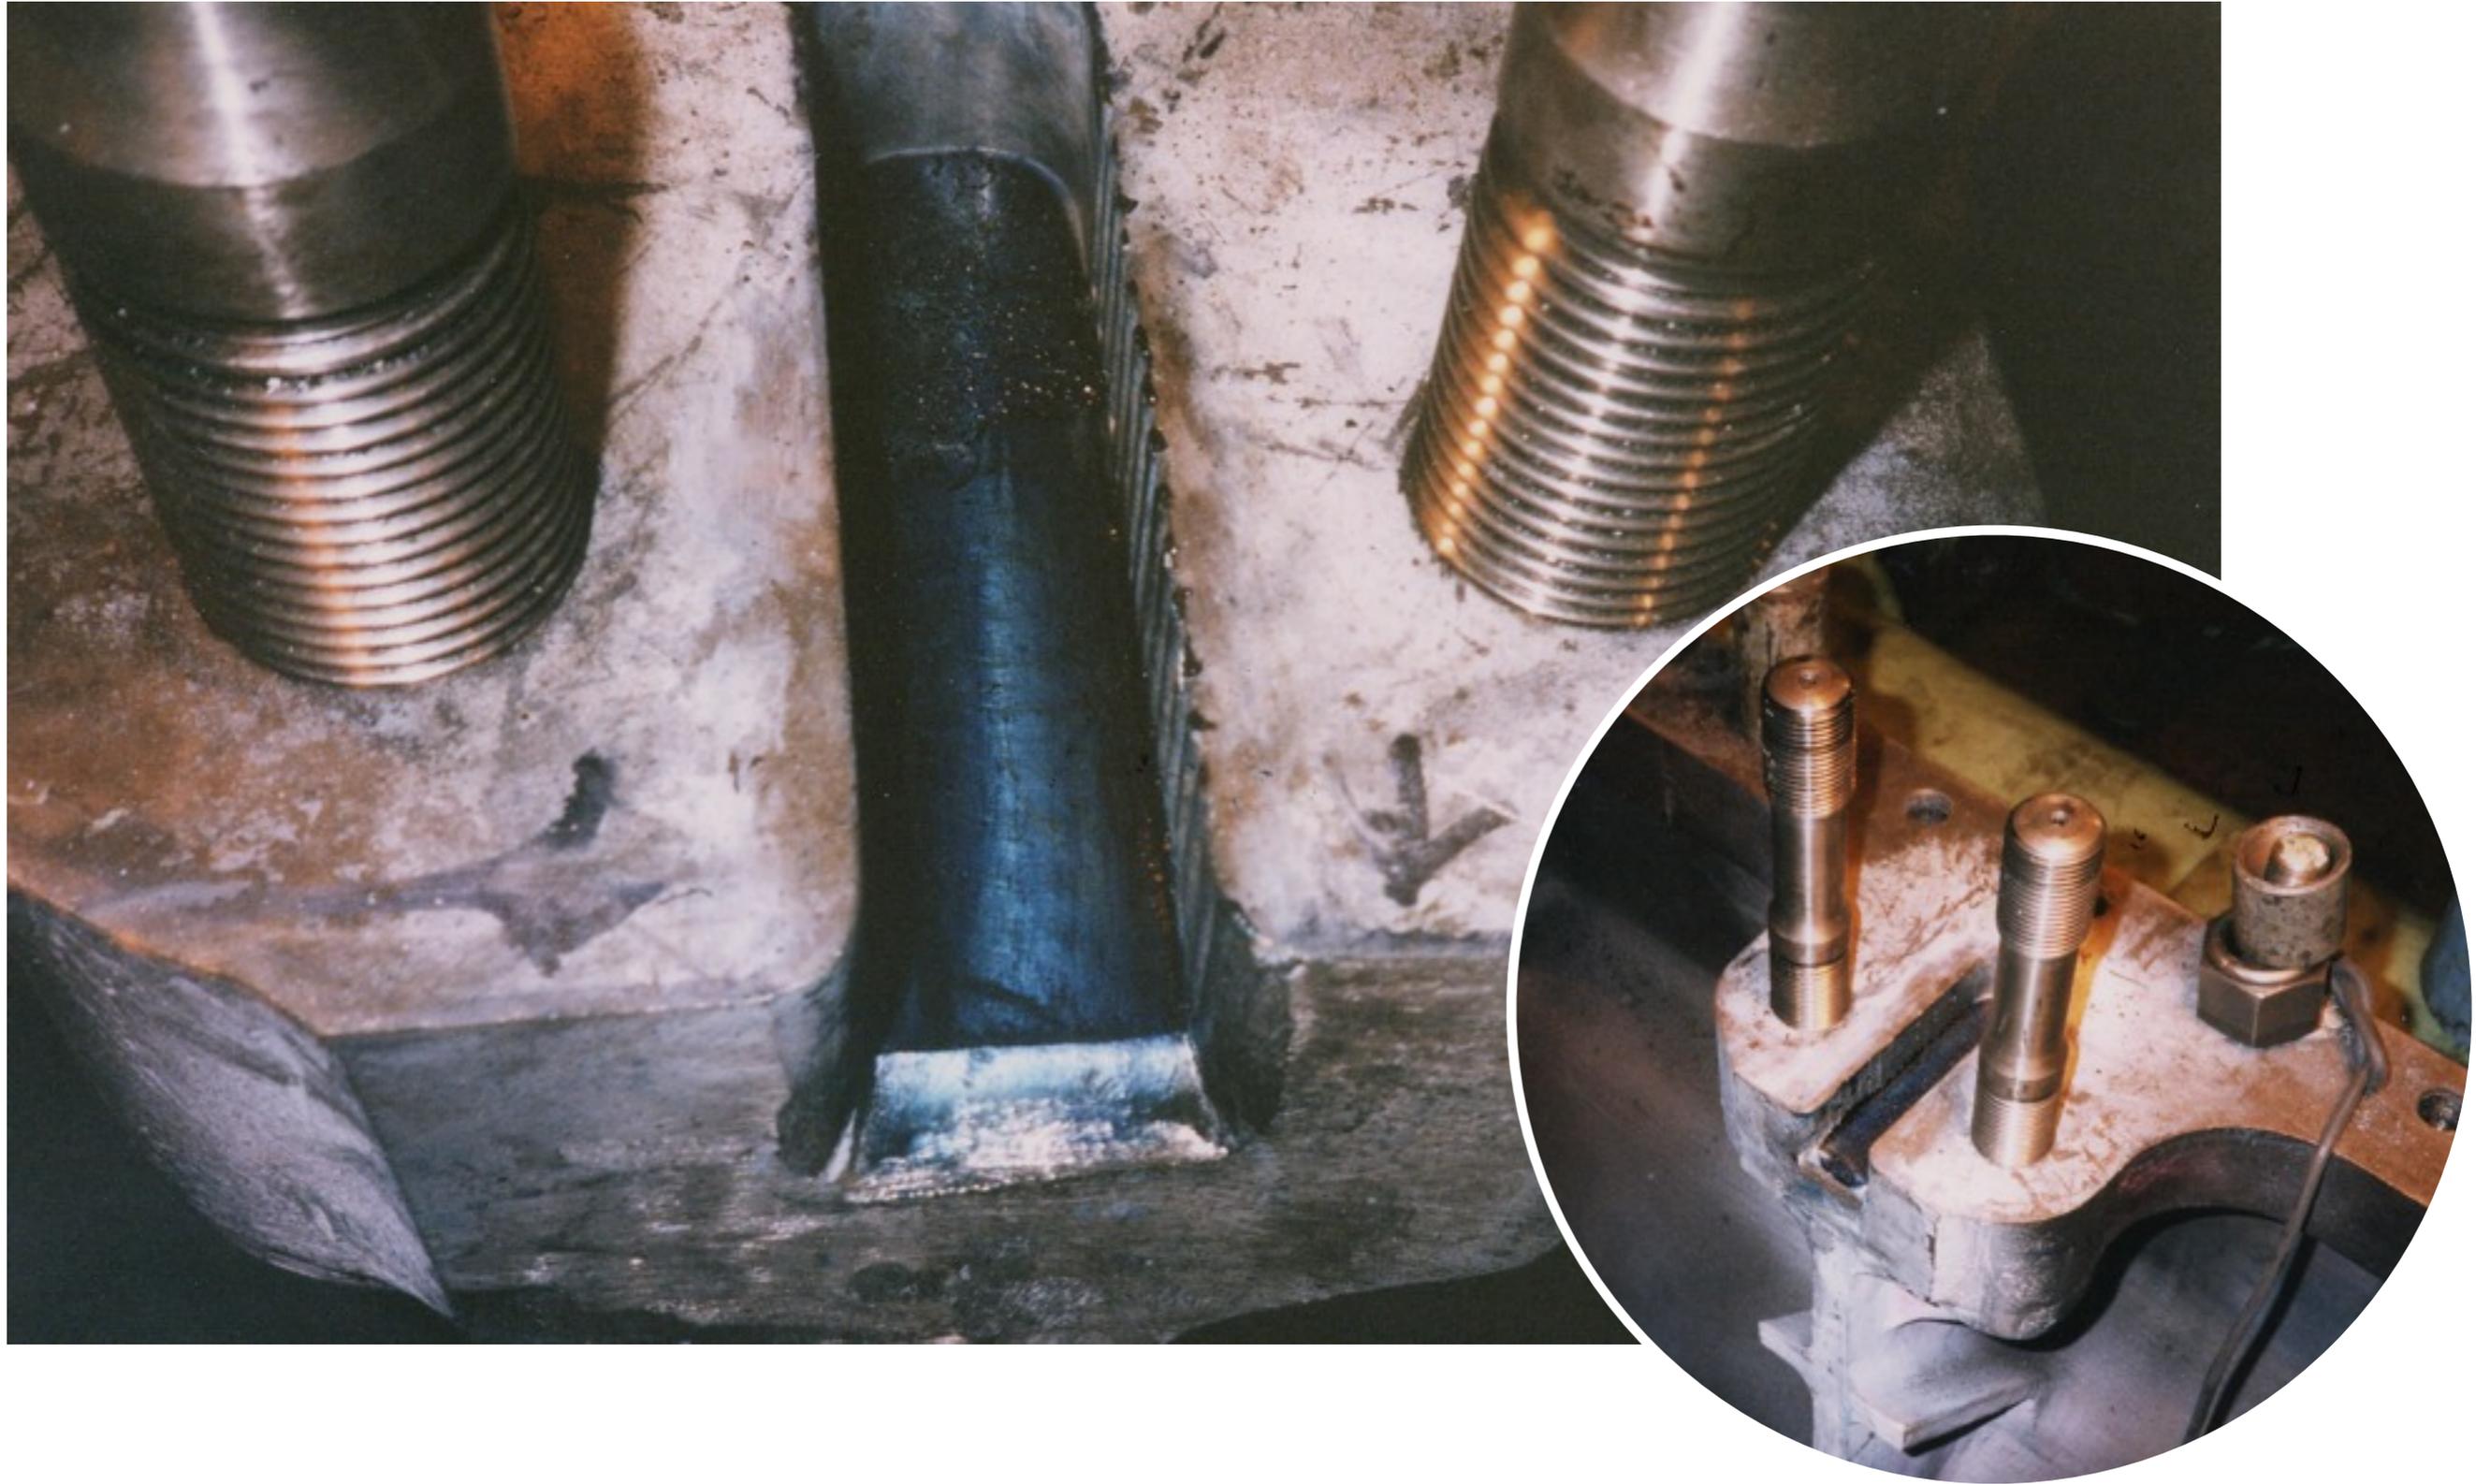
Attached Masterlocks are checked for correct seating using engineering blue

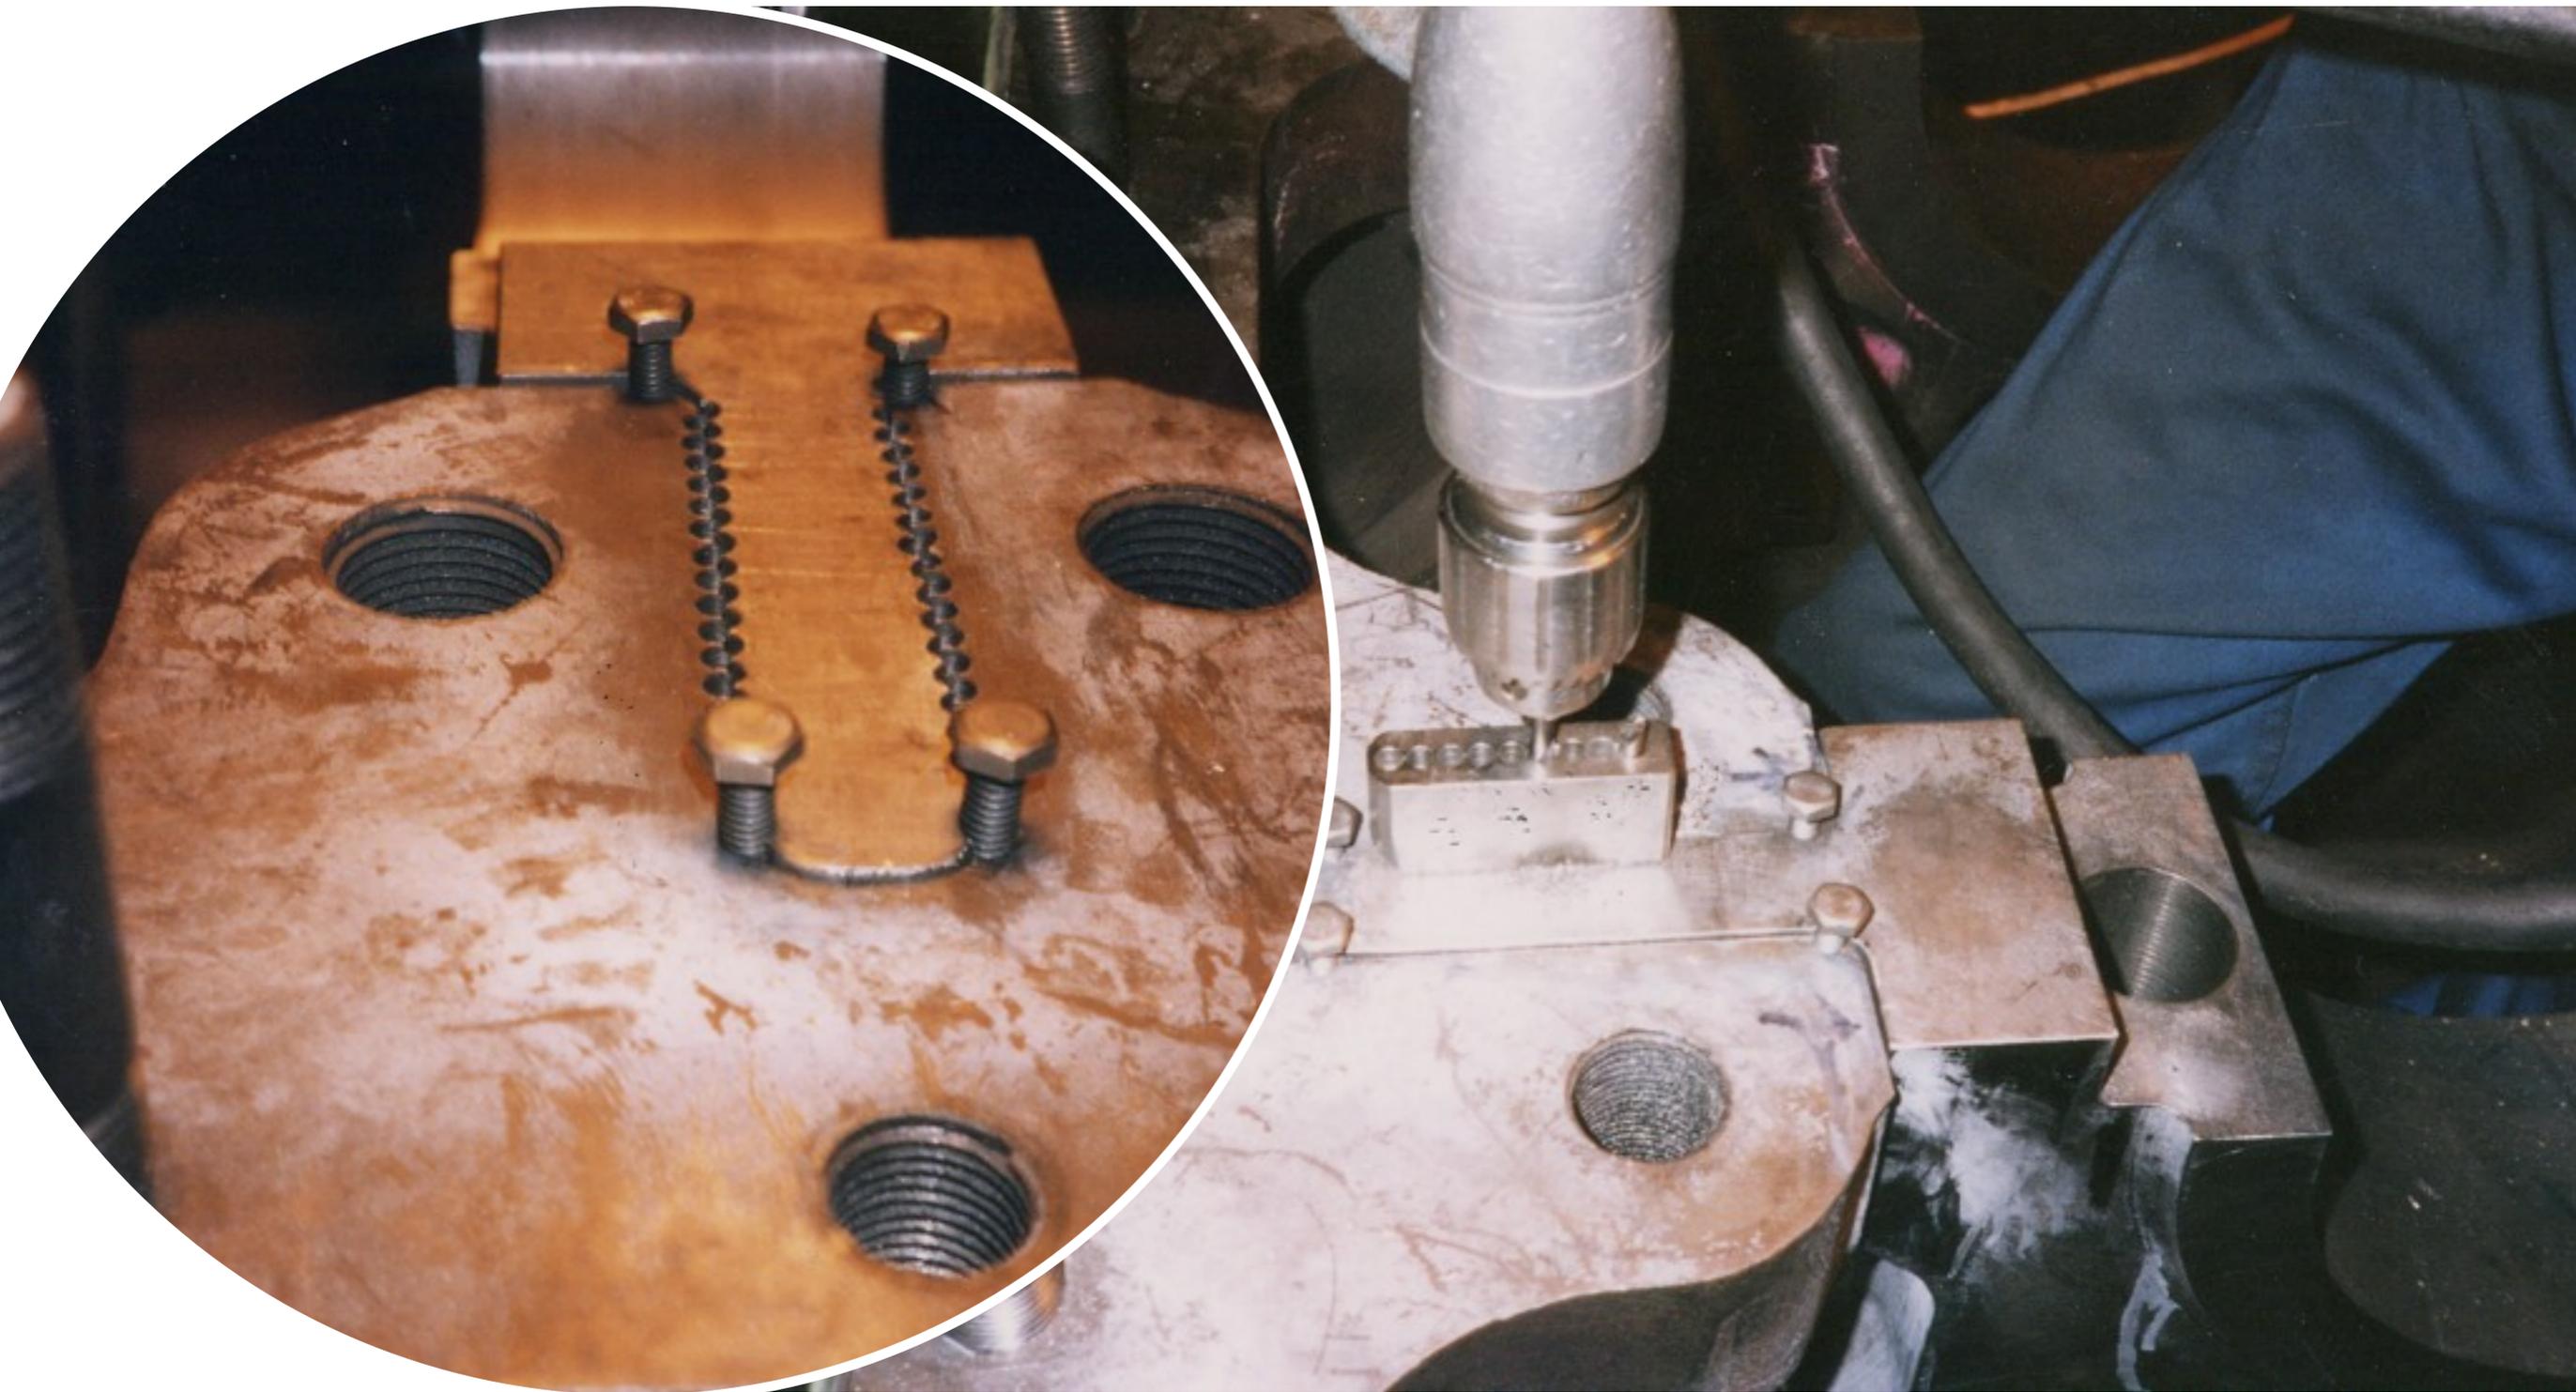
The process of securing the Insert begins with securing the Masterlocks

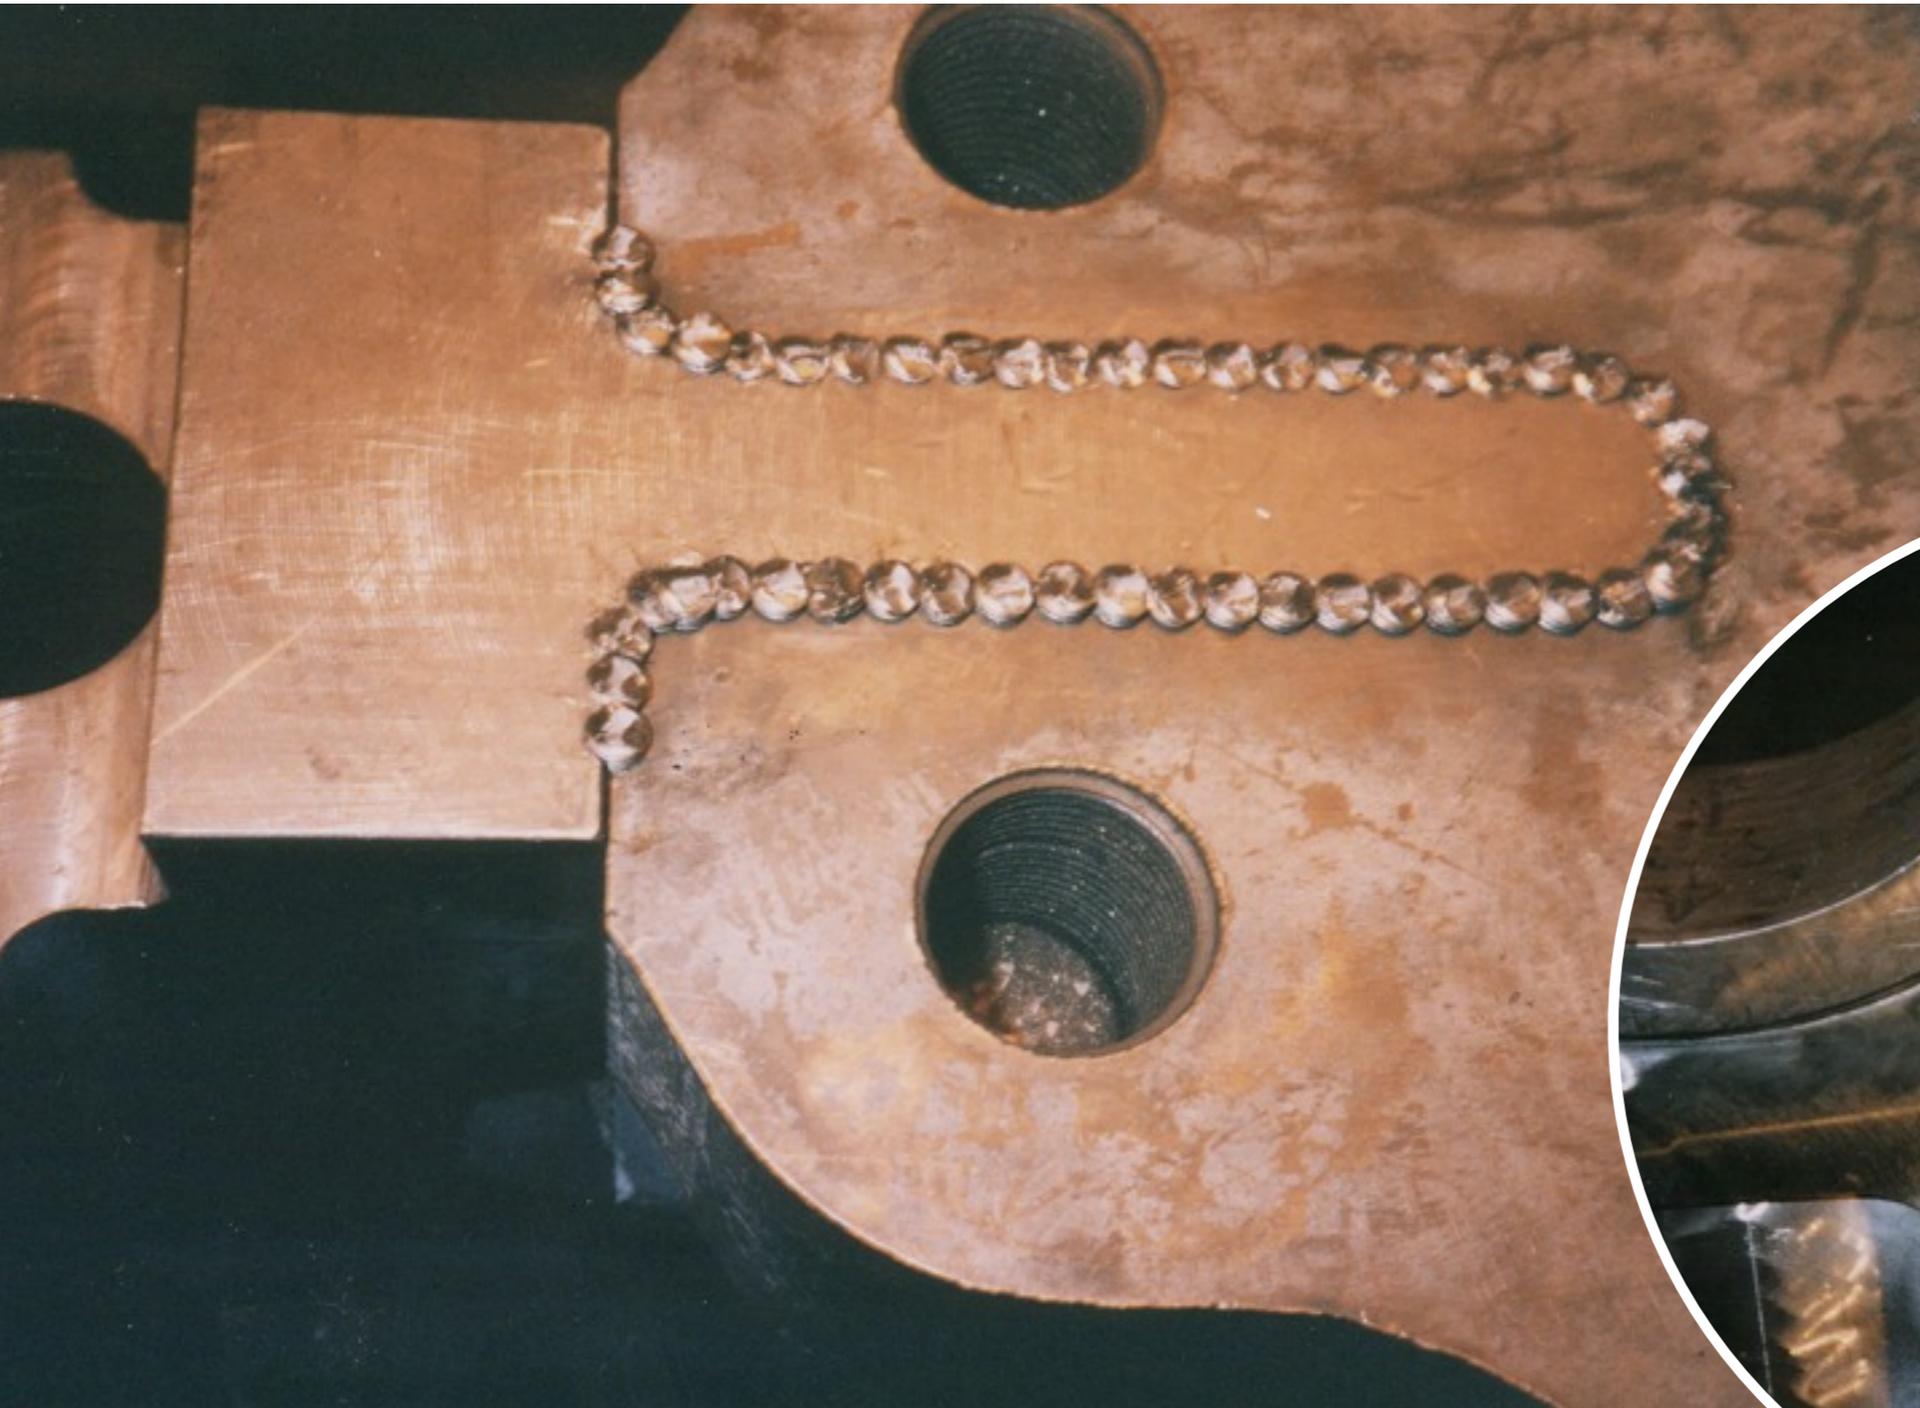
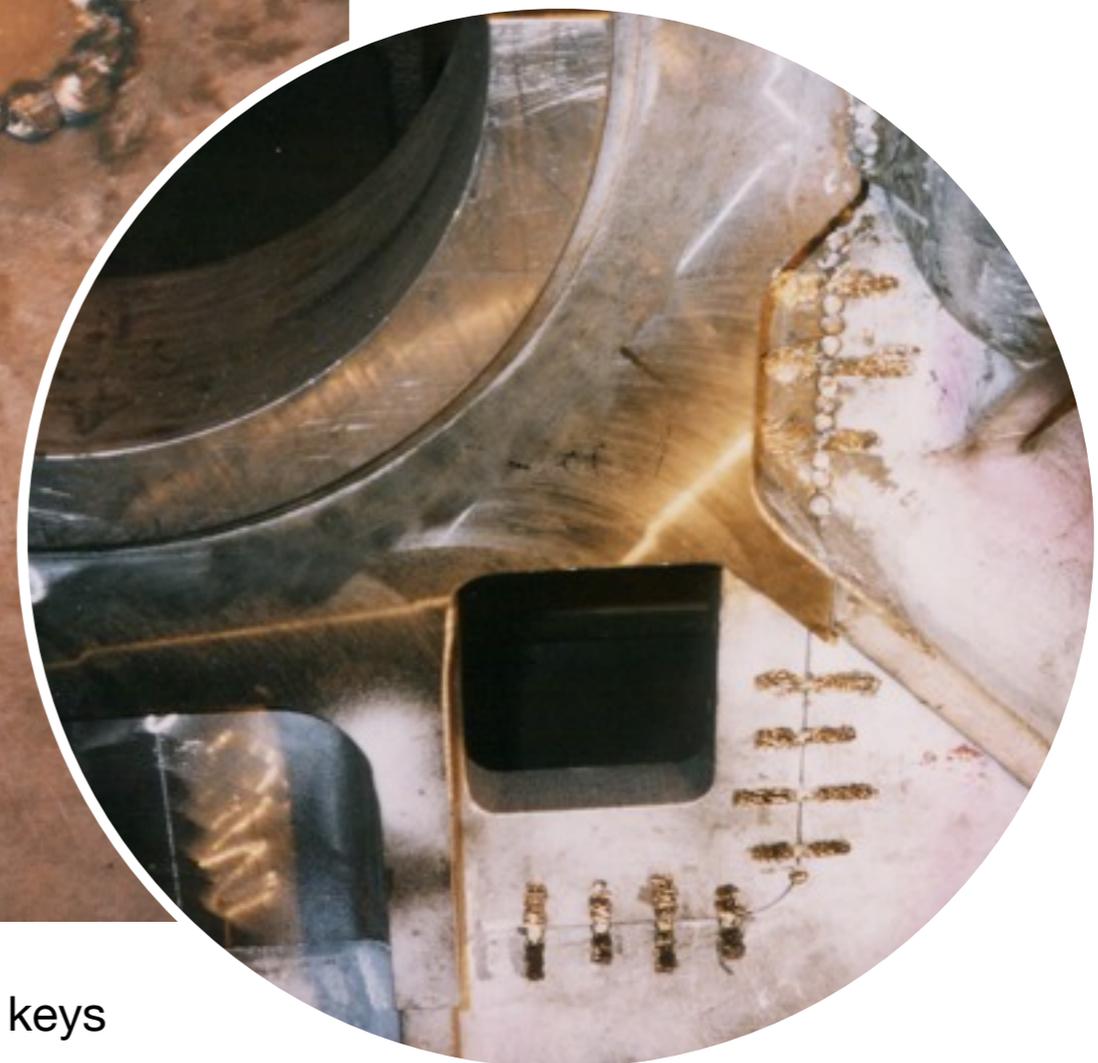
Line of Metaloy studs prior to peening

Apertures drilled off and filled with Metalock keys
