Engine Bearing Pocket Transplant

Ship owners James Fishers contacted Metalock Engineering UK to see if a repair was possible on their main engine bedplate.

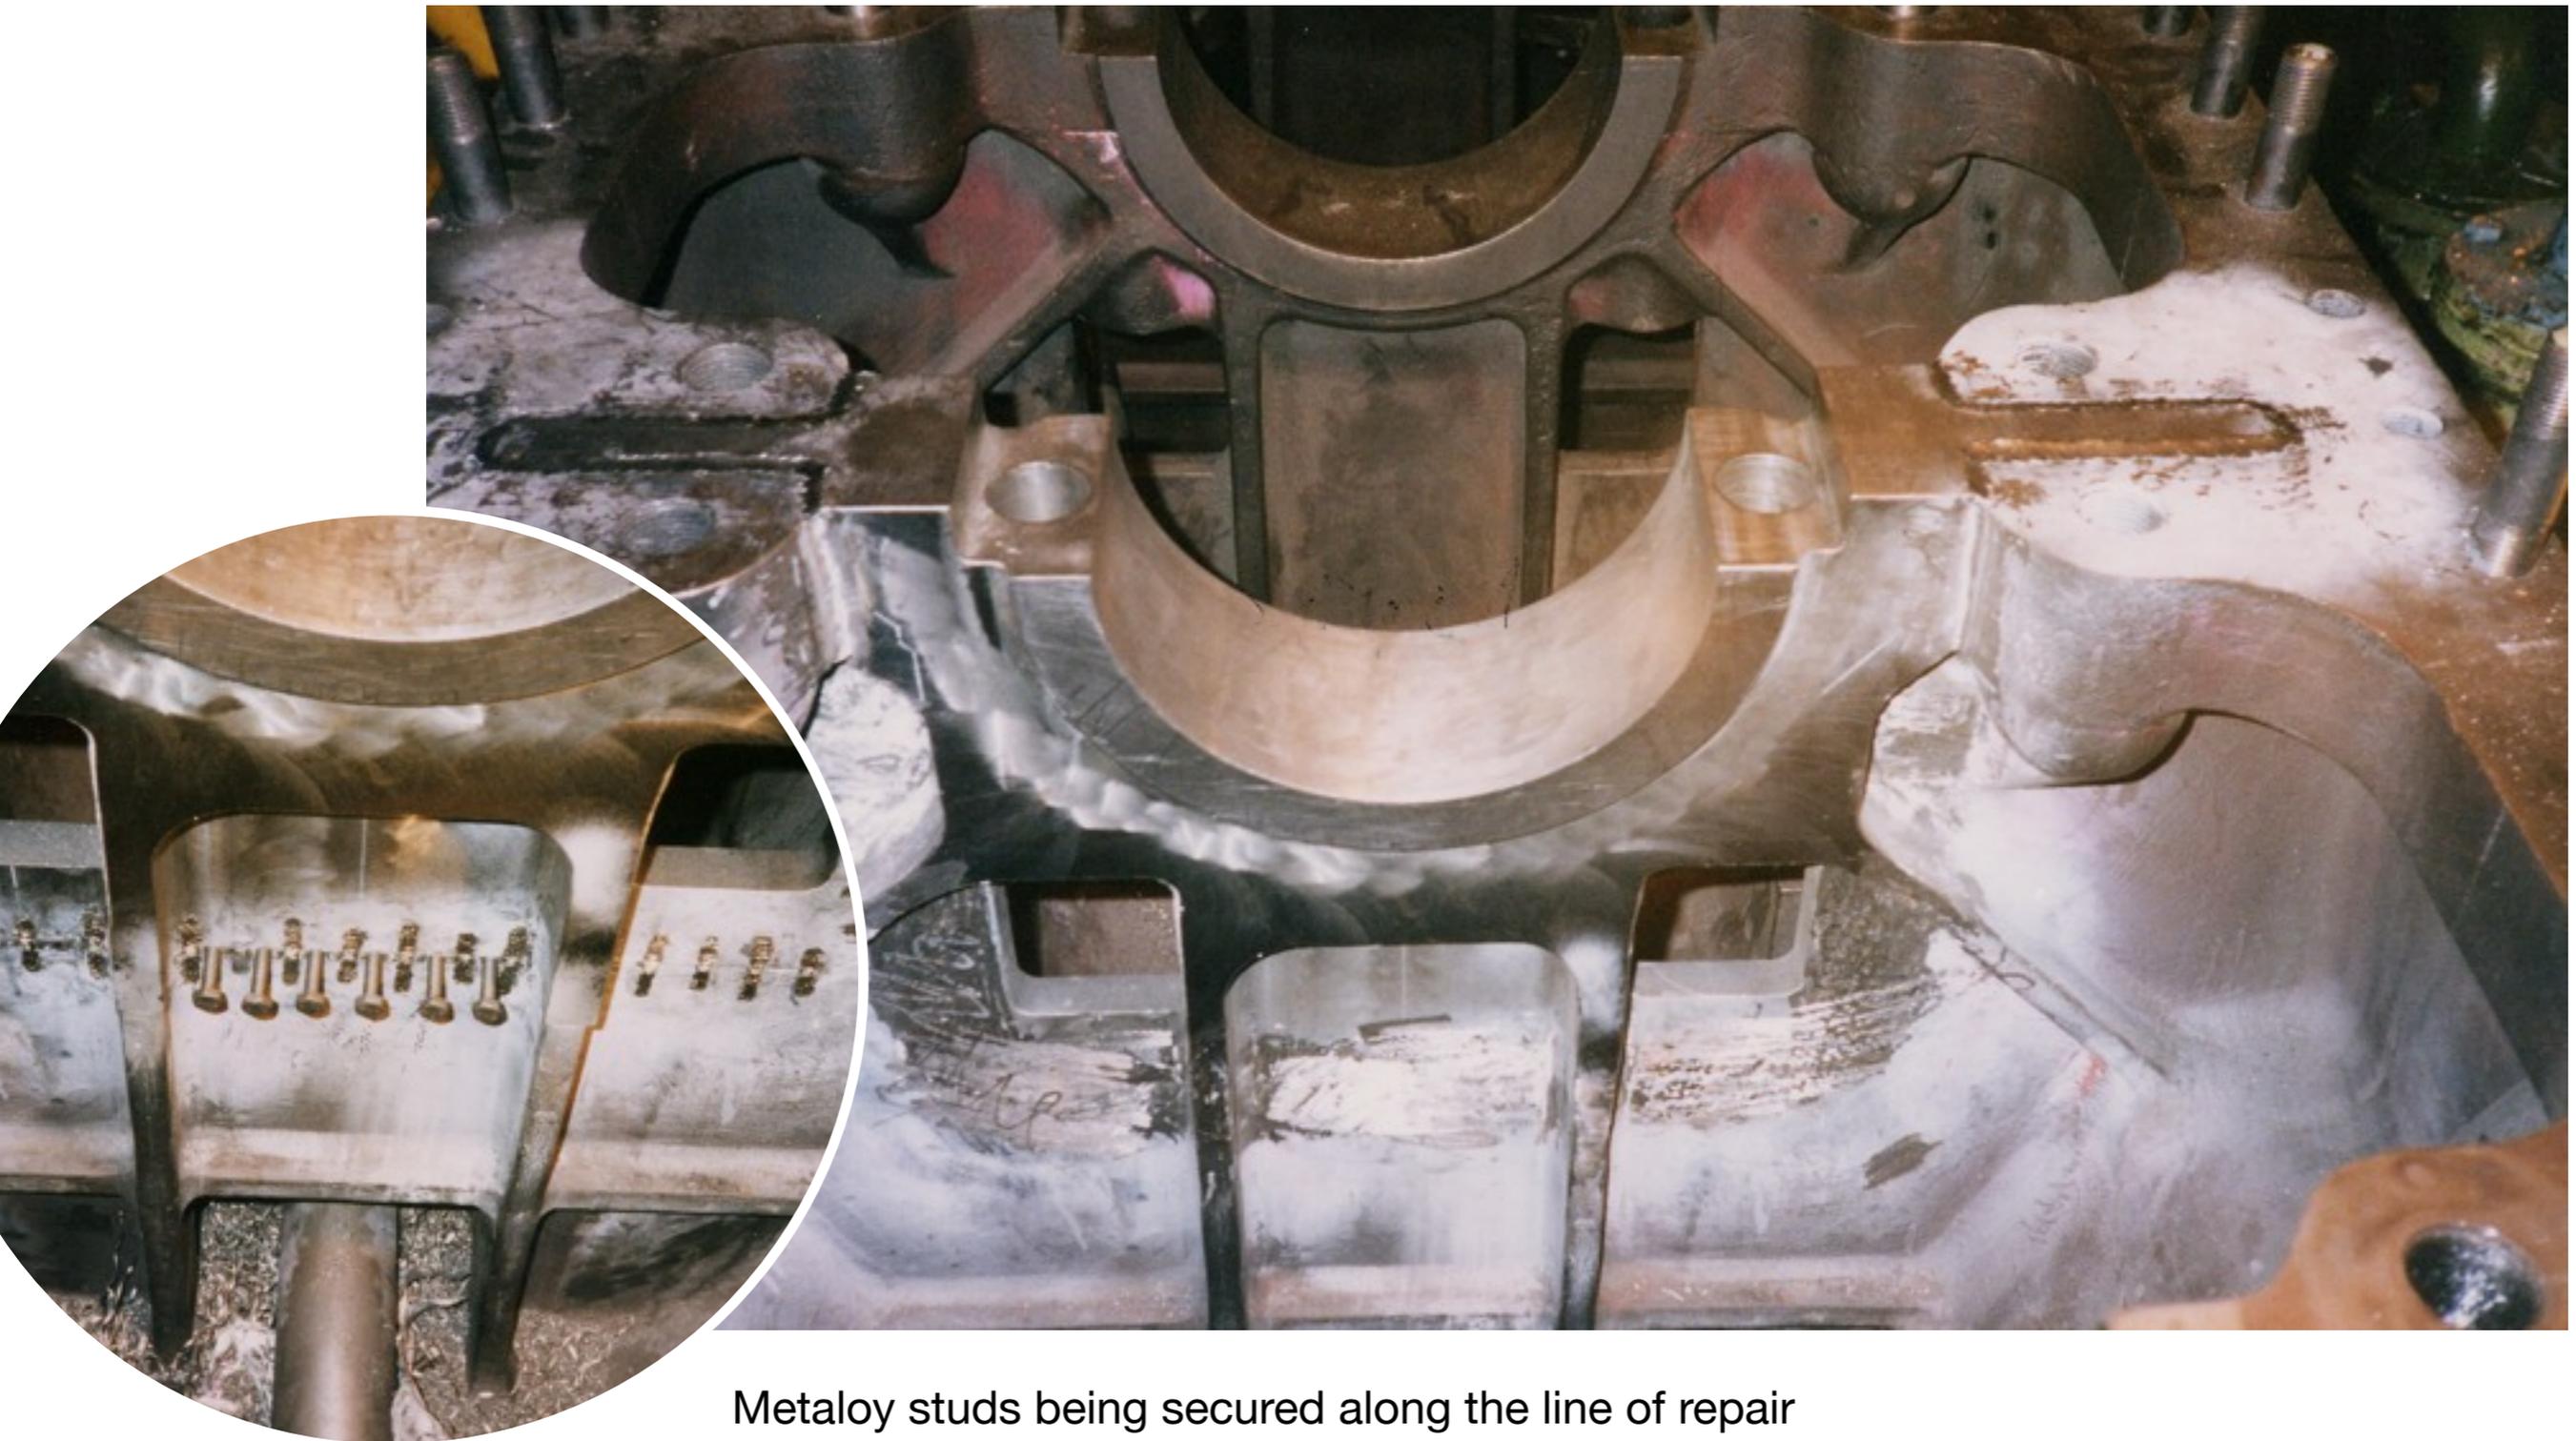
Repaired areas are hand dressed to complete the repair leaving the relevant faces and bore for machining

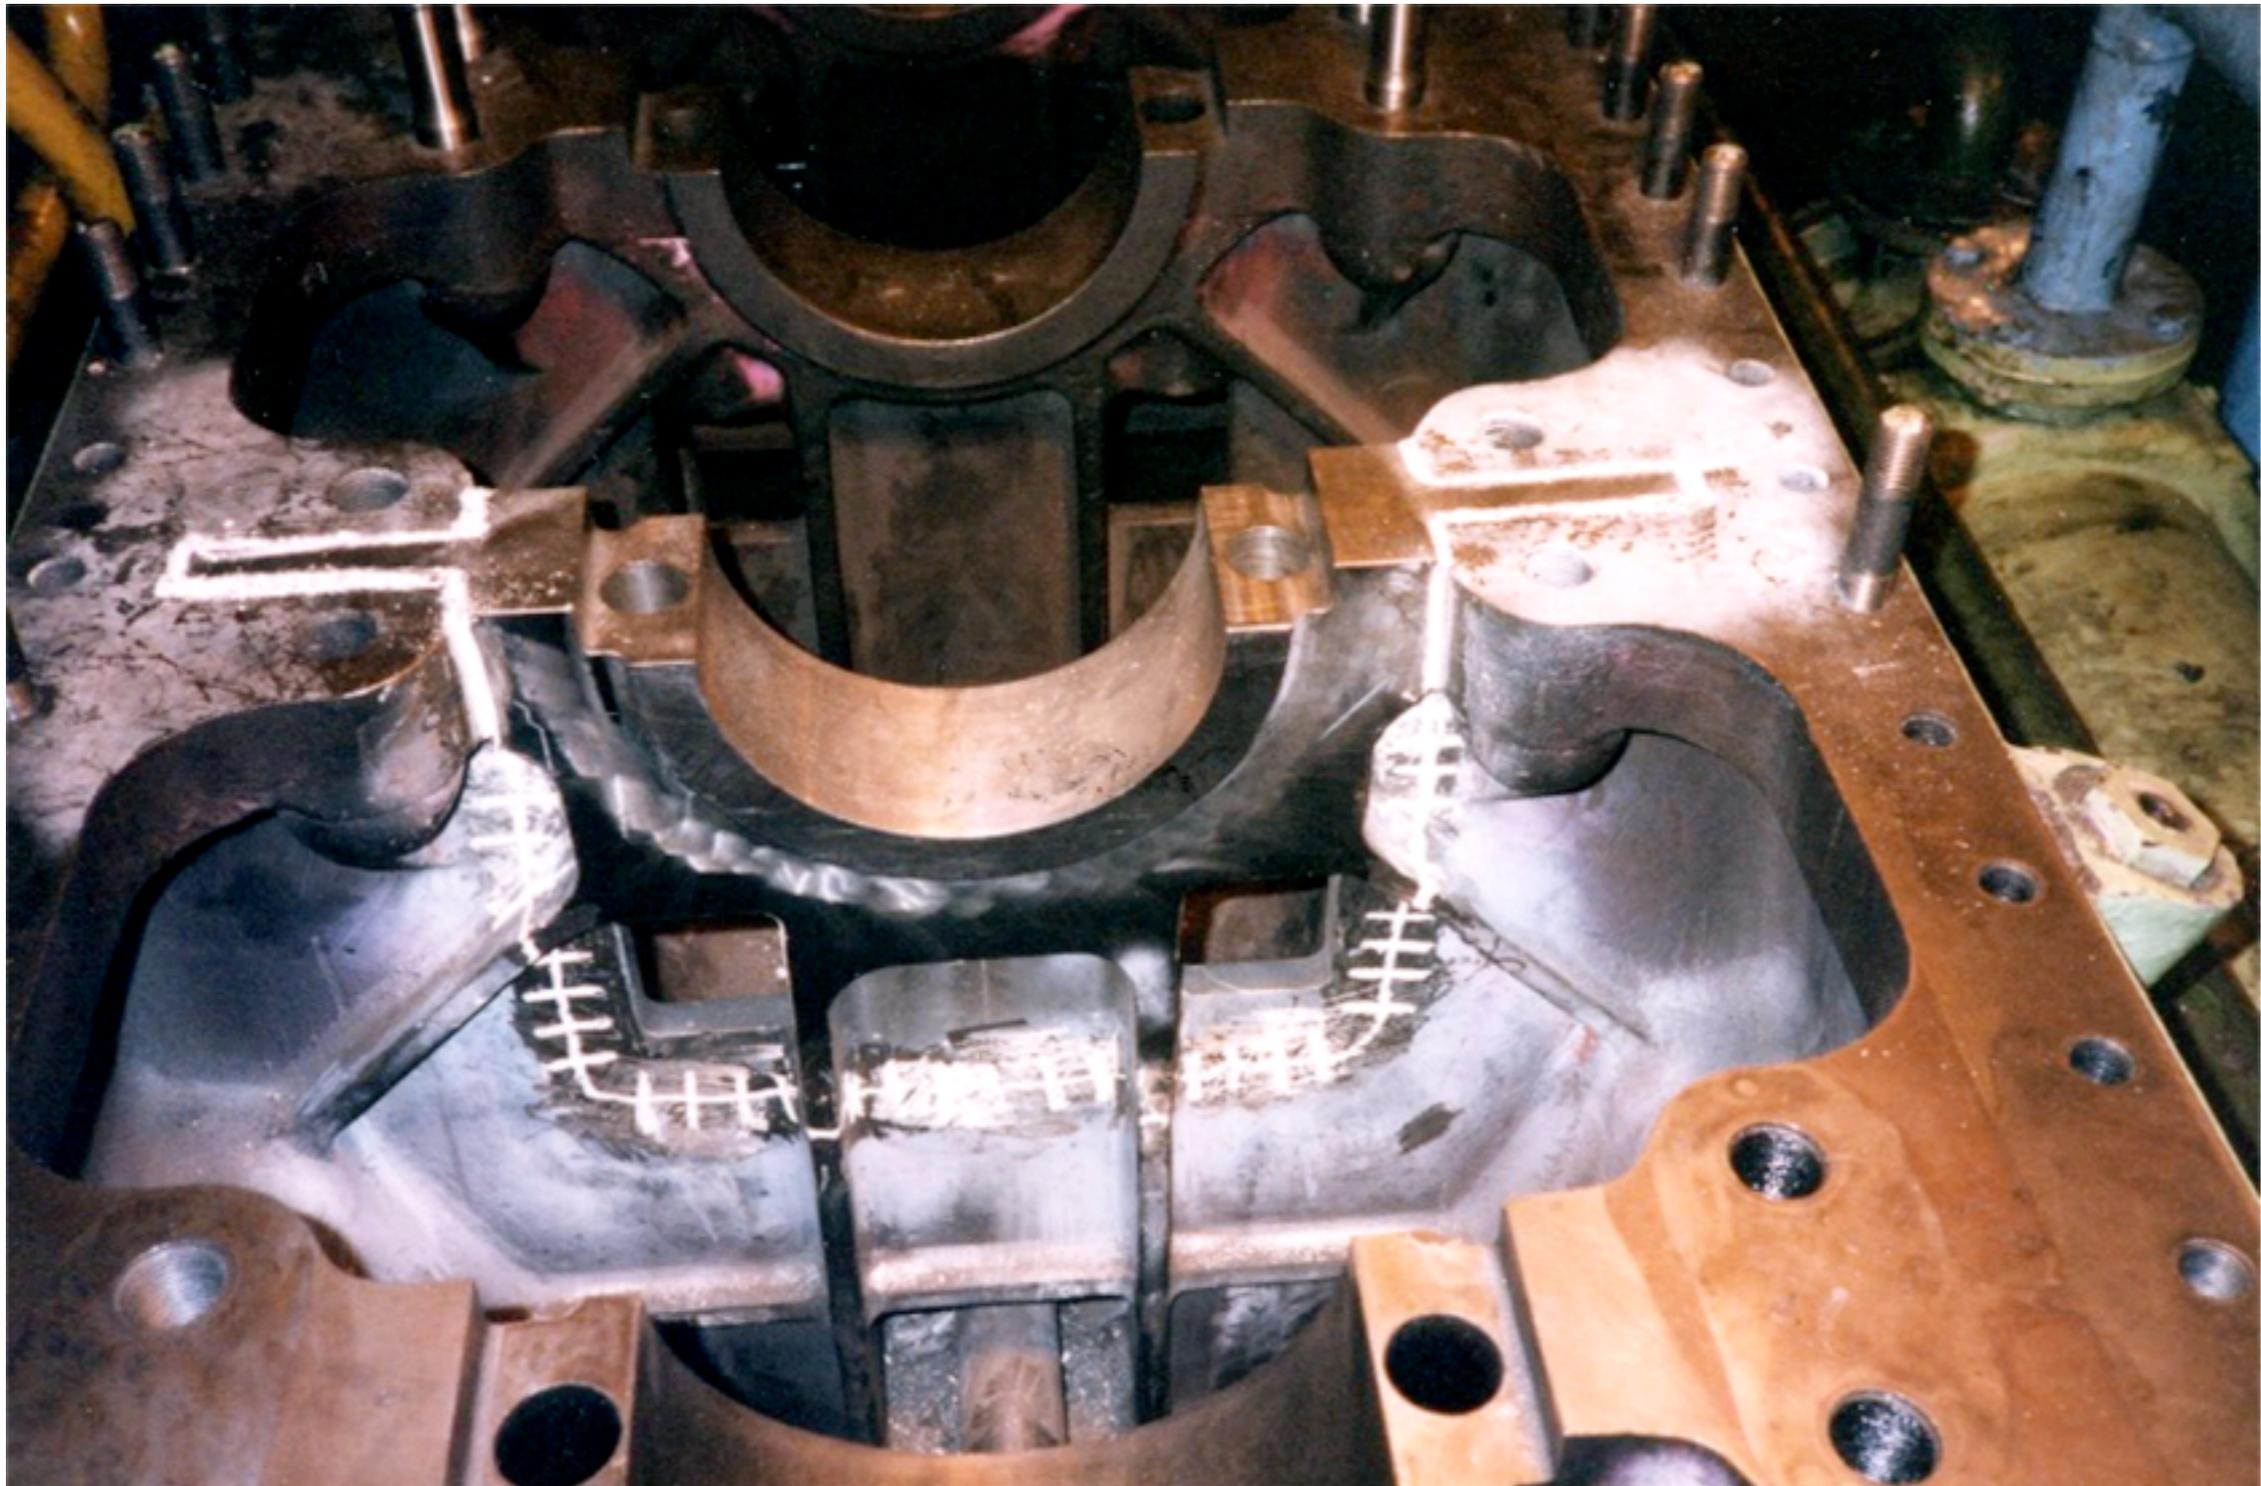
Metal studs being secured along the line of repair

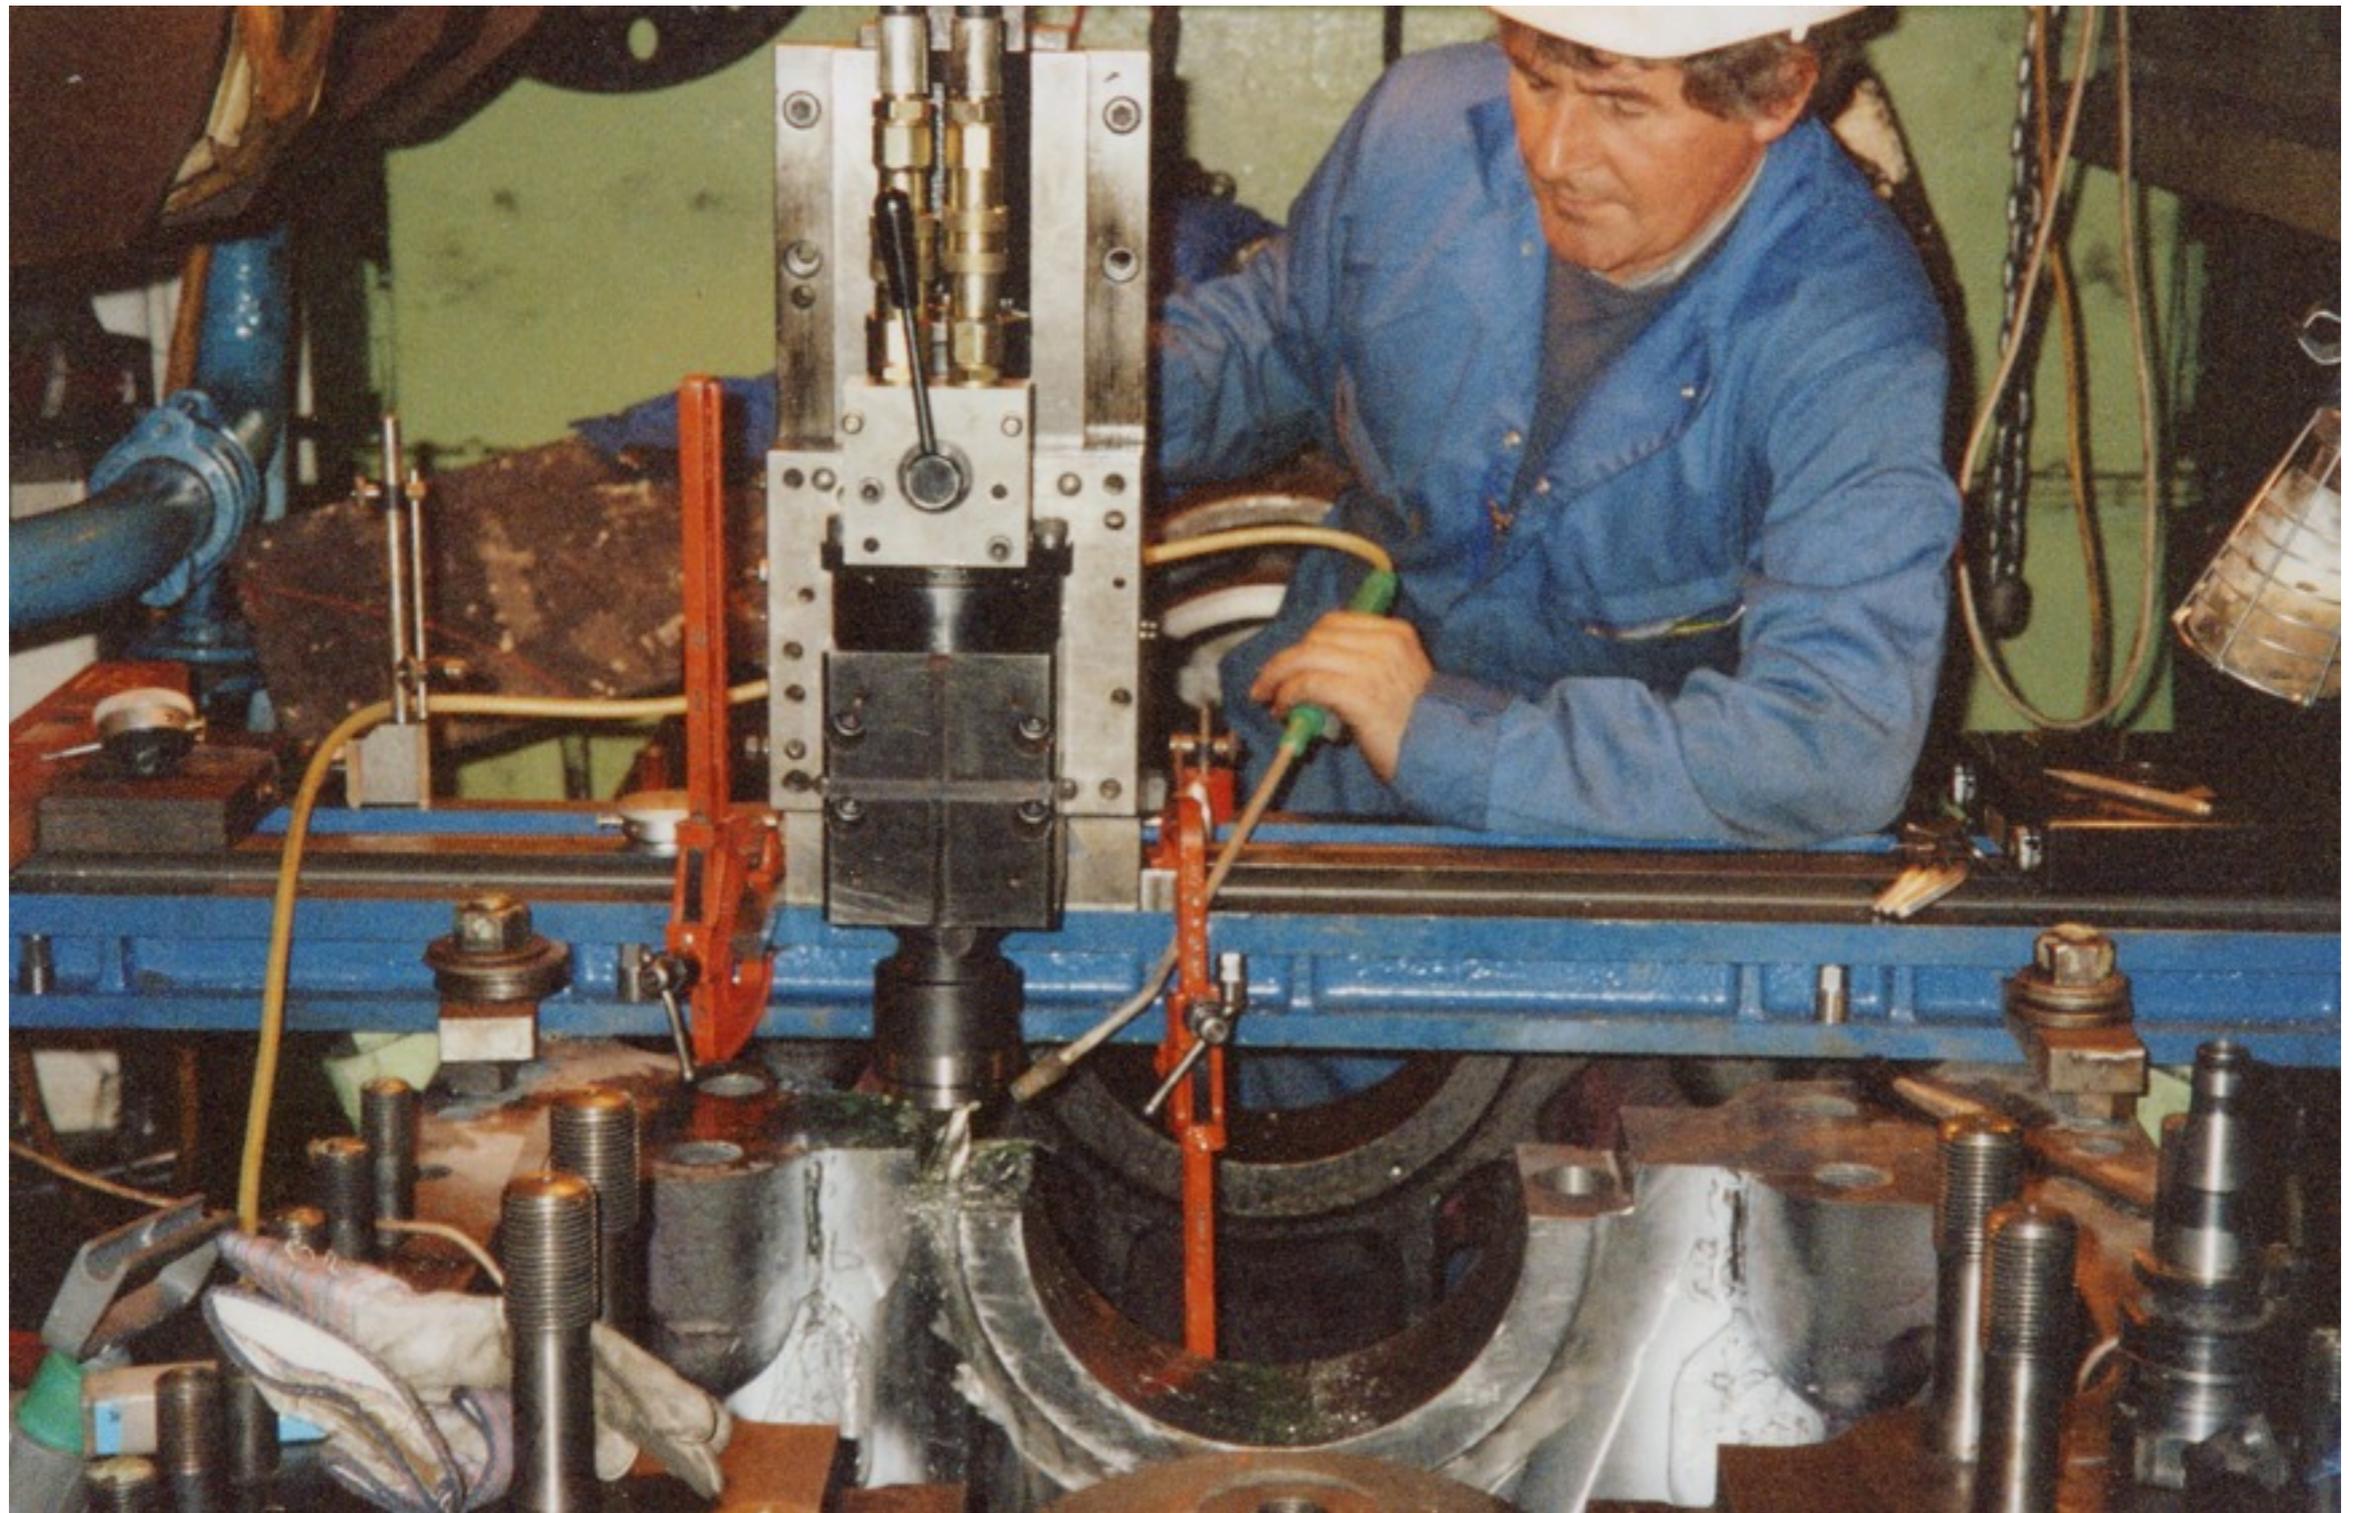
Completed repair awaiting On-Site Machining division

On-Site Machining division mill the top face

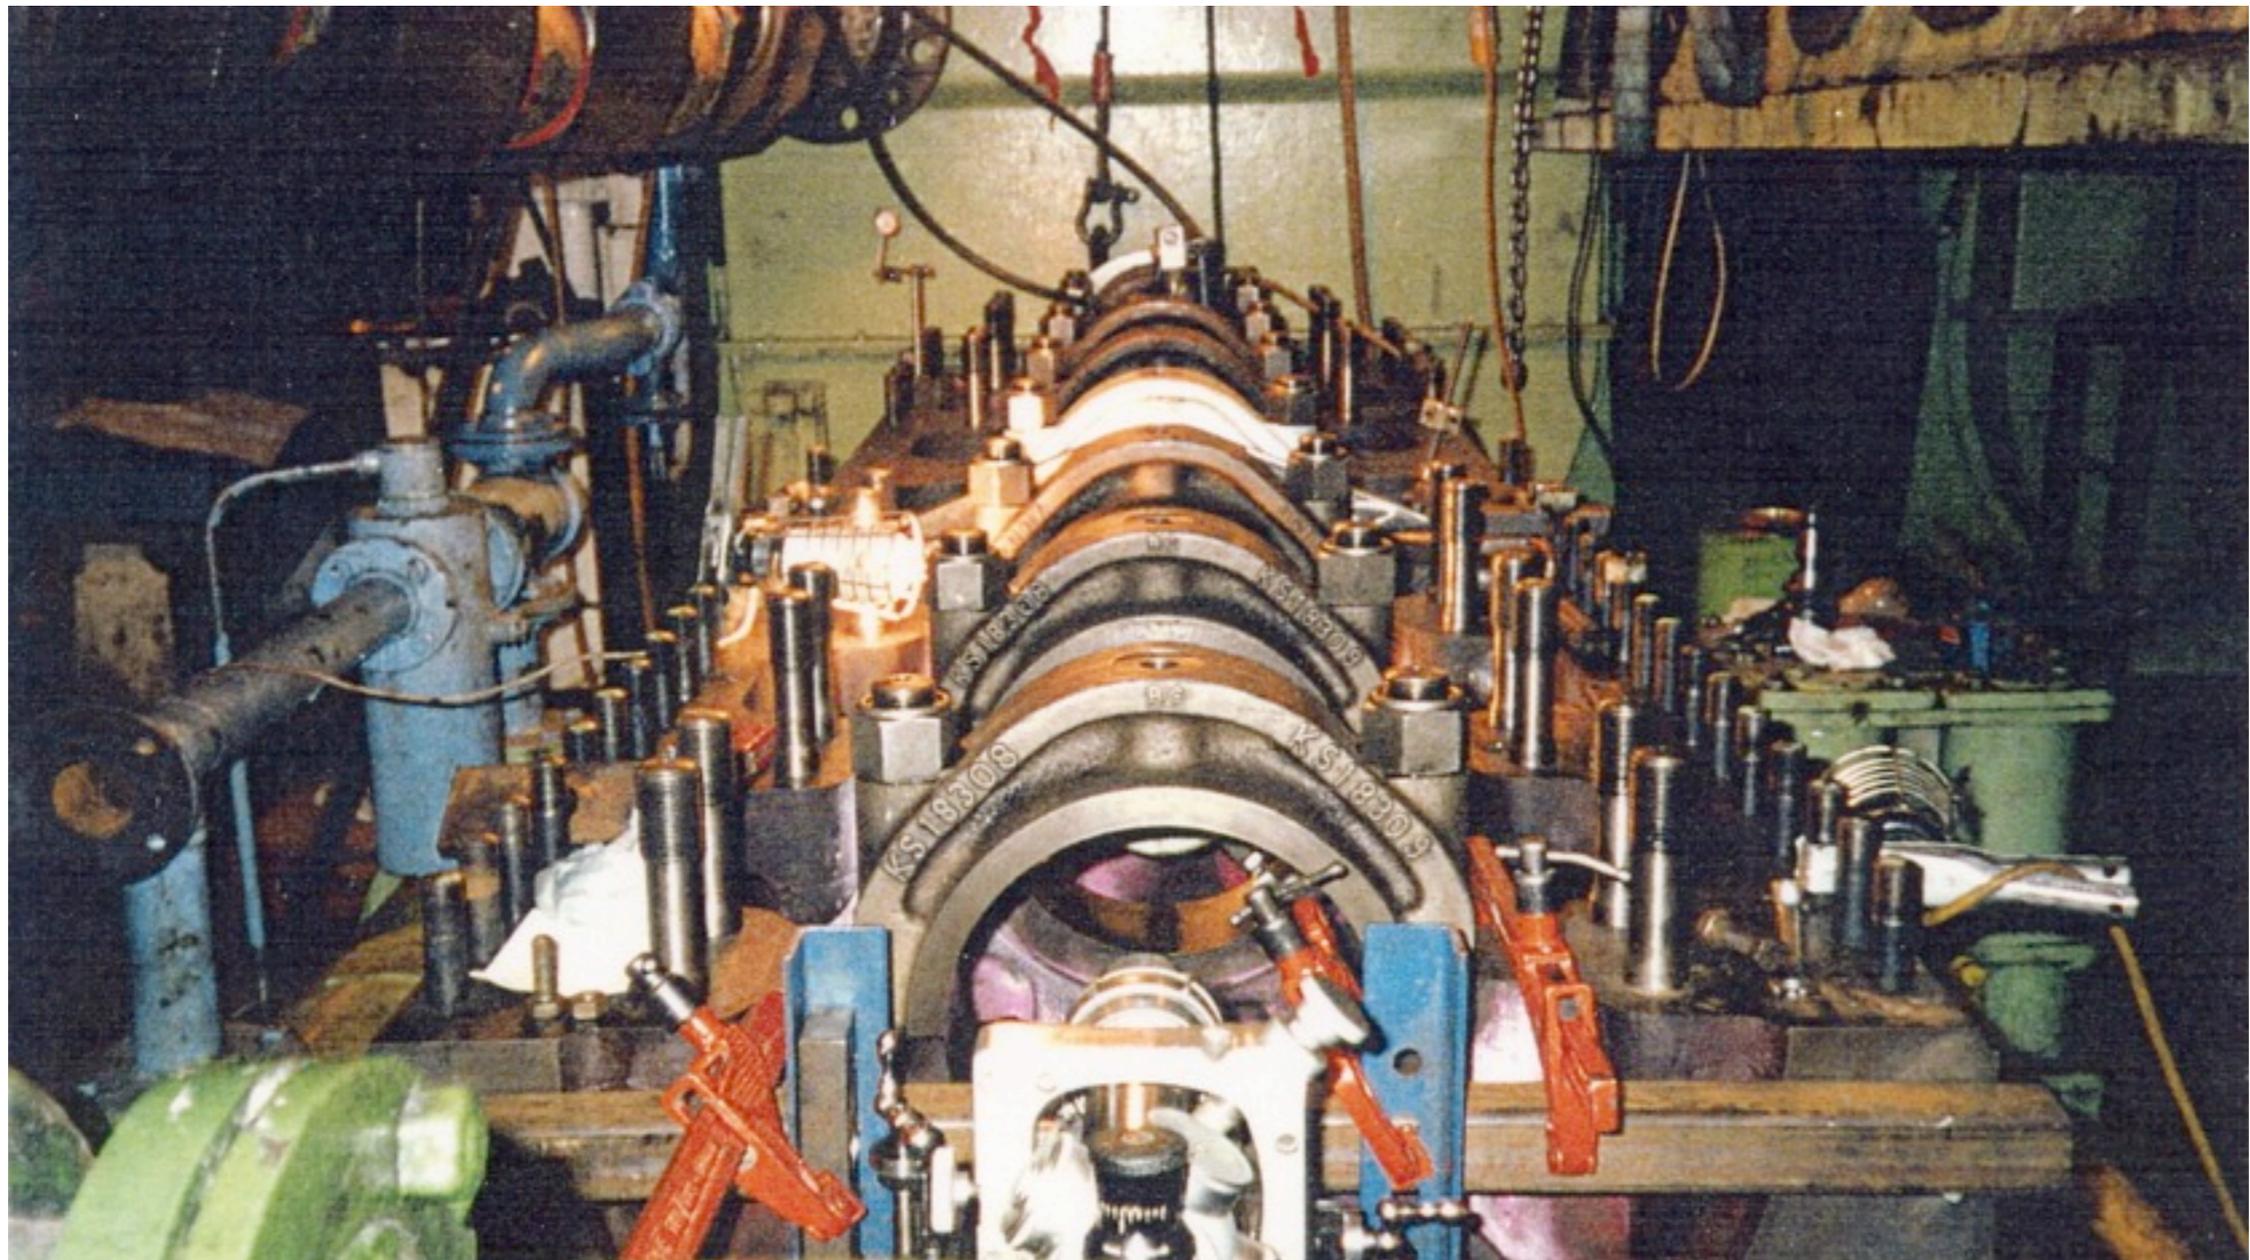
With a new bearing cap fitted a boring bar with integral optical targets mounted in the centre of the bar was optically aligned true to the centre line of the undamaged bearing pockets.

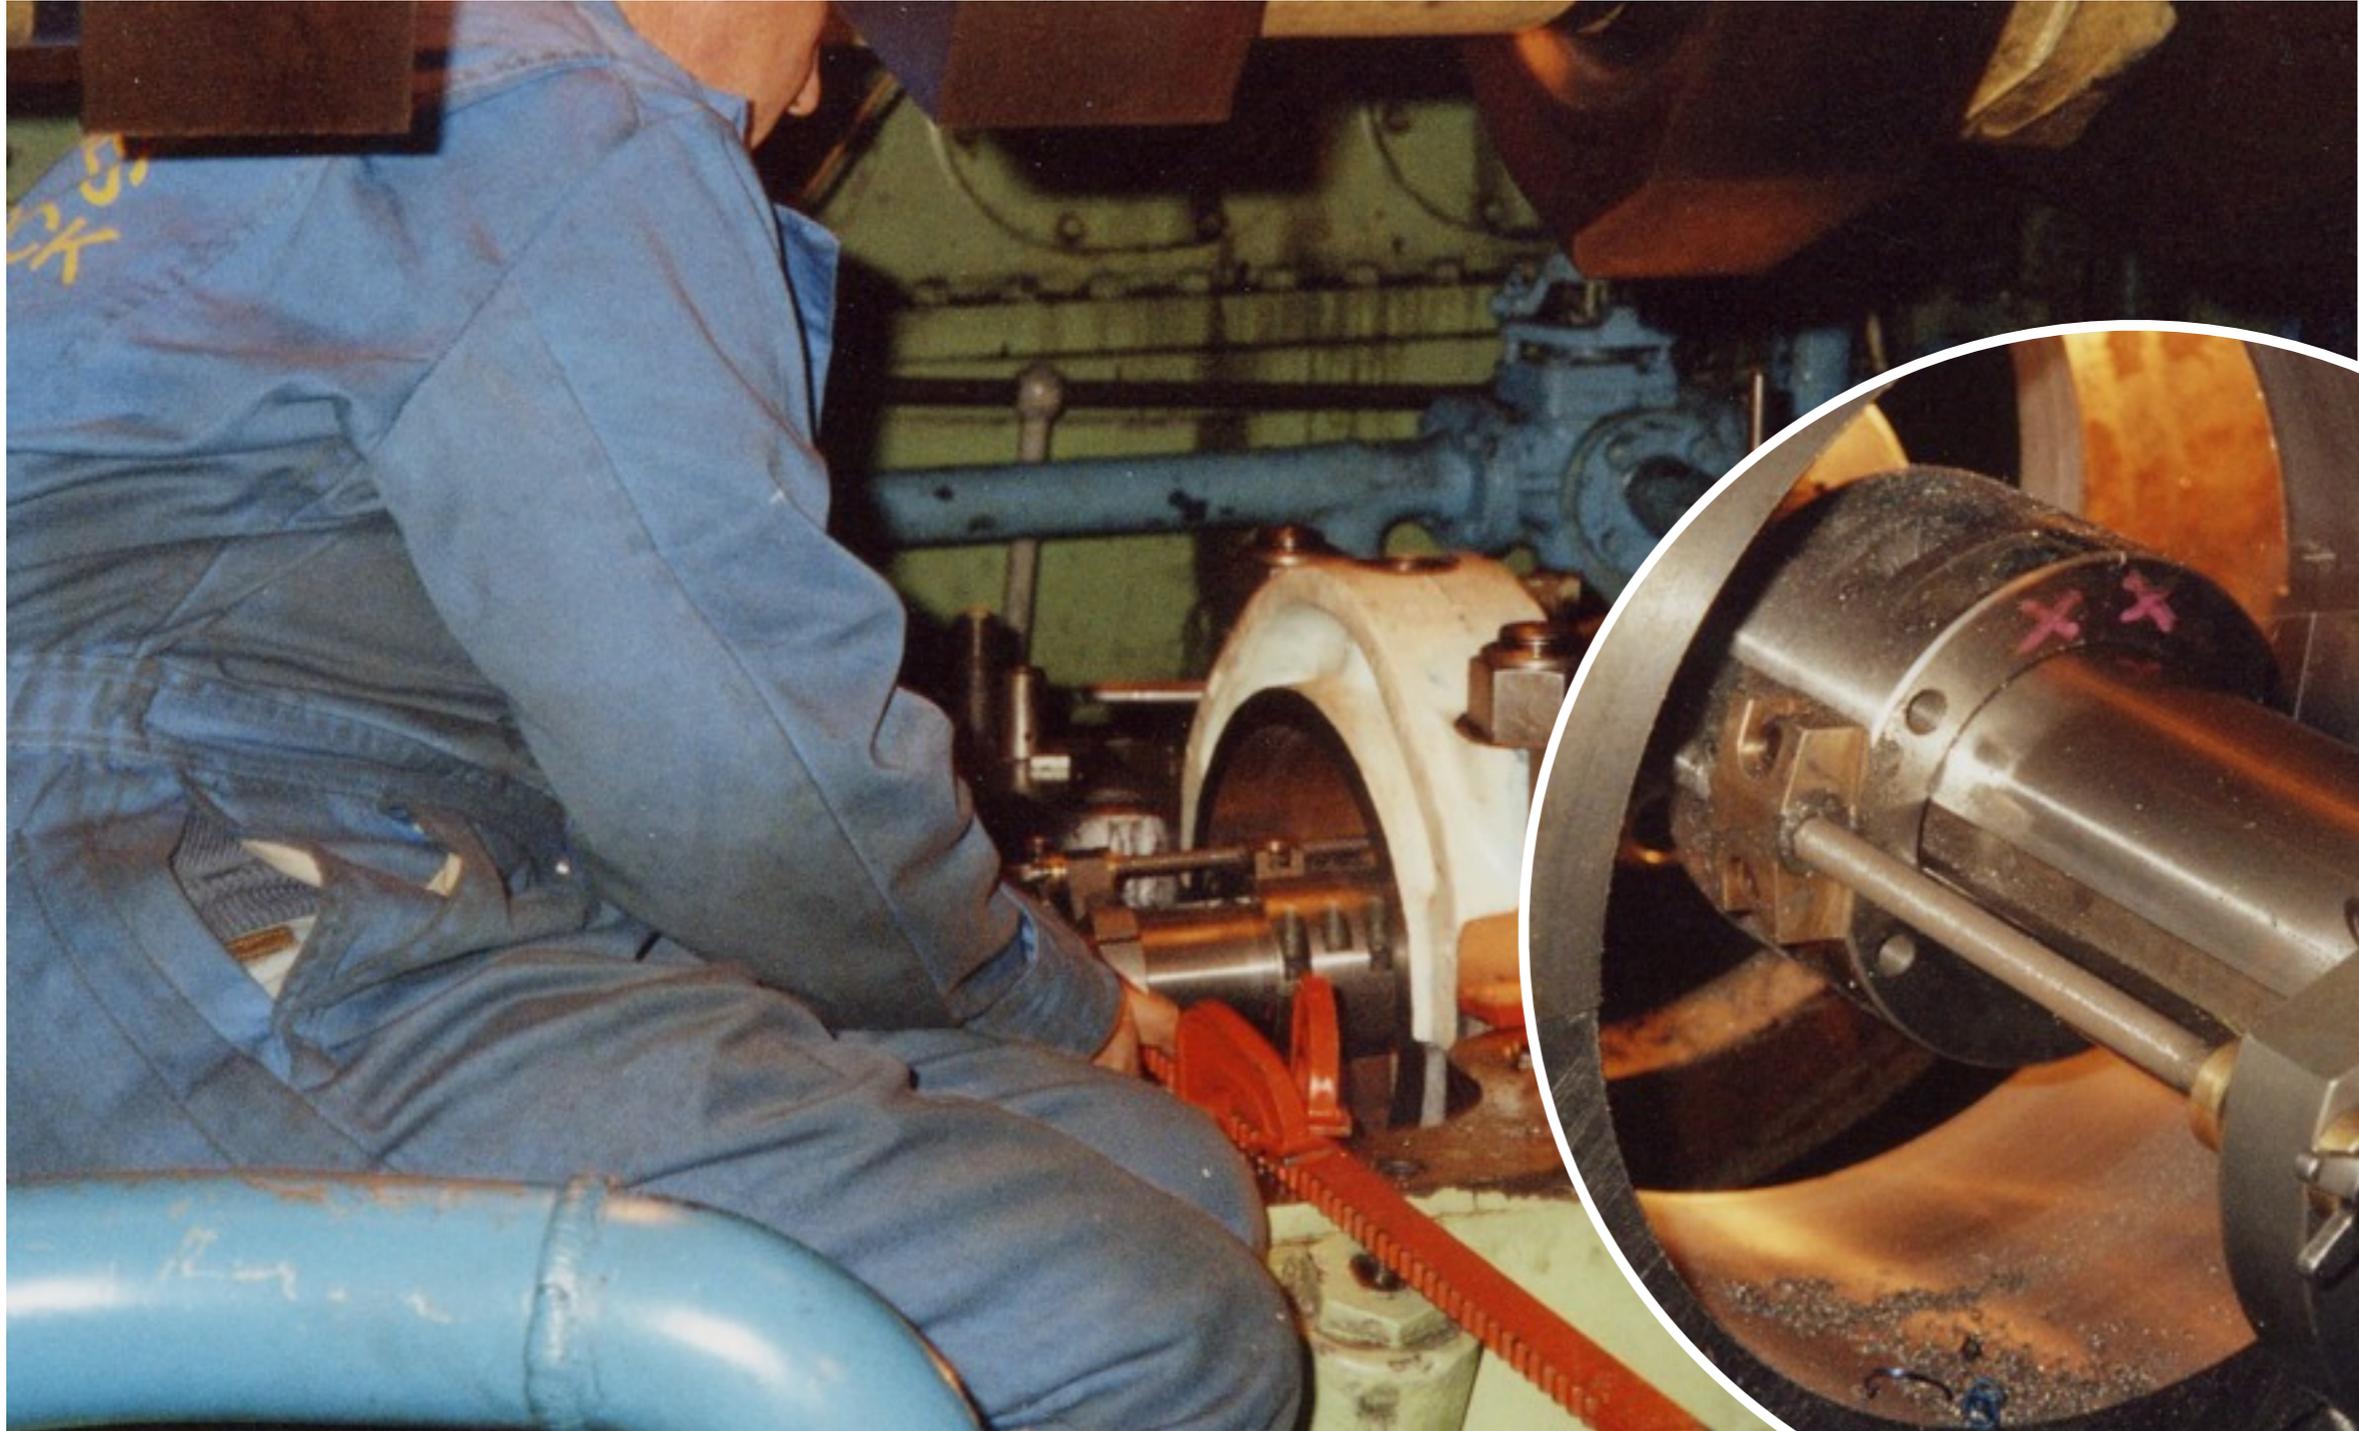
A new bearing cap is fitted alignment is checked and the bore machined back to standard
