PRESERVATION AND PROTECTION OF OUR RICH ARCHITECTURAL HERITAGE

Metalock
Engineering uk®

Protecting Britain's Heritage

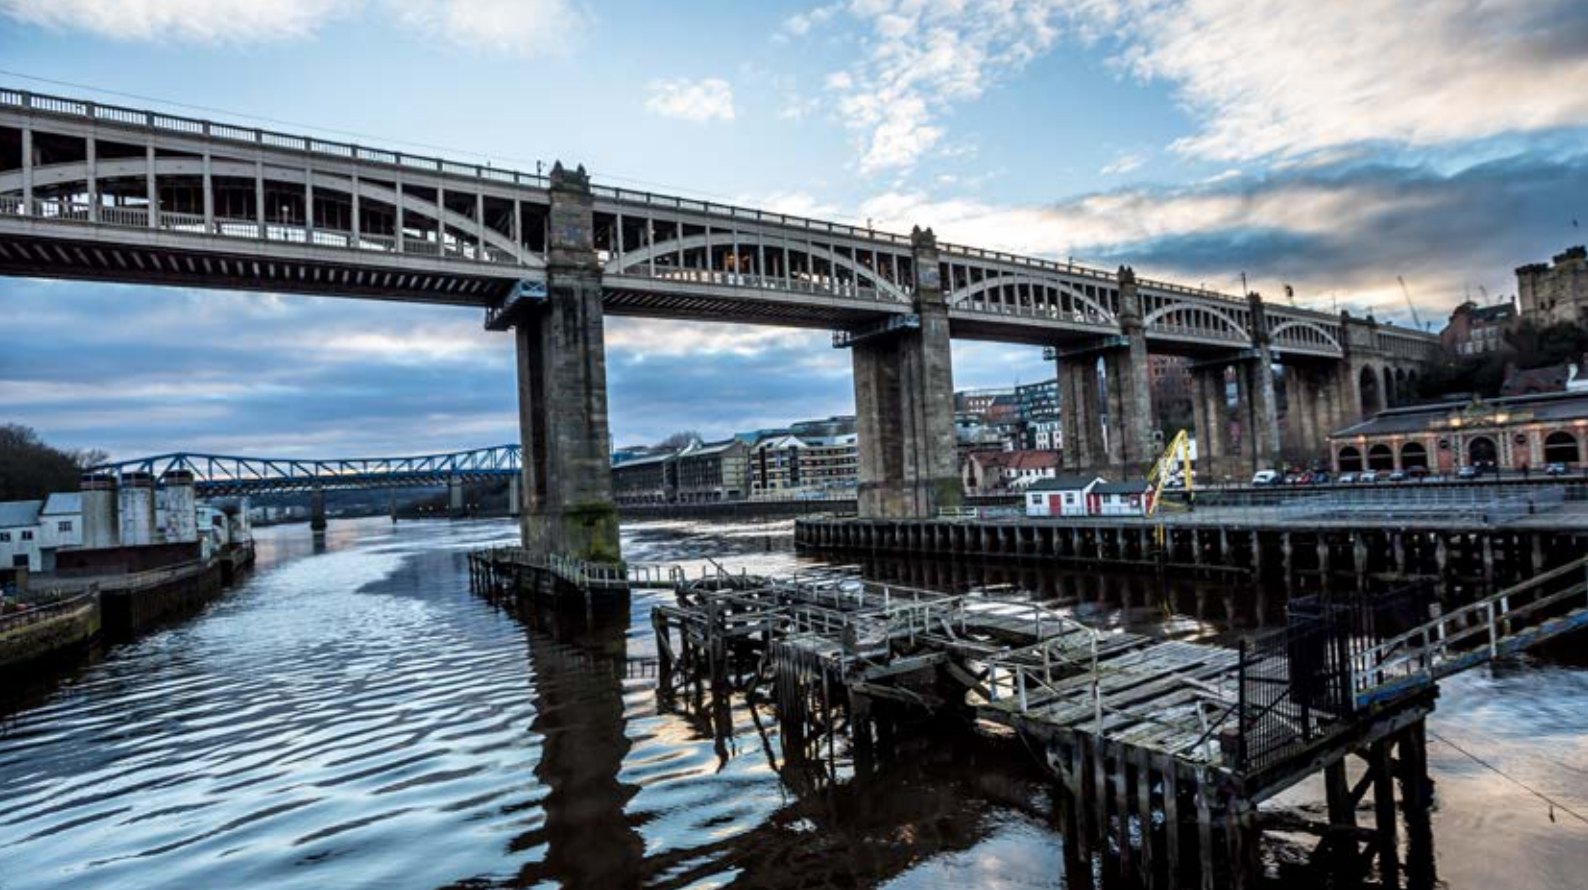
High Level Bridge Newcastle

The bridge was closed to road traffic to allow essential maintenance to ensure the bridge's long-term future, including replacement of wooden supports beneath the road deck.

The reopening slipped as severe cracks were found in some of the bridge's iron girders. Having assessed the bridge girders, engineers decided to engage the services of Metalock Engineering UK Ltd to carry out the essential cold Metallock repairs.

Designed by Robert Stephenson and built between 1847 and 1849, it is the first major example of a wrought iron tied arch or bow-string girder bridge. It is a fine and long standing engineering solution to a difficult problem; the spanning of 1337 feet of river valley, including 512 feet across water.

The High Level Bridge has six river spans of 125 feet (38 m) length, sitting on masonry piers, 46 by 16 feet in section and up to 131 feet (40 m) height.

There are also four land spans on each side, of 36 feet 3 inches. The single carriageway road and pedestrian walkways occupy the lower deck of the spans, 85 feet above the high water mark, and the railway the upper deck 112 above the high water mark.

The total weight of the structure is 5,000 tons.

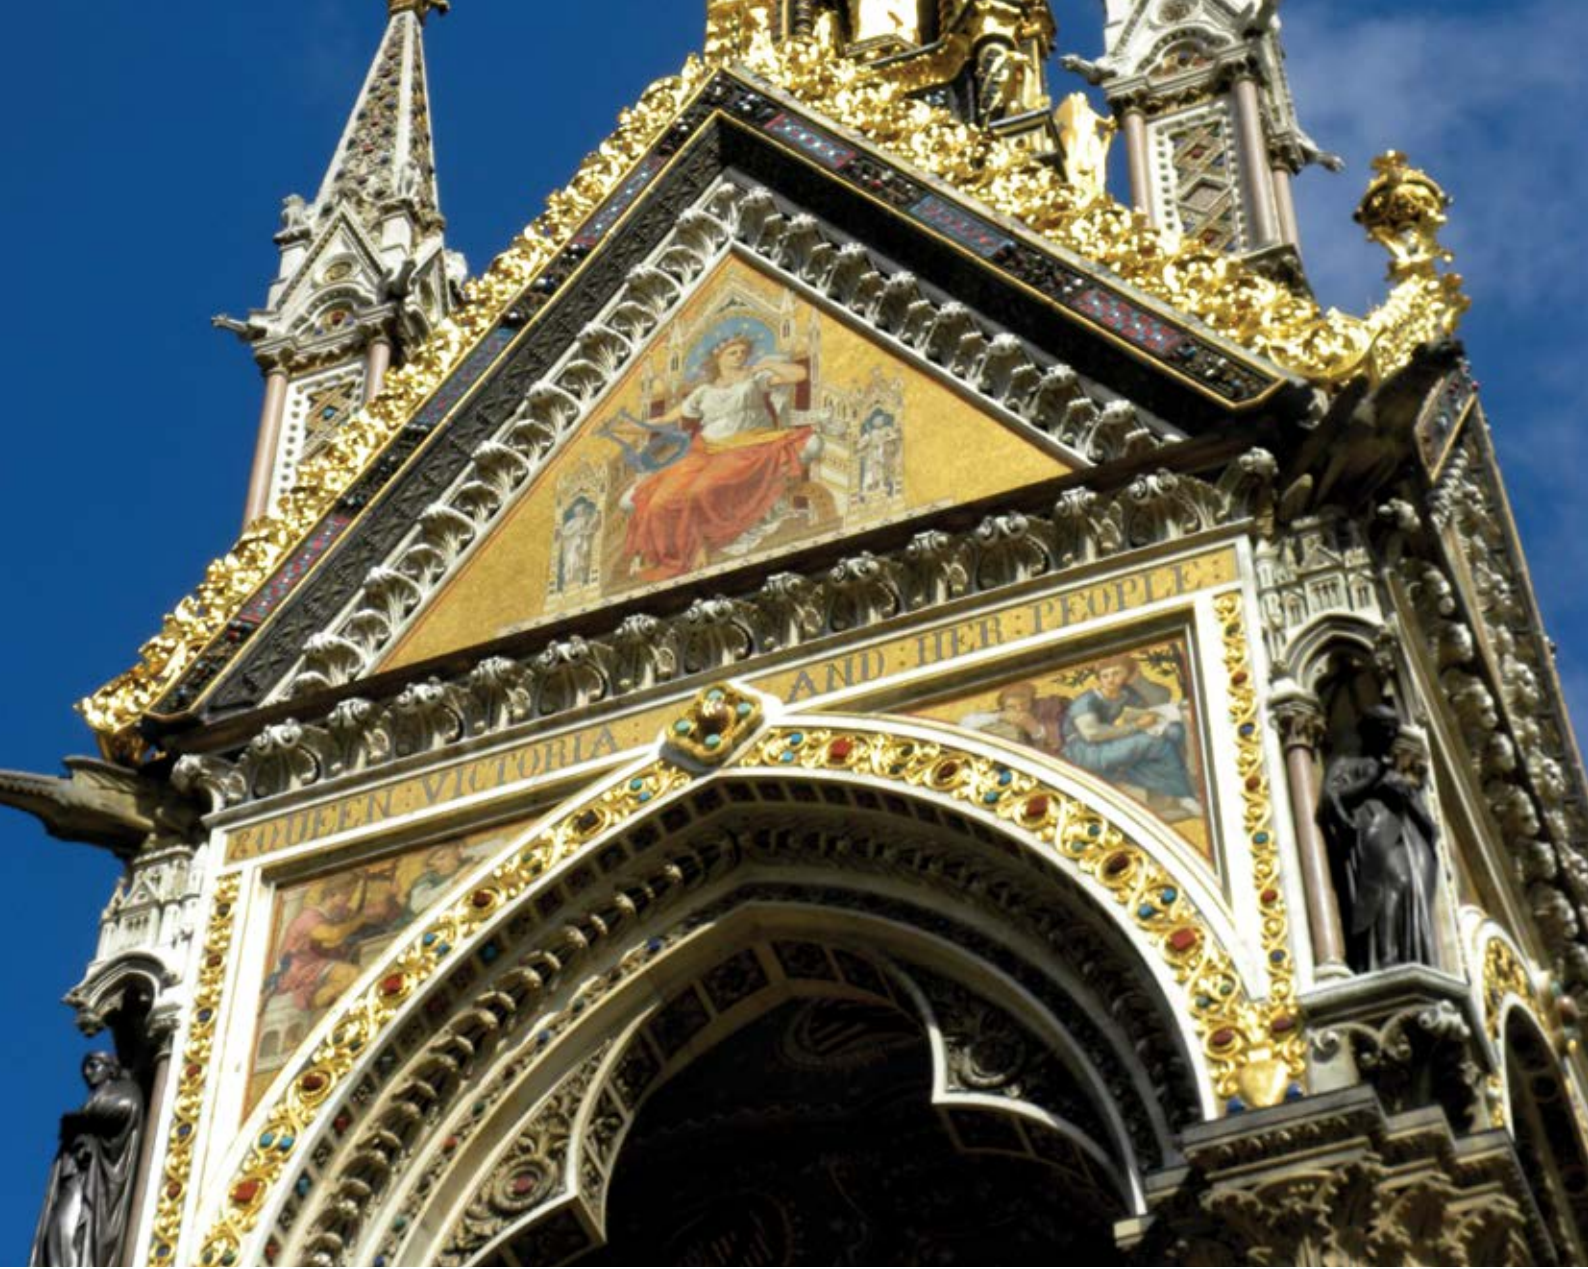
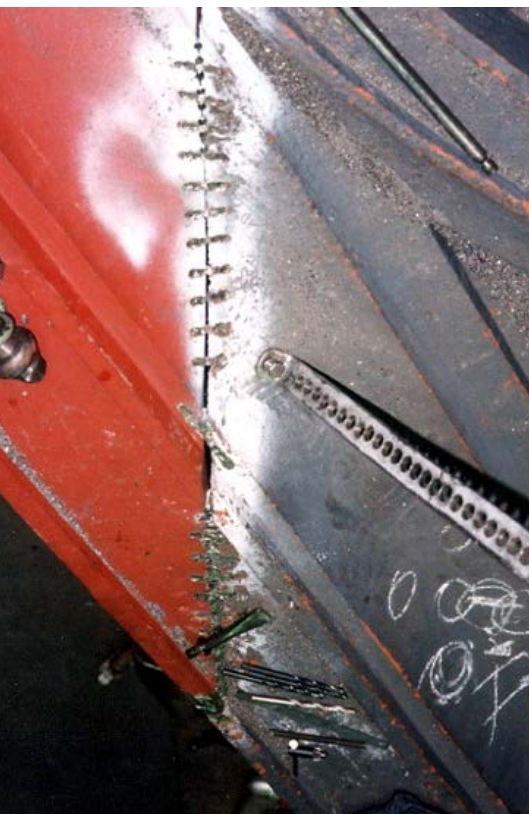
The Metalock Cold Repair Process assists in the successful restoration of London's Albert Memorial

The memorial is constructed from elaborate cast iron sections, up to 75mm thick, clad in lead and decorated with bronze and mosaics. There is also wrought iron, early mild steel, copper and gold. The lead in places is 20mm thick. In the original design there was no provision for the lead to expand, and being constrained it buckled in hot weather. Eventually, the buckled areas cracked and split and let water into the cast iron core leading to corrosion over the years. Corrosion jacked up the lead even more which increased the cracking. Parts of the cast iron core were severely corroded and in some areas there were cracks. These might have been the result of settlement over the years.

The memorial was systematically dismantled and inspected to assess the extent of the repairs required to various individual elements and sub - assemblies of the monument.

During the inspection it was decided to retain as much of the original casting as possible. The main damaged cast iron sections would be cut out by Metalock and replacement sections were cast and fitted back on to the original position to restore the overall monument structural design and appearance. Nearly 100 meters of Metalock repairs were completed in situ during this time as well as the repairs that were completed on the upper gables in the Metalock UK work shops.

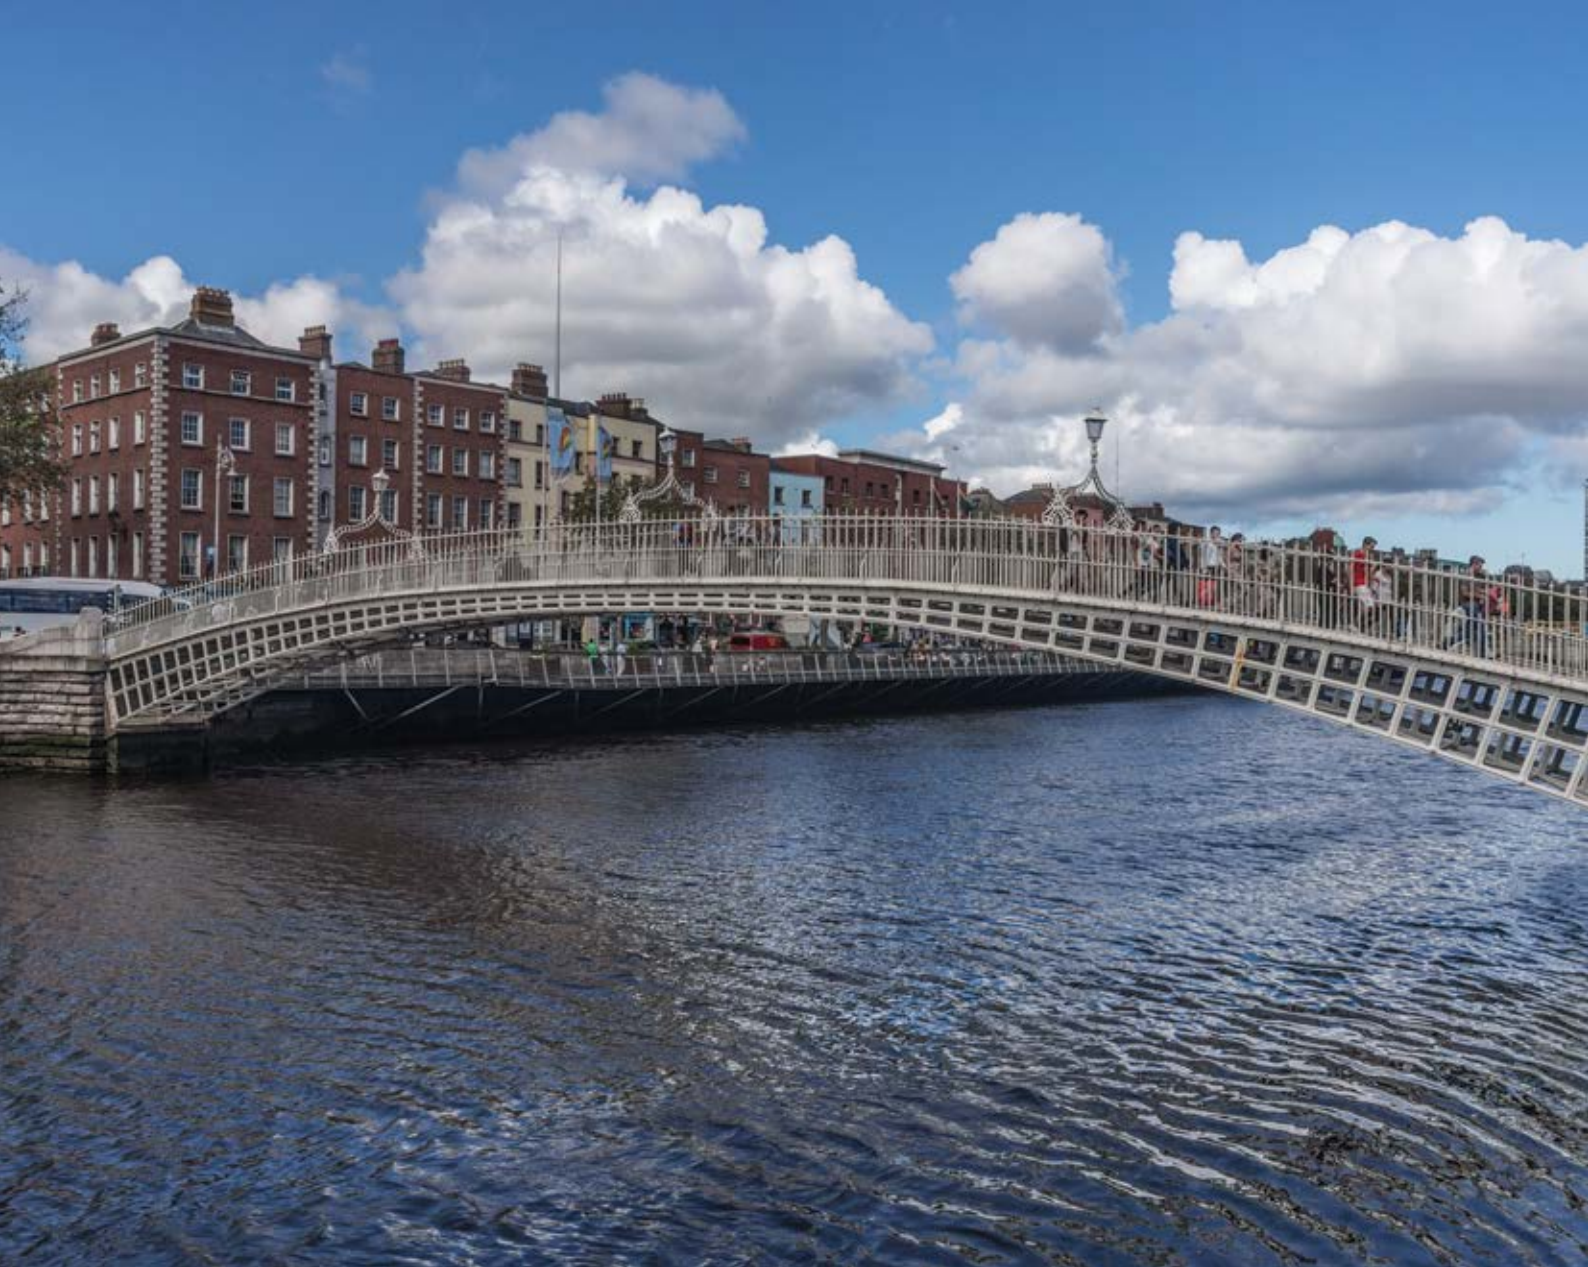
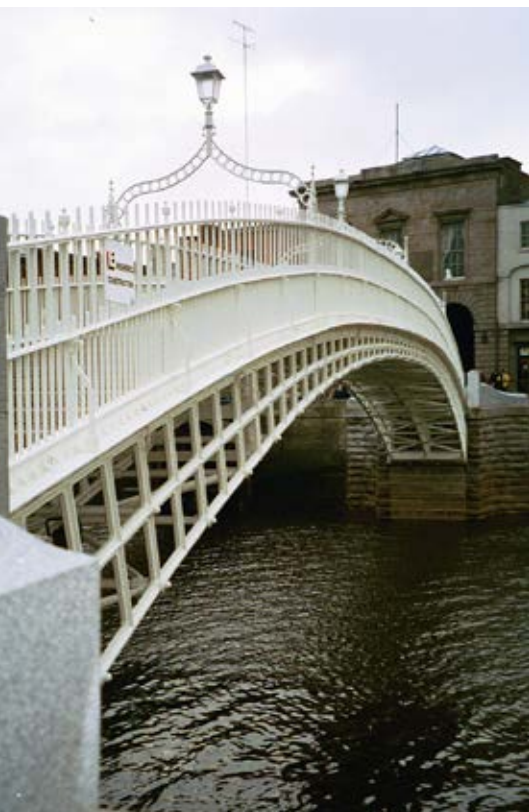
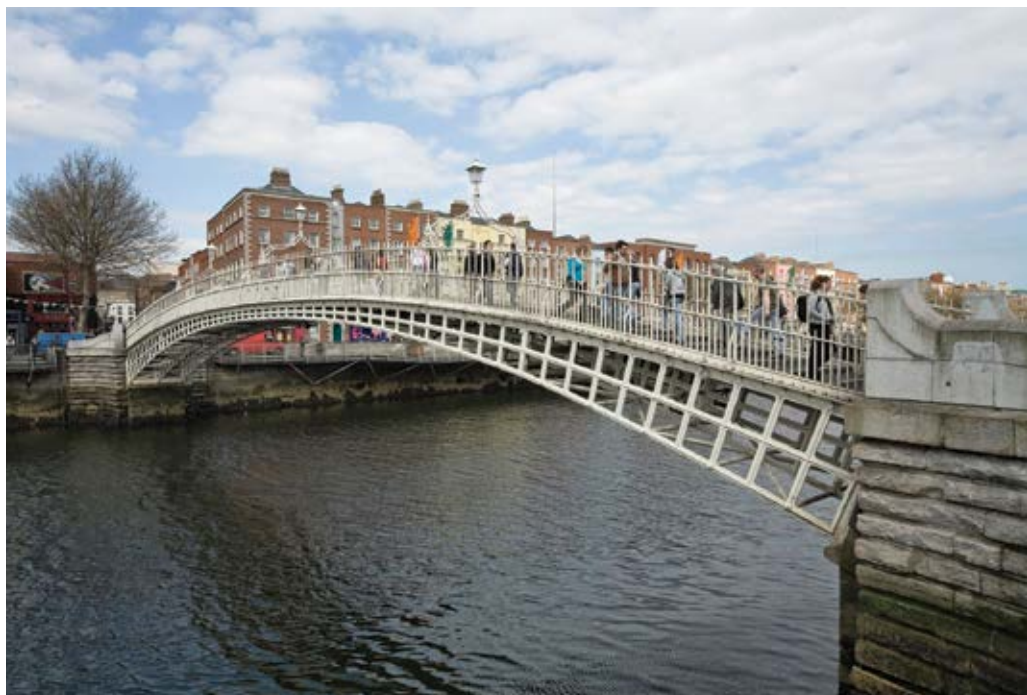
Ha'penny Bridge

The Ha'penny bridge, Dublin was opened to the public in May 1816 and spans 42 metres across the river Liffey. Metalock Engineering UK were asked to undertake all repairs to the cracked cast iron sections. Metalock carried out a series of magnetic particle inspection checks on various critical components and, using its Metalock metal stitching techniques repaired the damaged parts.

Most of Metalock's work involved tie-rod end caps, 43 of which had cracks and were repaired, and cracked diaphragm rib plates. Additionally, Metalocking was used to repair construction webs and install new corbel sections to replace those that had broken off over the years.

Most of the damage to the components that needed repair had been caused by expansion due to corrosion from moisture ingress following the breakdown of joint sealing materials.

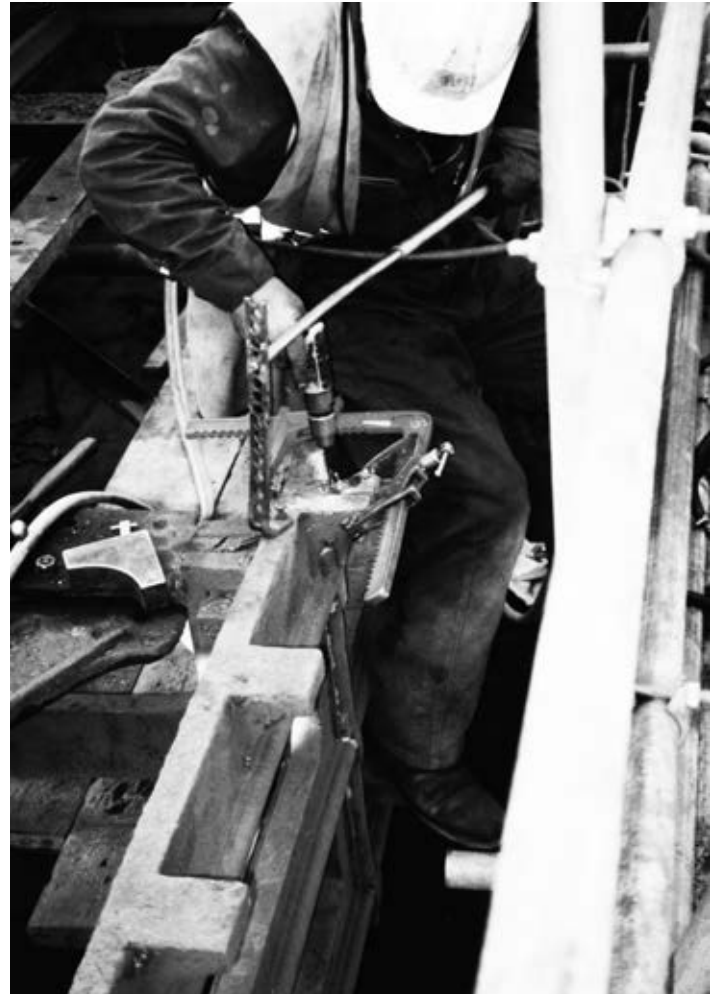
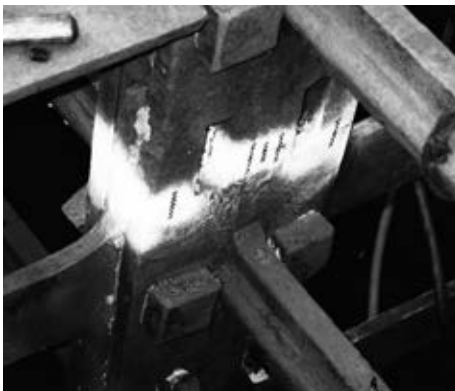
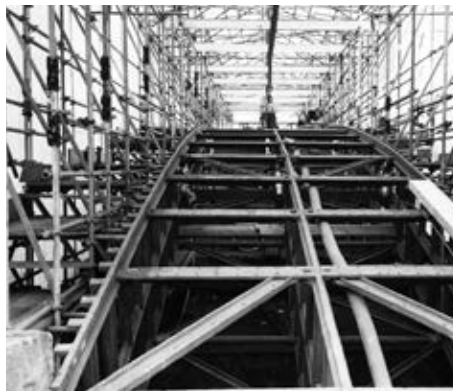
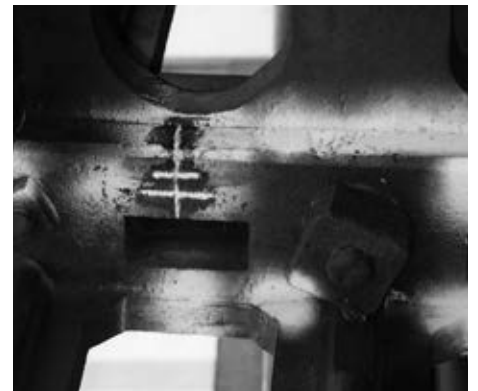
A famous landmark in Central London, the 100 year old Charing Cross Bridge carries 123,000 commuters across the Thames by rail each day. 720 feet of cracks to the structure's sixteen cast iron columns were successfully repaired by the Metalock process with 108,000 drillings and 36,000 tappings performed on site - without disruption to rail services.

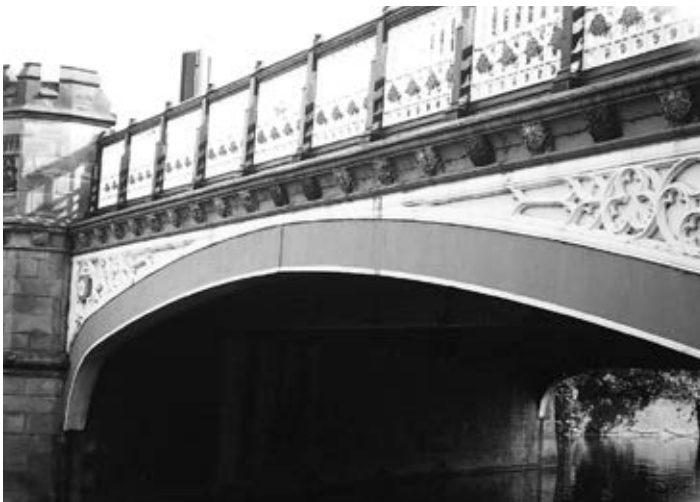
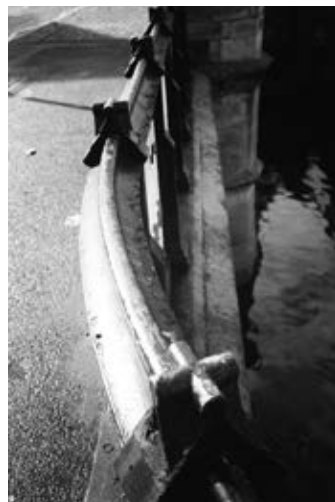
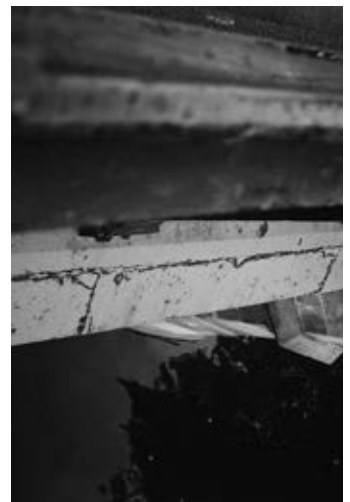
The scourge of low cast iron bridges are high sided vehicles coming into contact with the structures, causing major damage. Metalock are able to replace these areas with new sections secured into position by the cold repair process, as was done at the Gas Street Bridge in Birmingham.

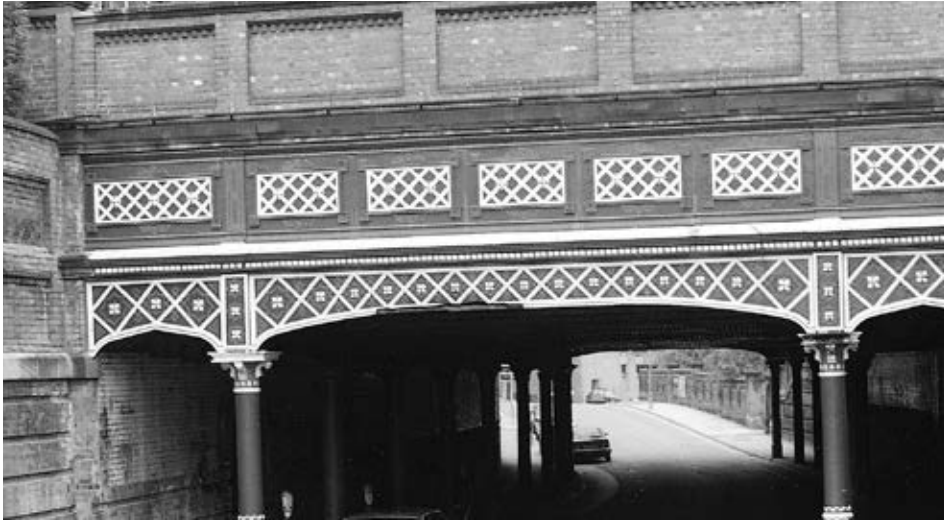
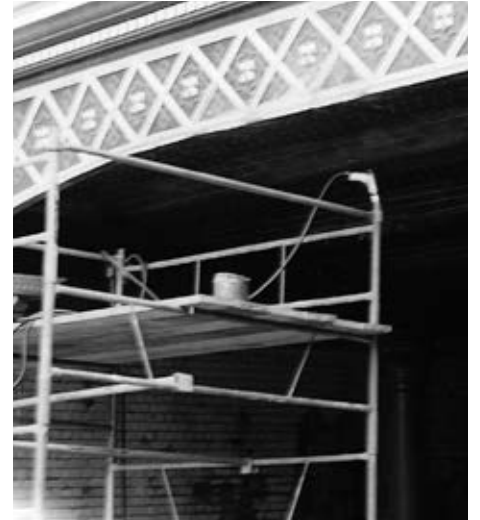
Codsall Railway Bridge

Broken cast iron lips that hold parapet panels in place on a grade 11 listed railway bridge at Codsall in South Staffordshire have been repaired by Metalock Engineering.

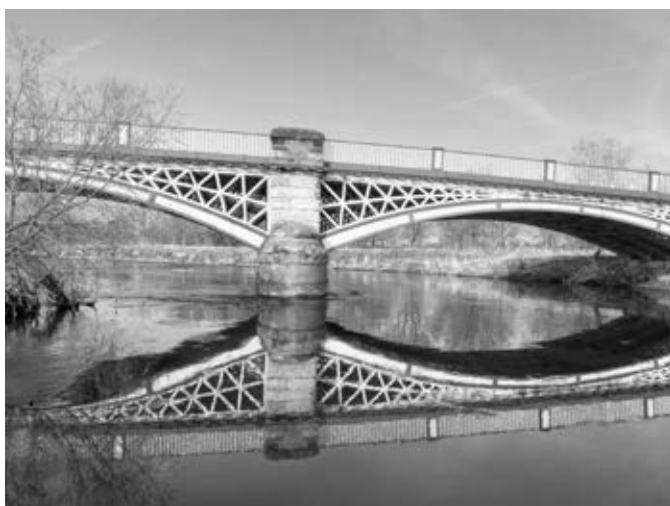
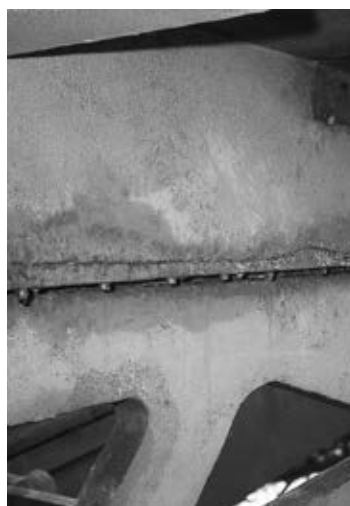
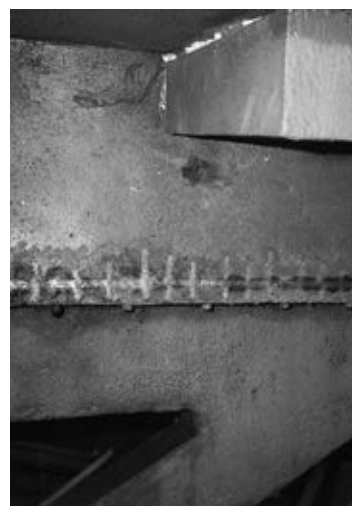
Northumberland Bridge

Metalock Engineers undertaking repairs to cast iron Column supporting a river bridge in Northumberland.

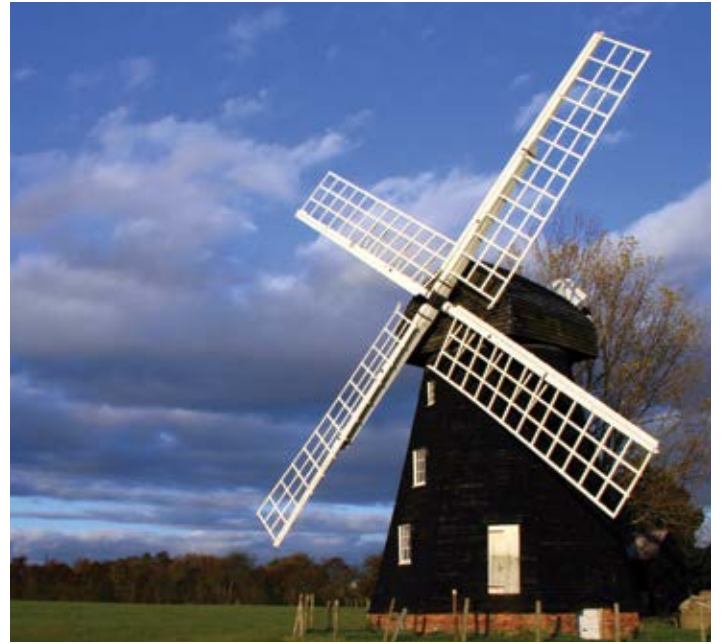
Lacey Green Windmill

The 1970 picture below shows the sad condition it had reached. It has been restored to preserve its unique wooden machinery, which probably dates from around 1650, making this the oldest smock windmill in the country.

Metalock repaired ten segmental castings, six of which were cracked, and four broken in two. In addition, ten circular rack sections were broken in two or three pieces. From patterns Metalock were able to repair these and also produce three additional segmental sections.

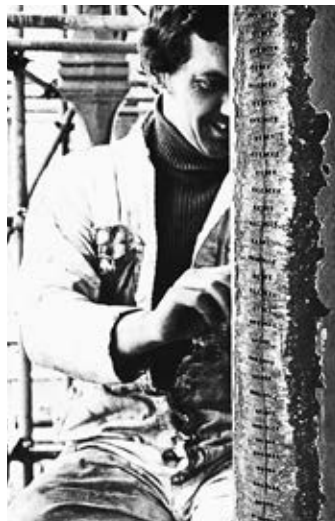
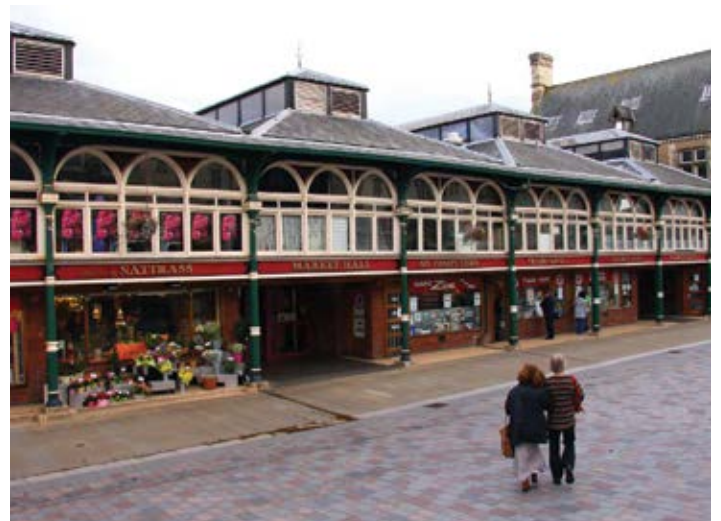
Darlington Market

Restoration of this 100 year old historic covered market was carried out under a preservation order. Inspection showed 24" to 48" fractures in six of the cast iron architectural columns supporting the roof. As it was virtually impossible to replace the columns without a total stripdown, a repair was essential, avoiding the shortcomings of welding.

The Metalock repair required no dismantling, was guaranteed and approved by Lloyd's.

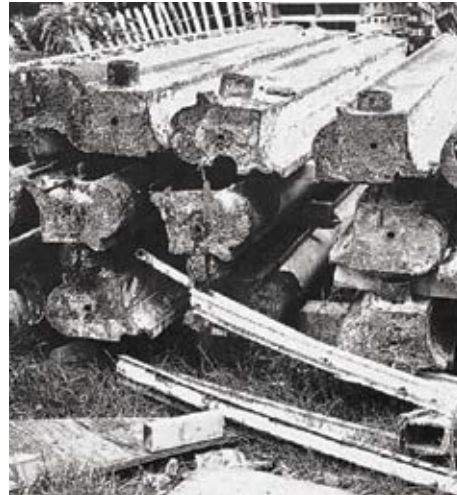
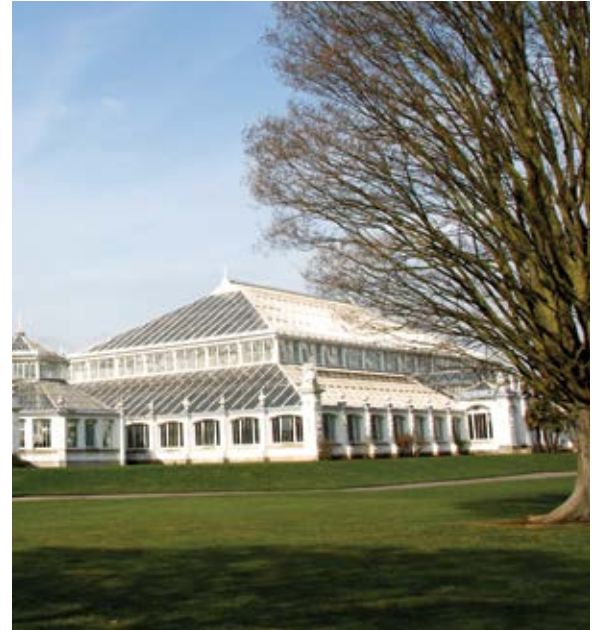
Kew Gardens

The Palm House forms an integral part of the structure of Kew Gardens, and is being renovated as part of the overall restoration programme. The sills, guttering and floor plates, which are over 100 years old, need to be restored to their original condition.

Metalock are undertaking this work by their cold repair process which restores the inherent strength and is the only way of retaining the authentic appearance of this historic structure.

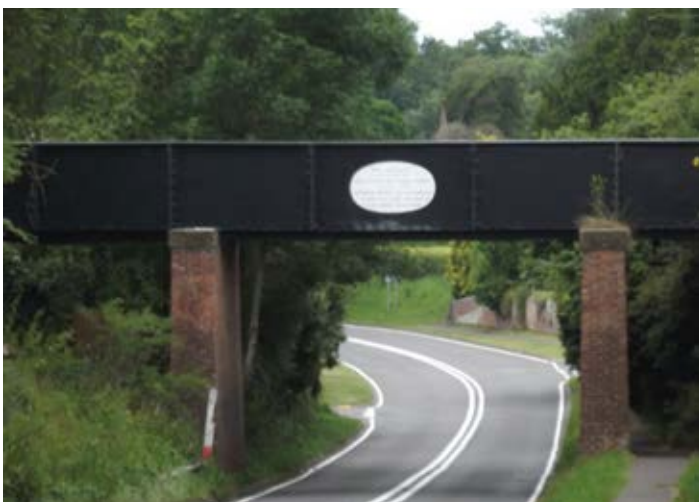
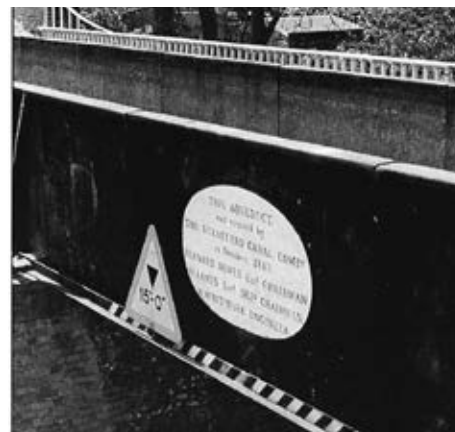
Wootton Wawen Aqueduct

Built 166 years ago, the Aqueduct at Wootton Wawen was damaged by a heavy road vehicle, causing a 3 foot fracture in a cast iron tray. As it carried the busy A34 road from Birmingham time was of the essence.

The watertight repair was successfully completed in four days with minimum disruption to road and canal traffic.

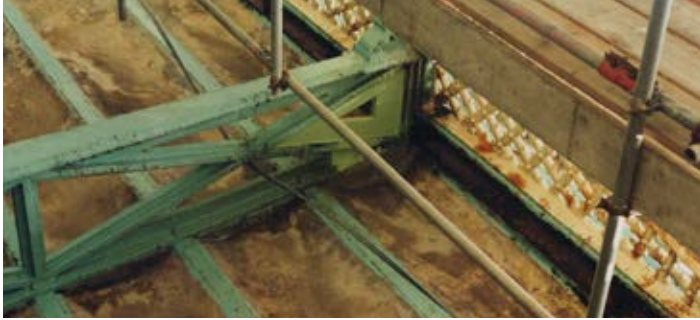
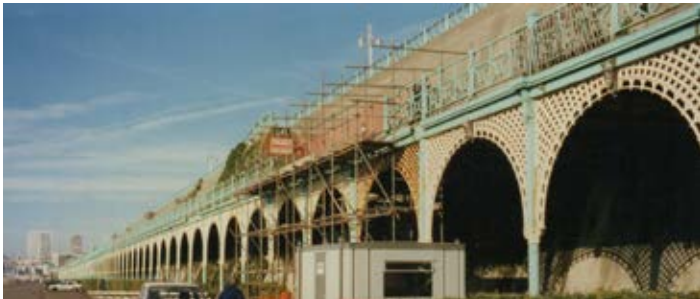
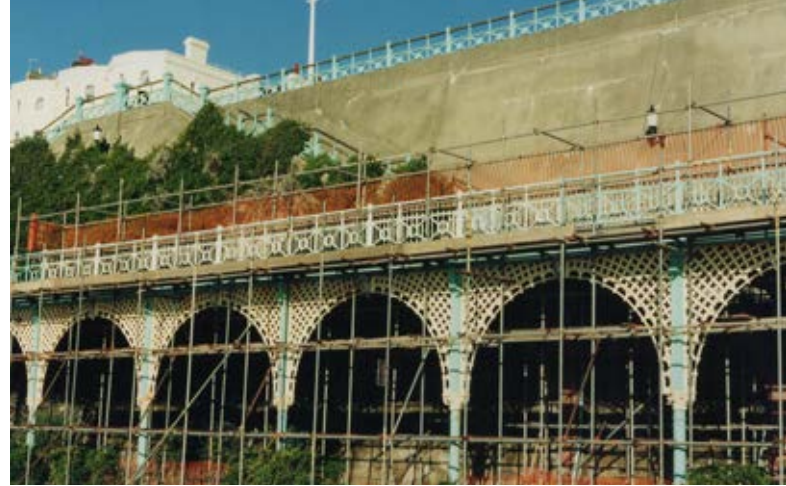
Madeira Terrace

Visitors to Brighton who will recognise and appreciate the iron terrace built in 1895 will be pleased to learn that Brighton Corporation were able to save the structure with the aid of Metallock.

The repair, accomplished on site, introduced no additional stresses, which would occur if it was conventionally welded, returning the cracked supporting columns to their original strength.

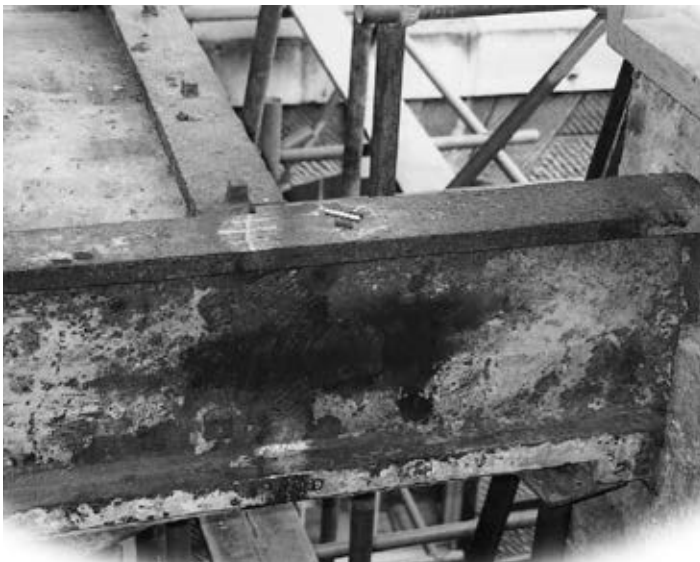
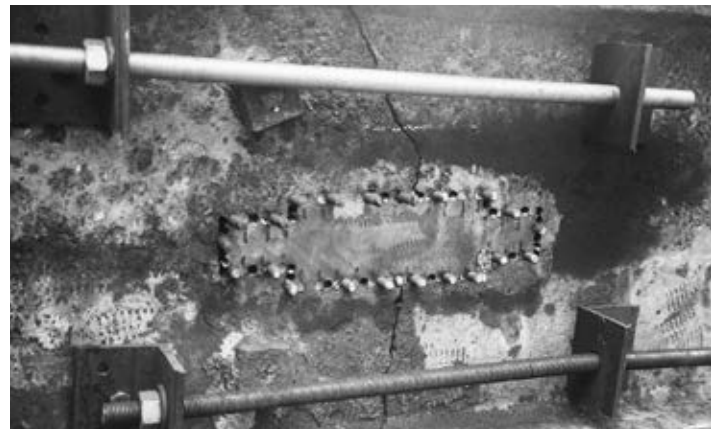
Somerset House

During refurbishment at Somerset House, inspection to the Main Support Girders showed extensive fractures. These fractures were repaired using a combination of Masterlocks and Metallock Keys, giving additional strength to the repair.

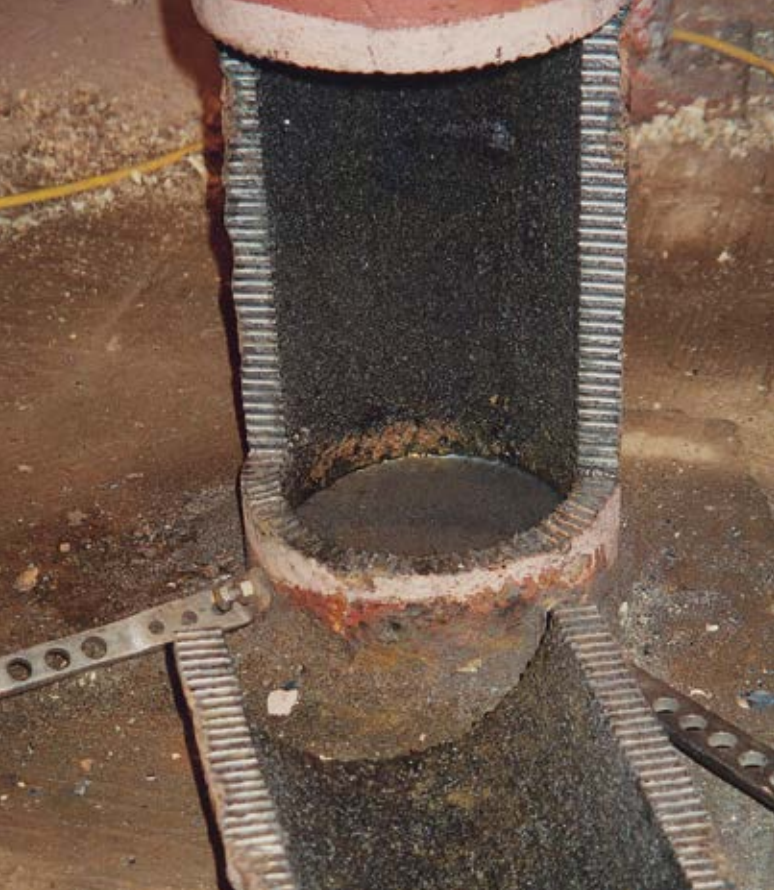
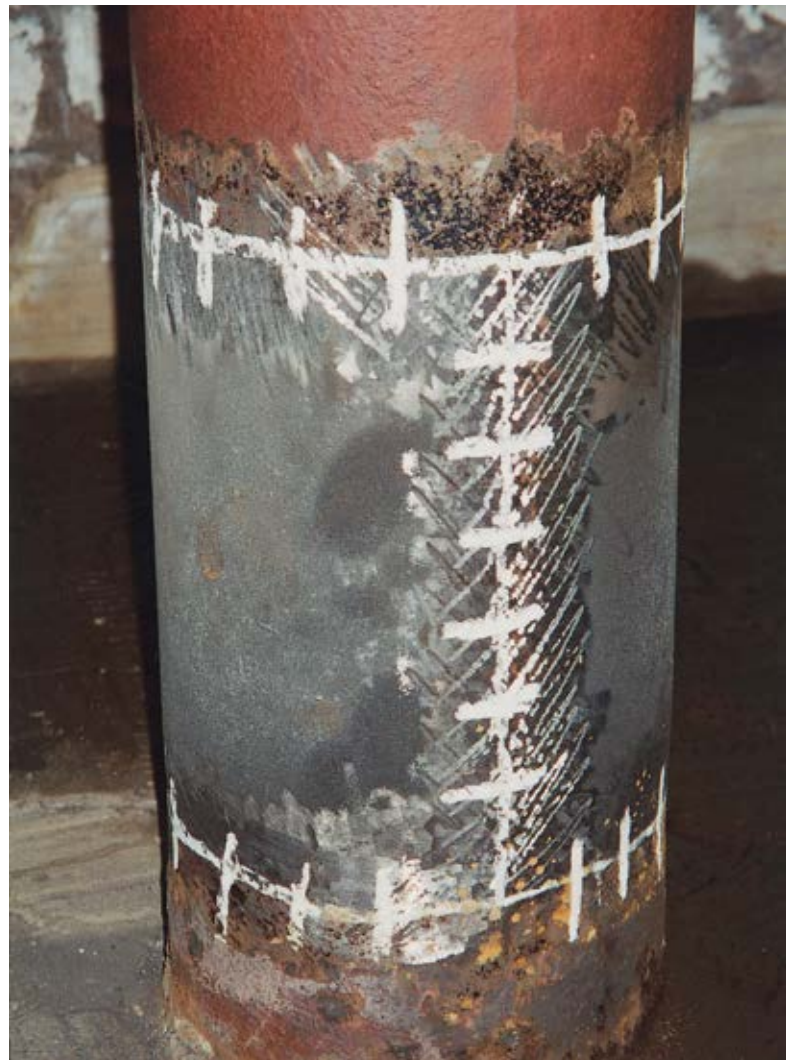
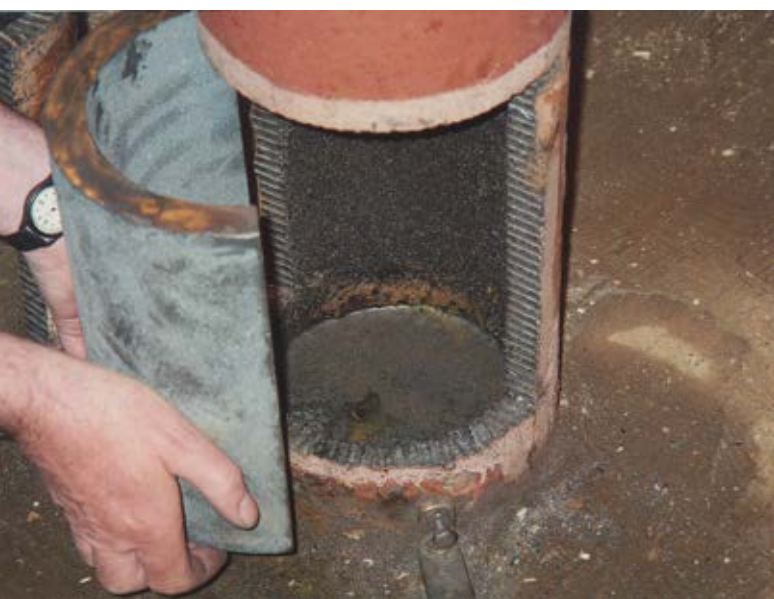
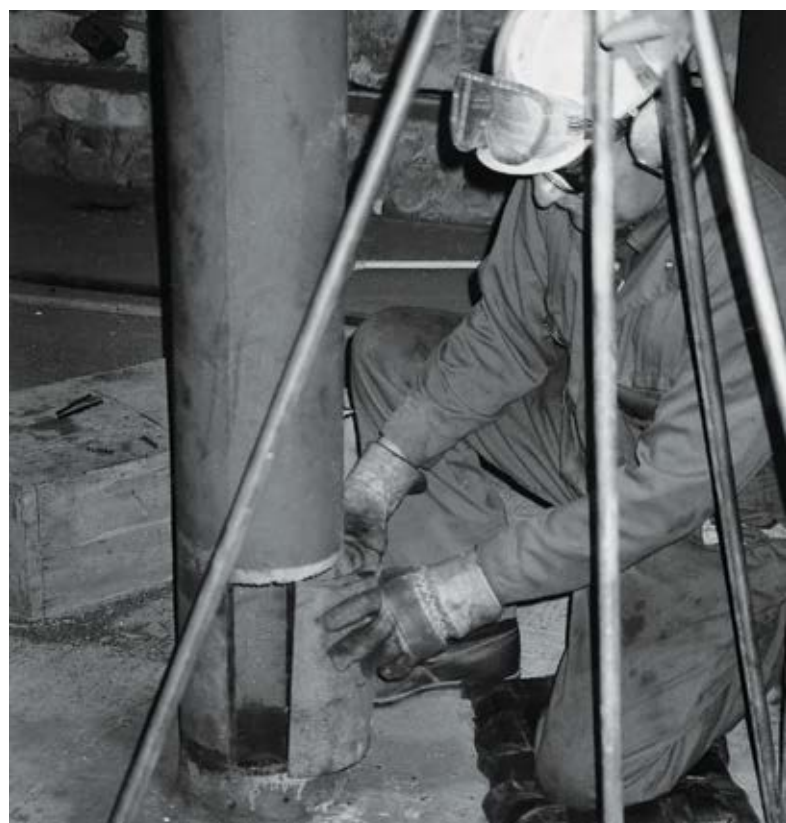
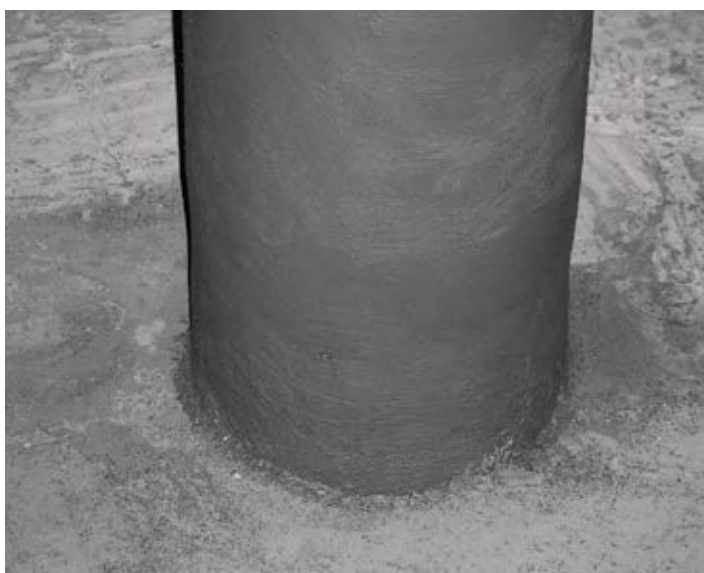
Above: Support column repair from beginning to end, using the Metallock process.

- 4 The holes are then joined by the use of pneumatic chisels to conform to the shape of the Metallock Keys.
- 5 Individual layers of Keys are inserted in the apertures and peened into a metal-to-metal condition, which becomes almost integral with the parent metal.

- 6 Holes are then drilled along the line of the fracture, then tapped.
- 7 Filled with studs.
- 8 Each stud biting into it's predecessor, resulting in a pressure-tight joint and restoring a rigidity to the casting.

- 9 A Metallock stud is an important aspect of the Metallock process, bearing in mind that pressure repairs are often required.
- 10 The studs are then run down till the heads shear, the remaining rough metal being removed by pneumatic chisels.

- 11 The whole repair receives treatment from hand grinders.
- 12 Prior to it's final coat of paint.

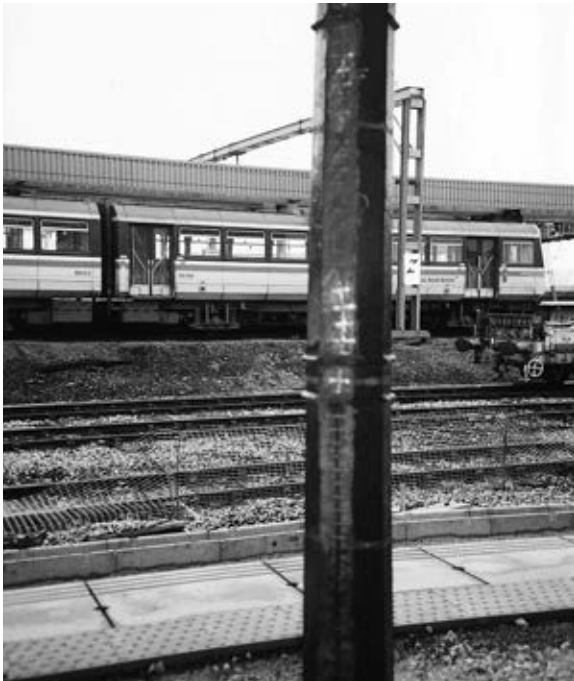
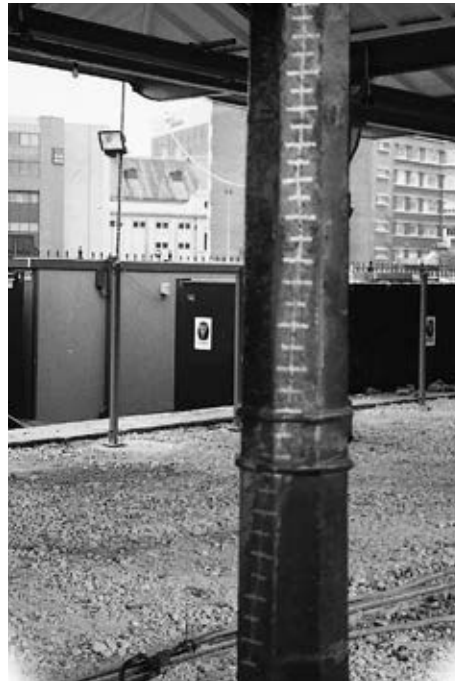
Left: Railway platform support column fractures due to frost and repaired on-site.

Metalock repairs can be carried out to all sorts of support columns, under workshop conditions or on-site, without the costly need to remove the column. A new section can be cast and split in two halves and cut out of the column to match one of the halves. The new section can be inserted and secured by the Metalock process, the remaining section can then be removed and replaced with the second new section and finally secured into position.

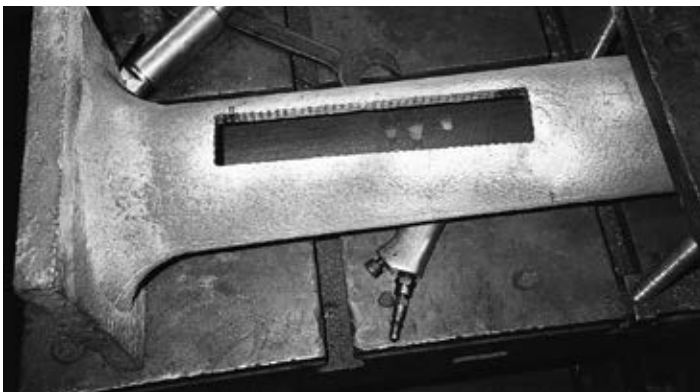
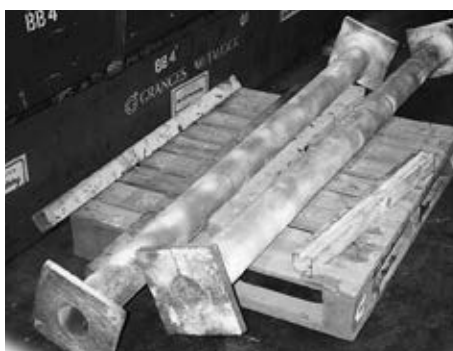
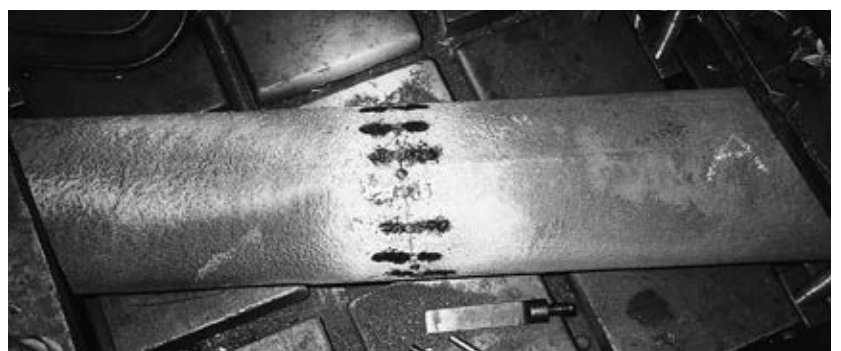
Below: Bellway Home support columns showing the removal and replacement of damaged sections in the workshop.
