High Level Bridge Newcastle

Essential cold Metallock repairs

Essential cold Metalock repairs

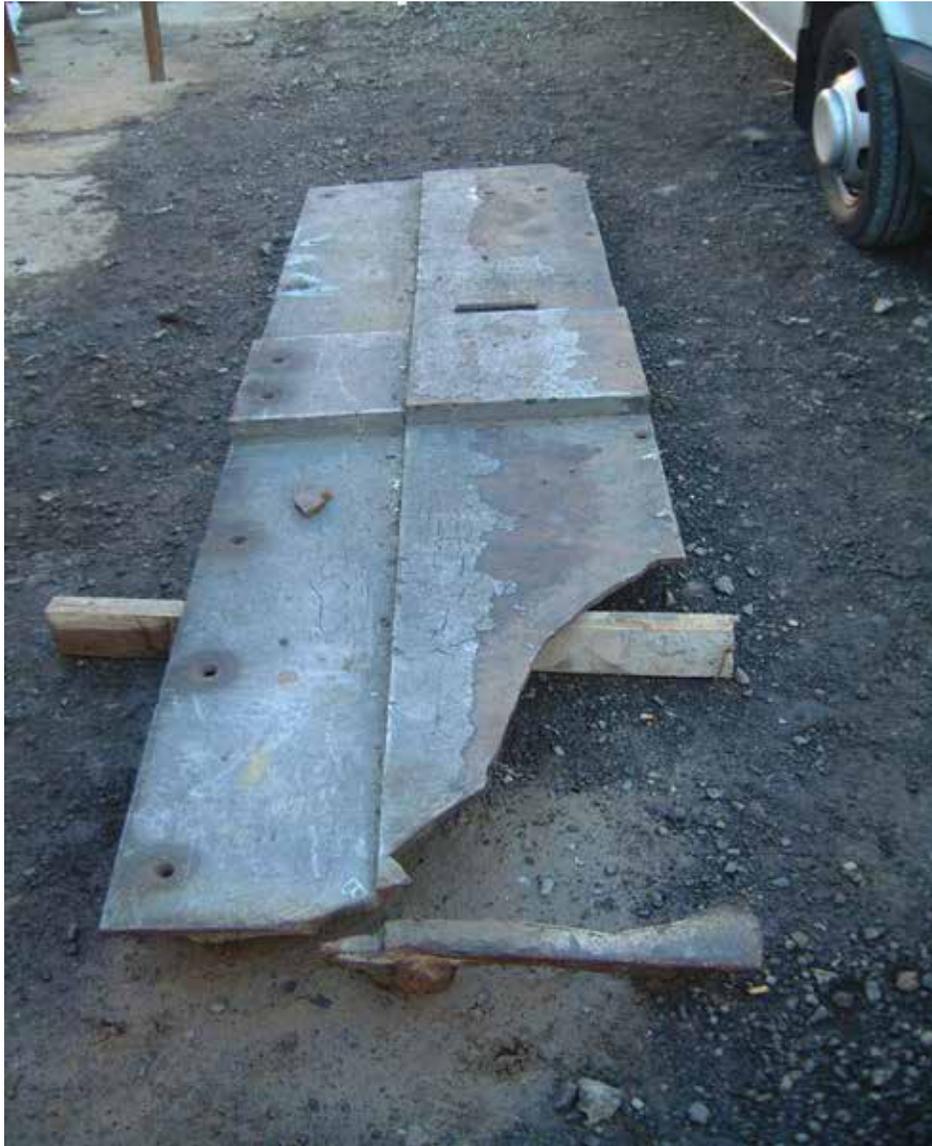
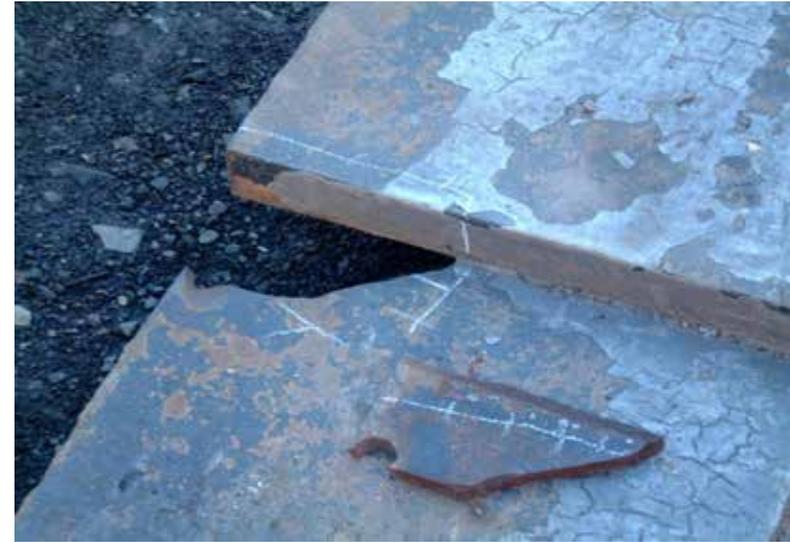
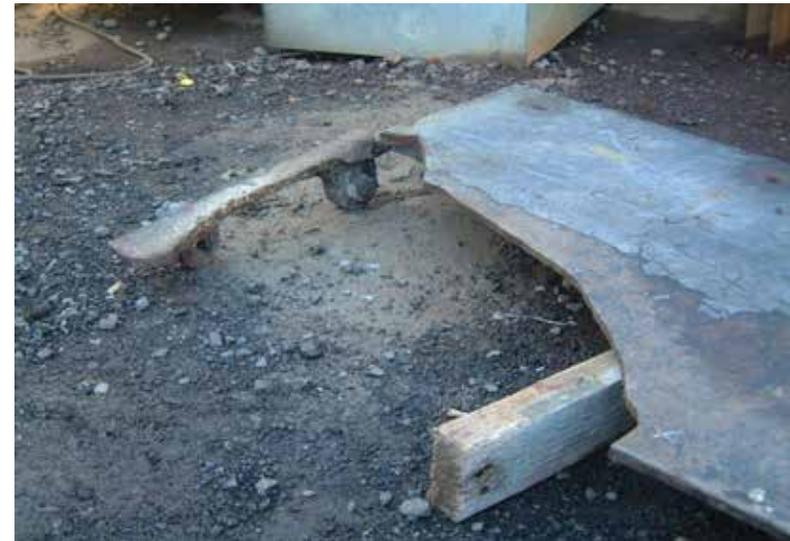
Typical damage to Fascia Panels

Initial repair

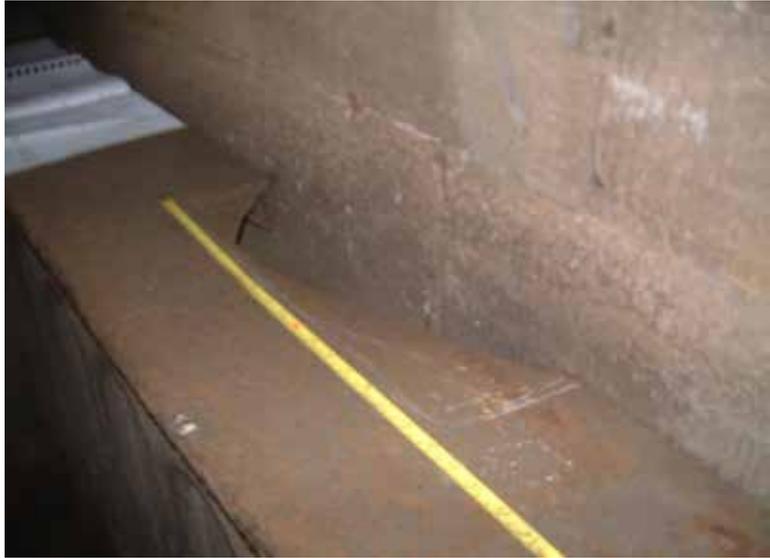
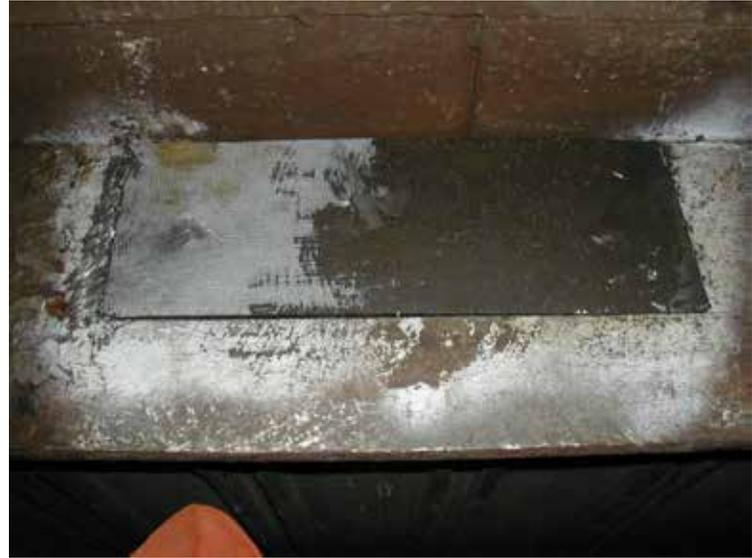
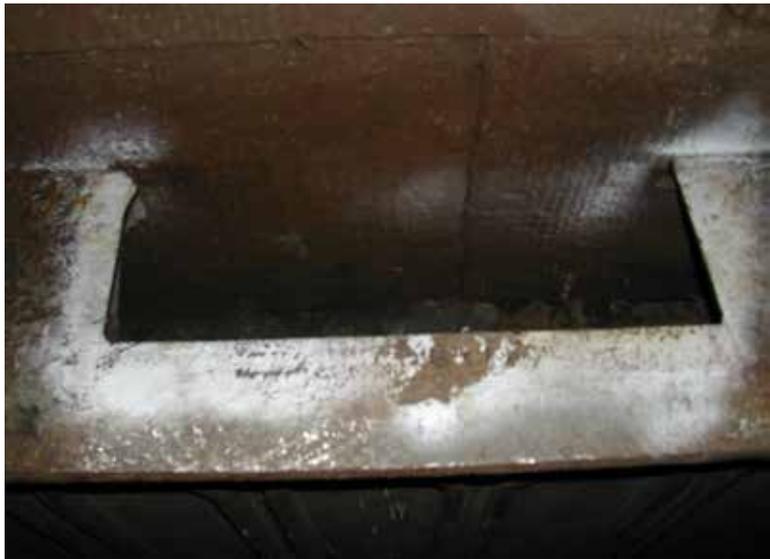
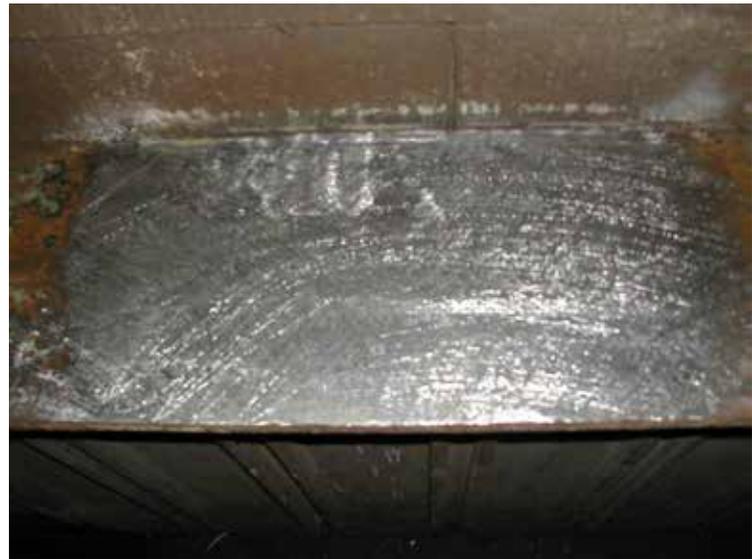
Commenced repairs on the Road Deck level

20th December 2004

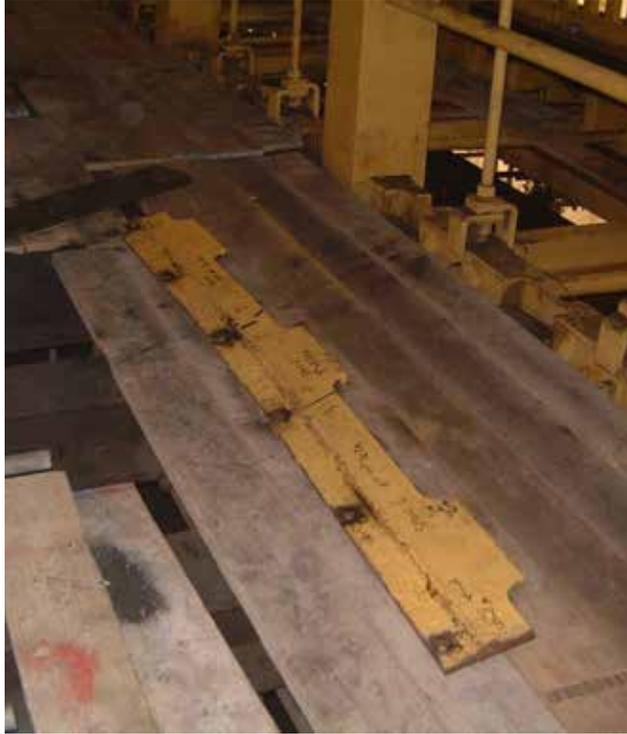
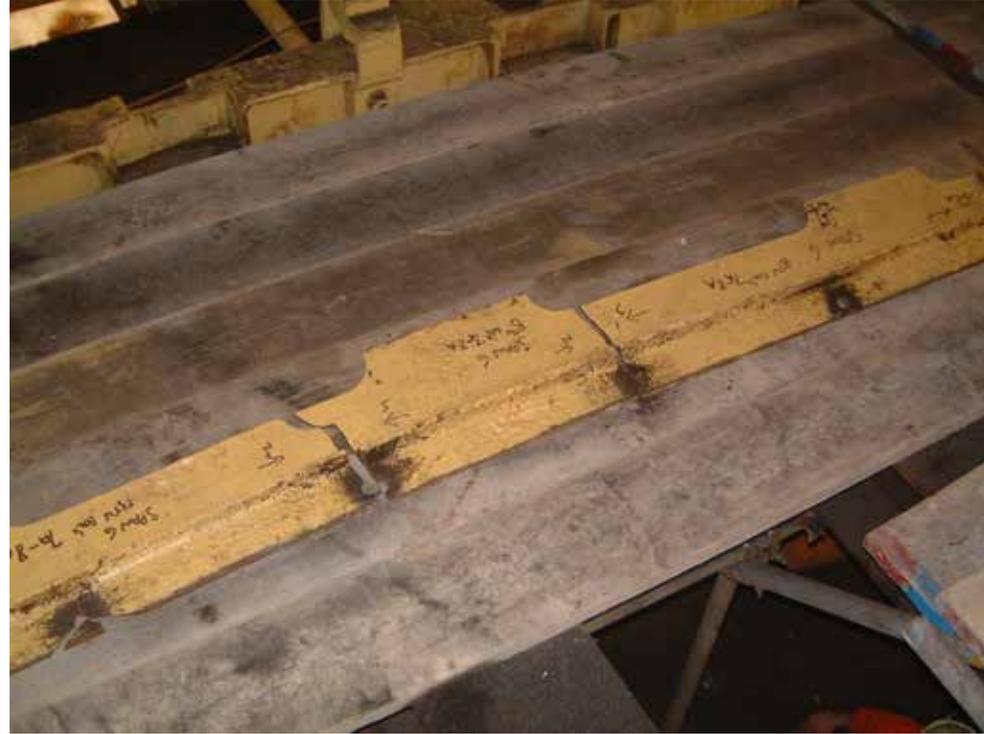
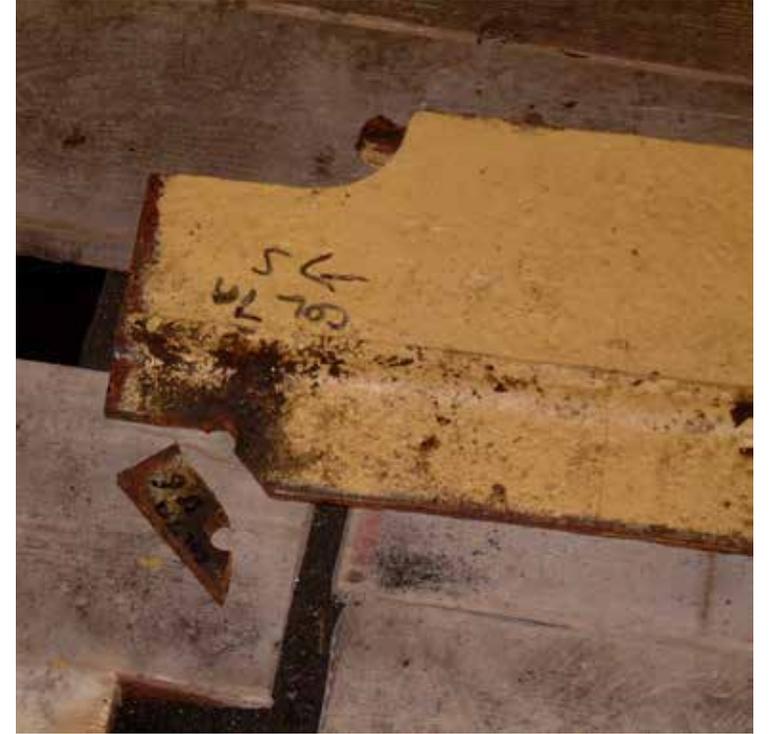
Fascia plates

**Items still waiting
a repair decision**

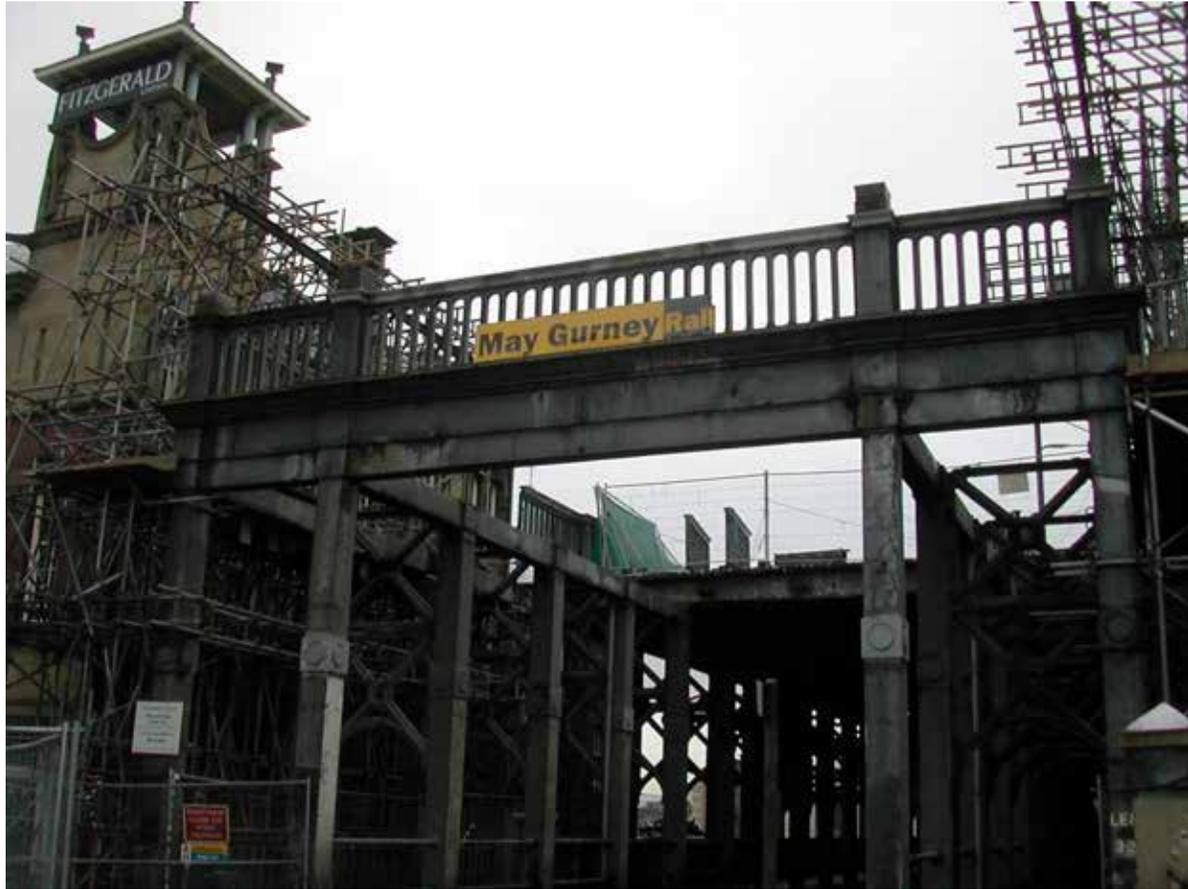
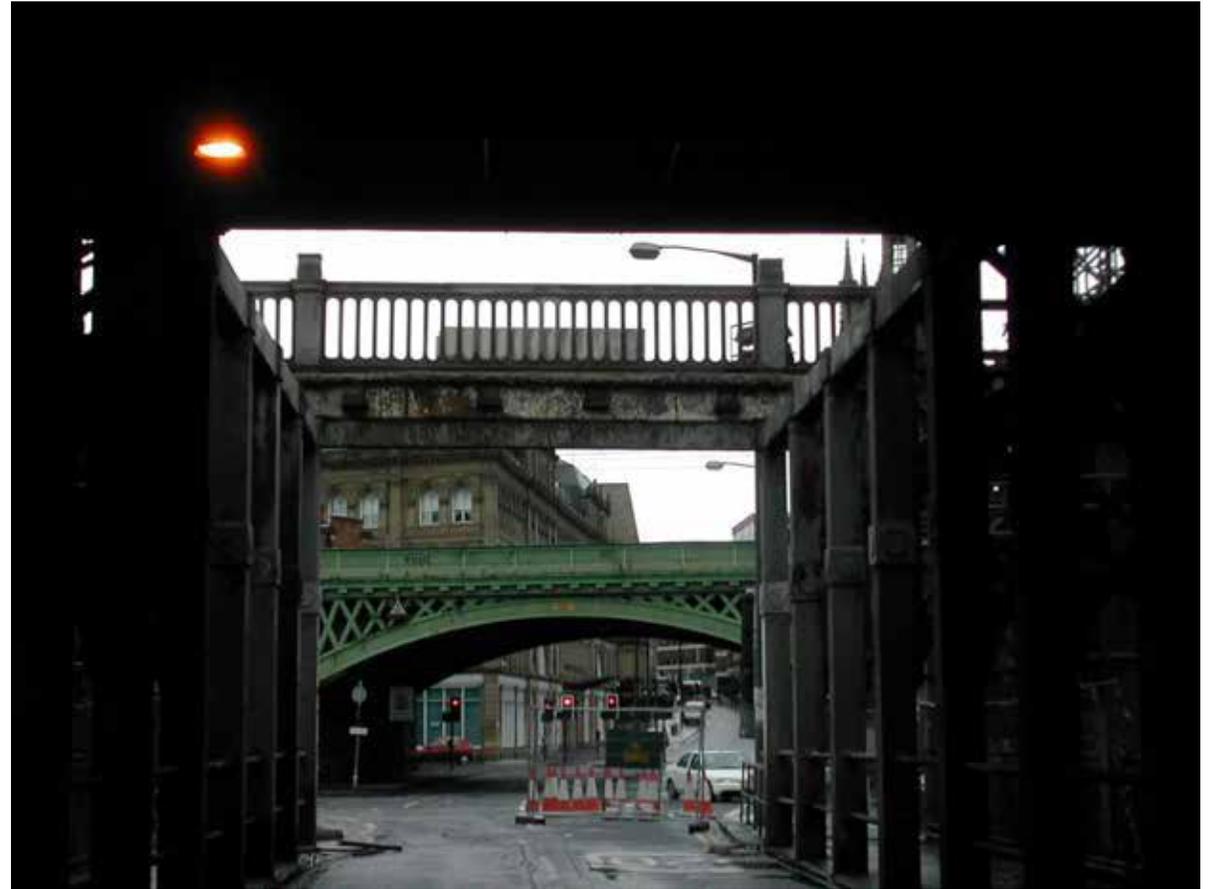
Longitudinal girder

- 140 Main Girders x 12 metres long span the Bridge
- 3 were removed and tested to destruction
- Metalock were asked to carry out repairs

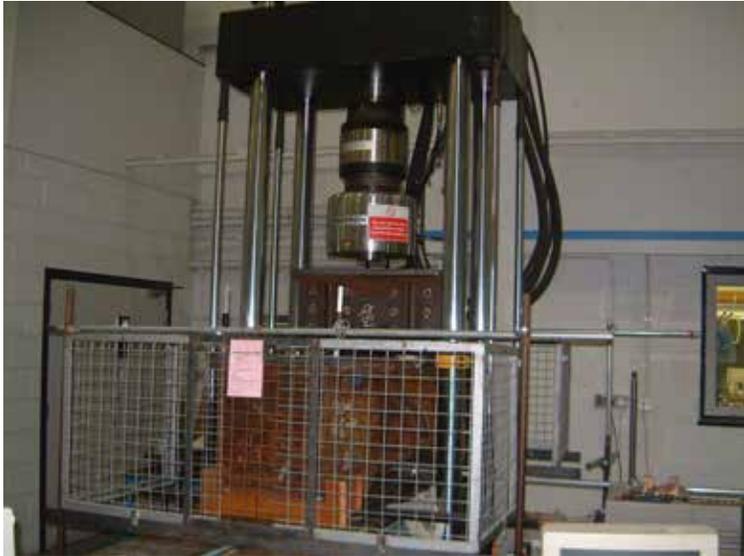
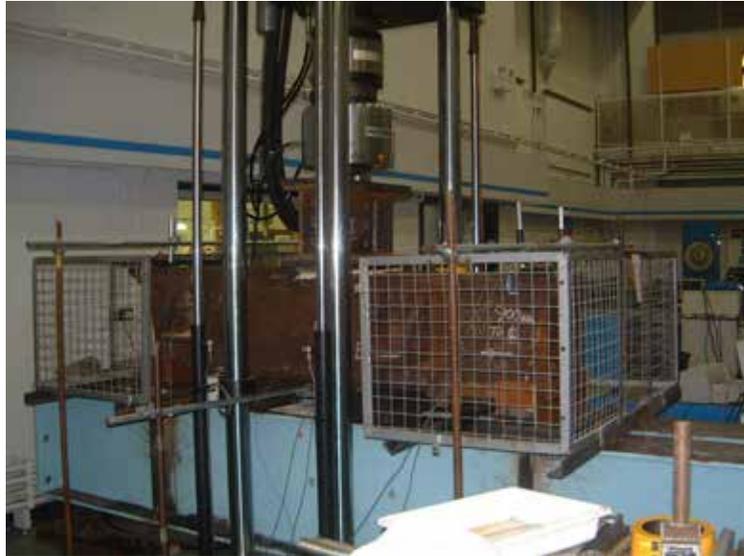
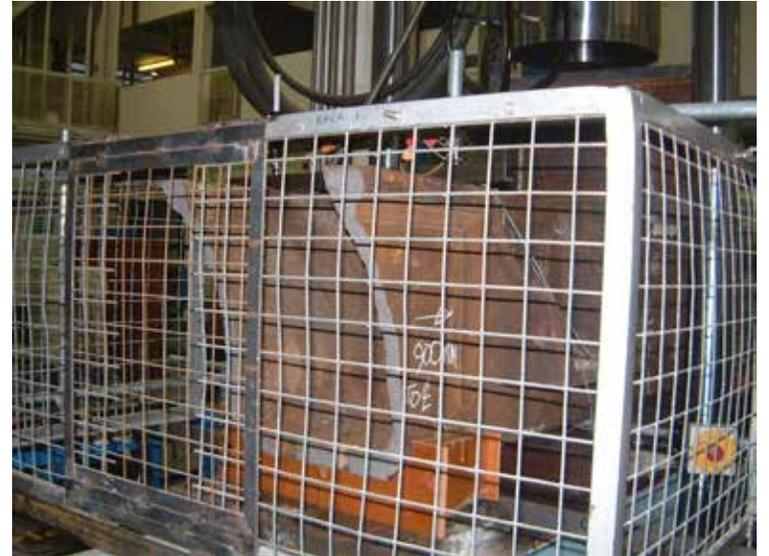
Cut into 2 piece by drilling and breaking along its weakest point.

Each Girder Section was placed into a machine at Manchester University and tested to destruction

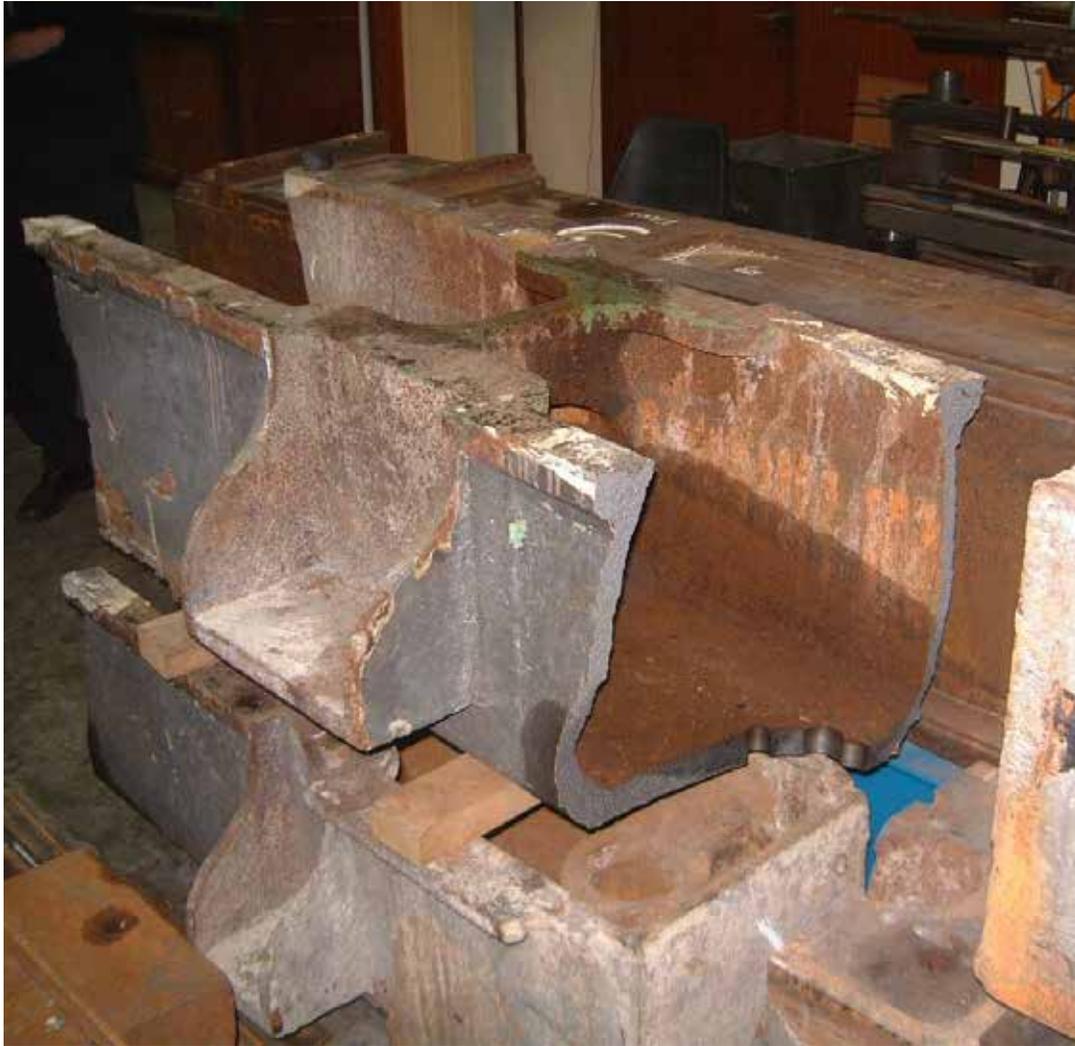
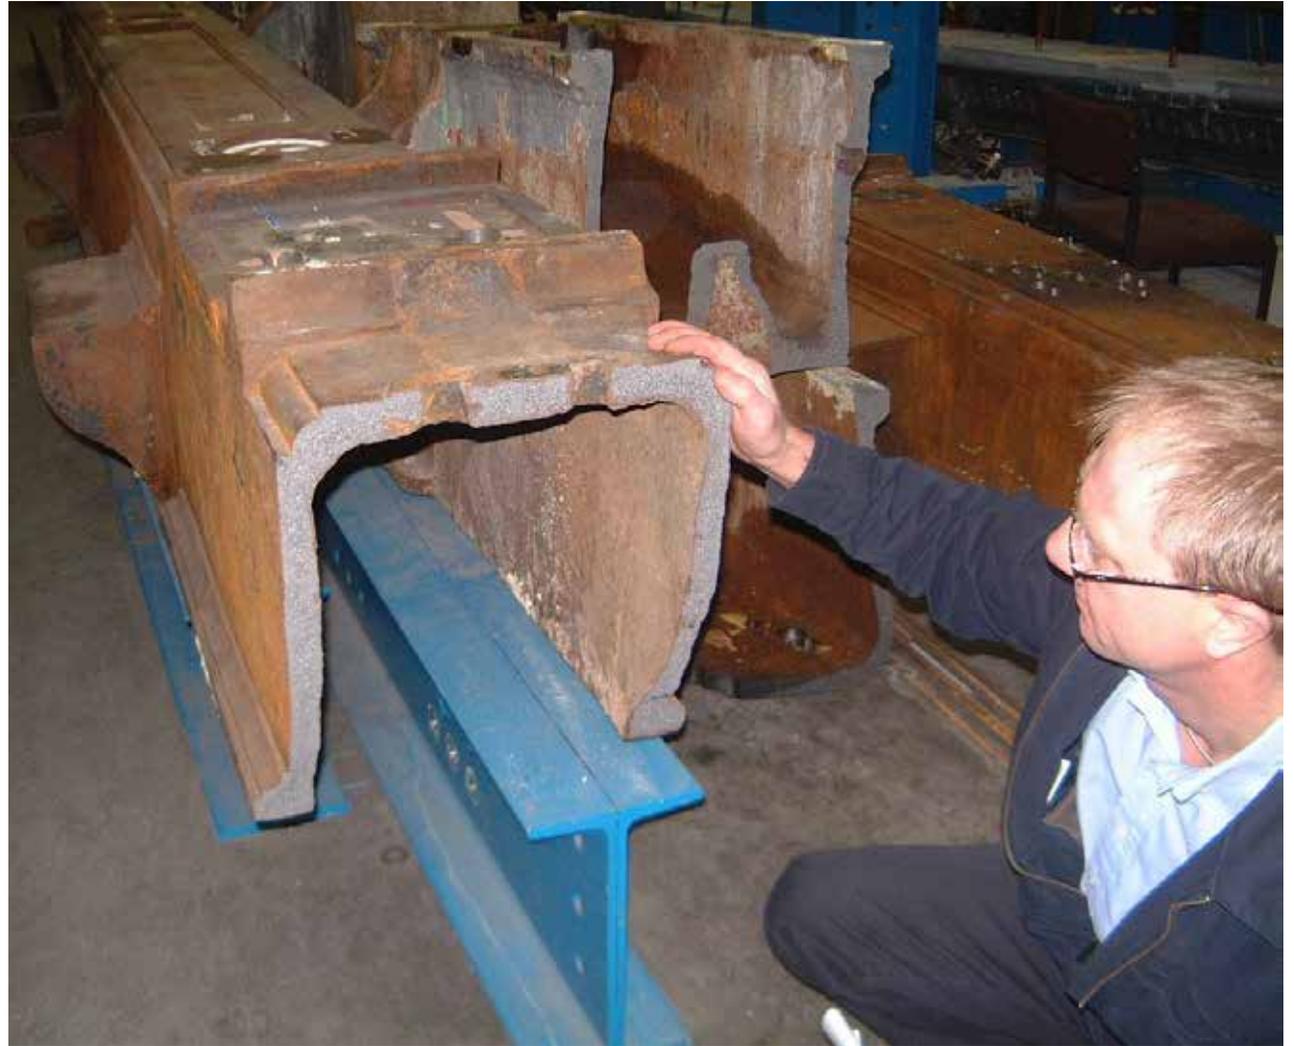
All readings were within an acceptable level with the order being given to Metalock to repair

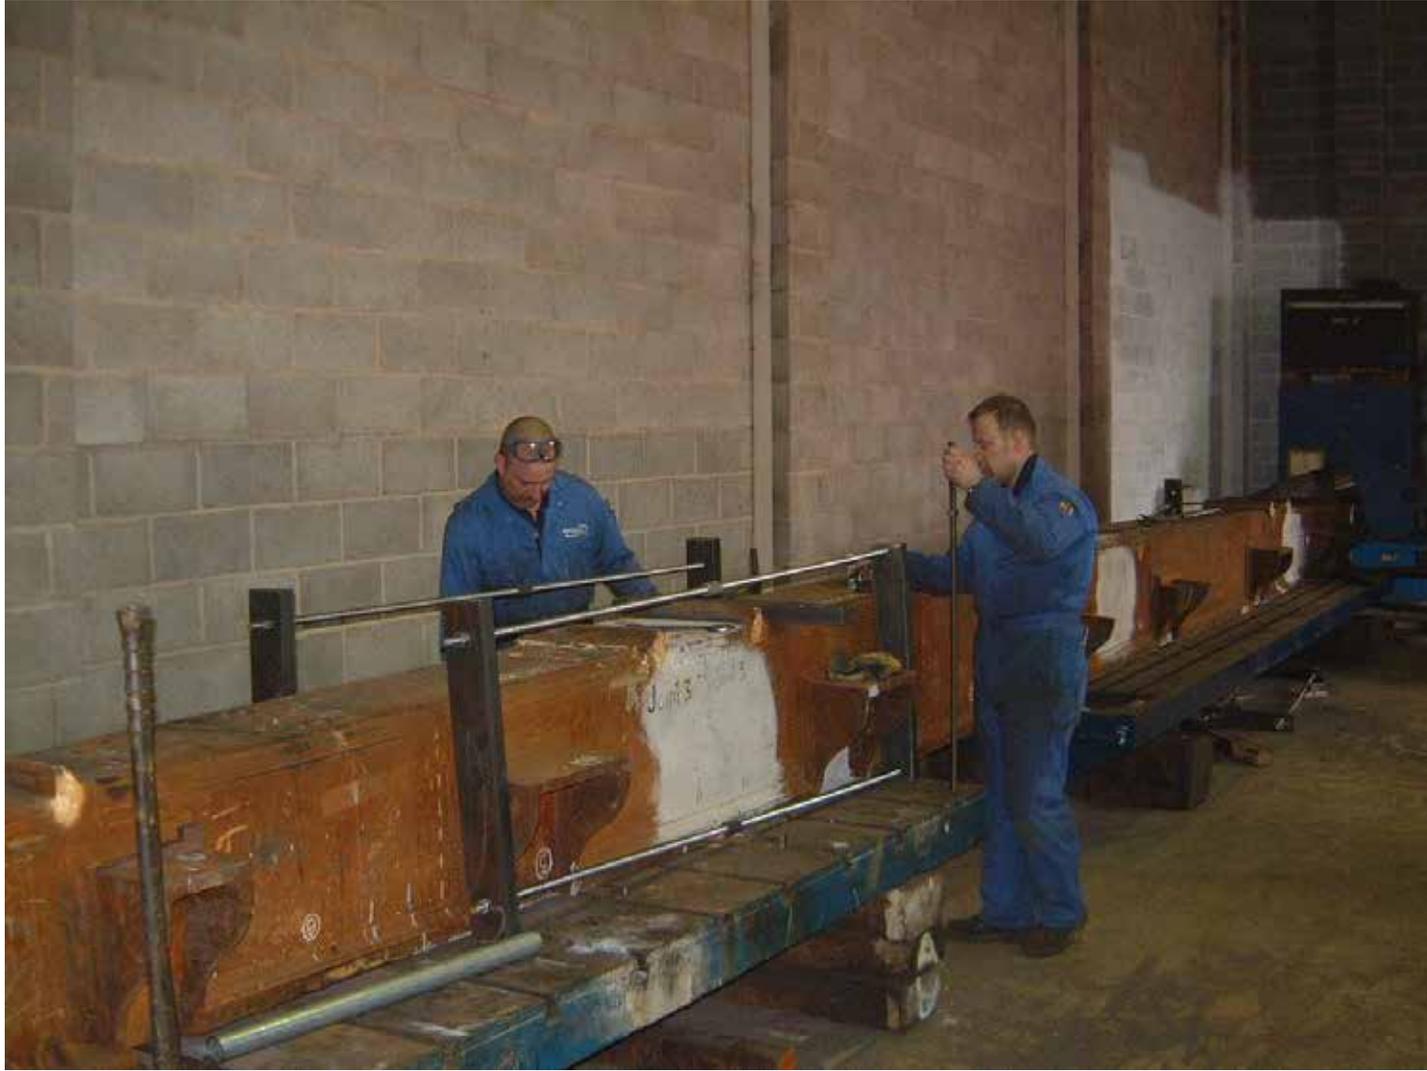
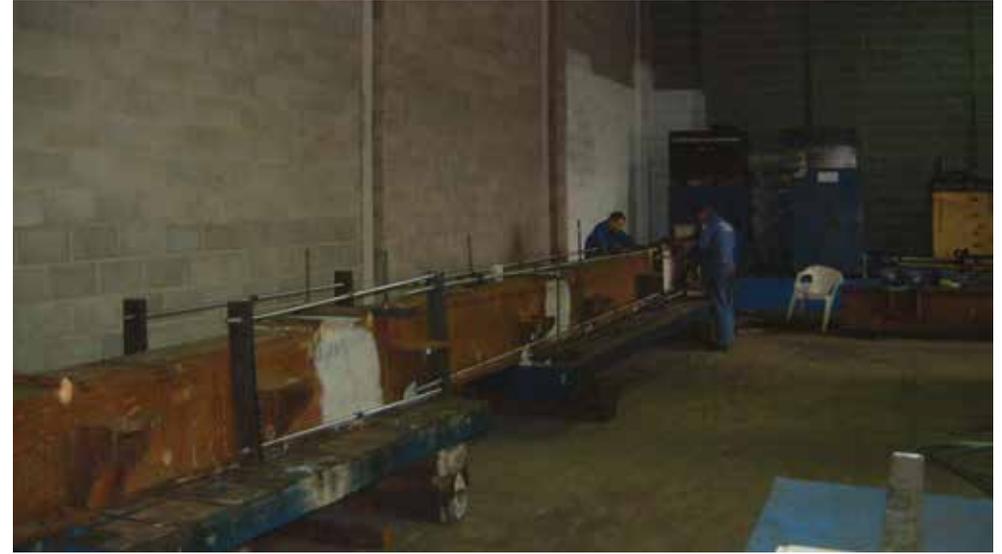
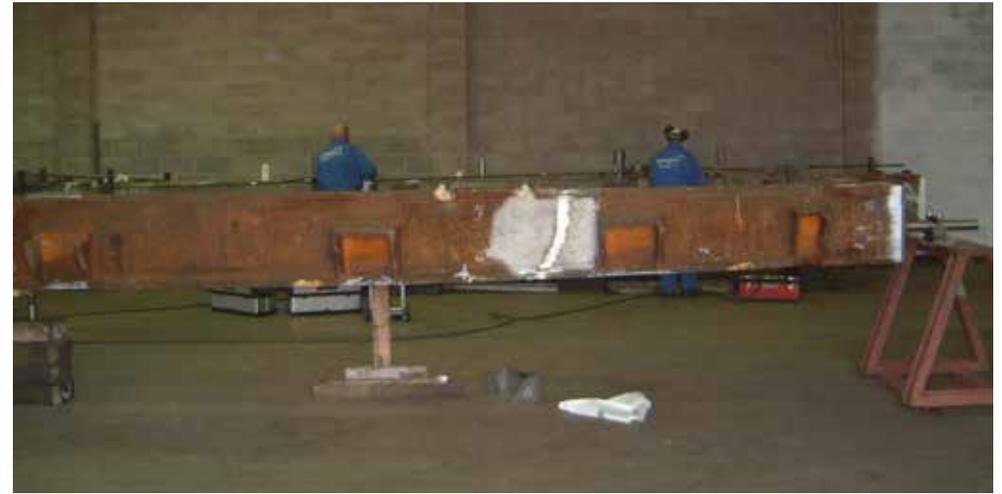
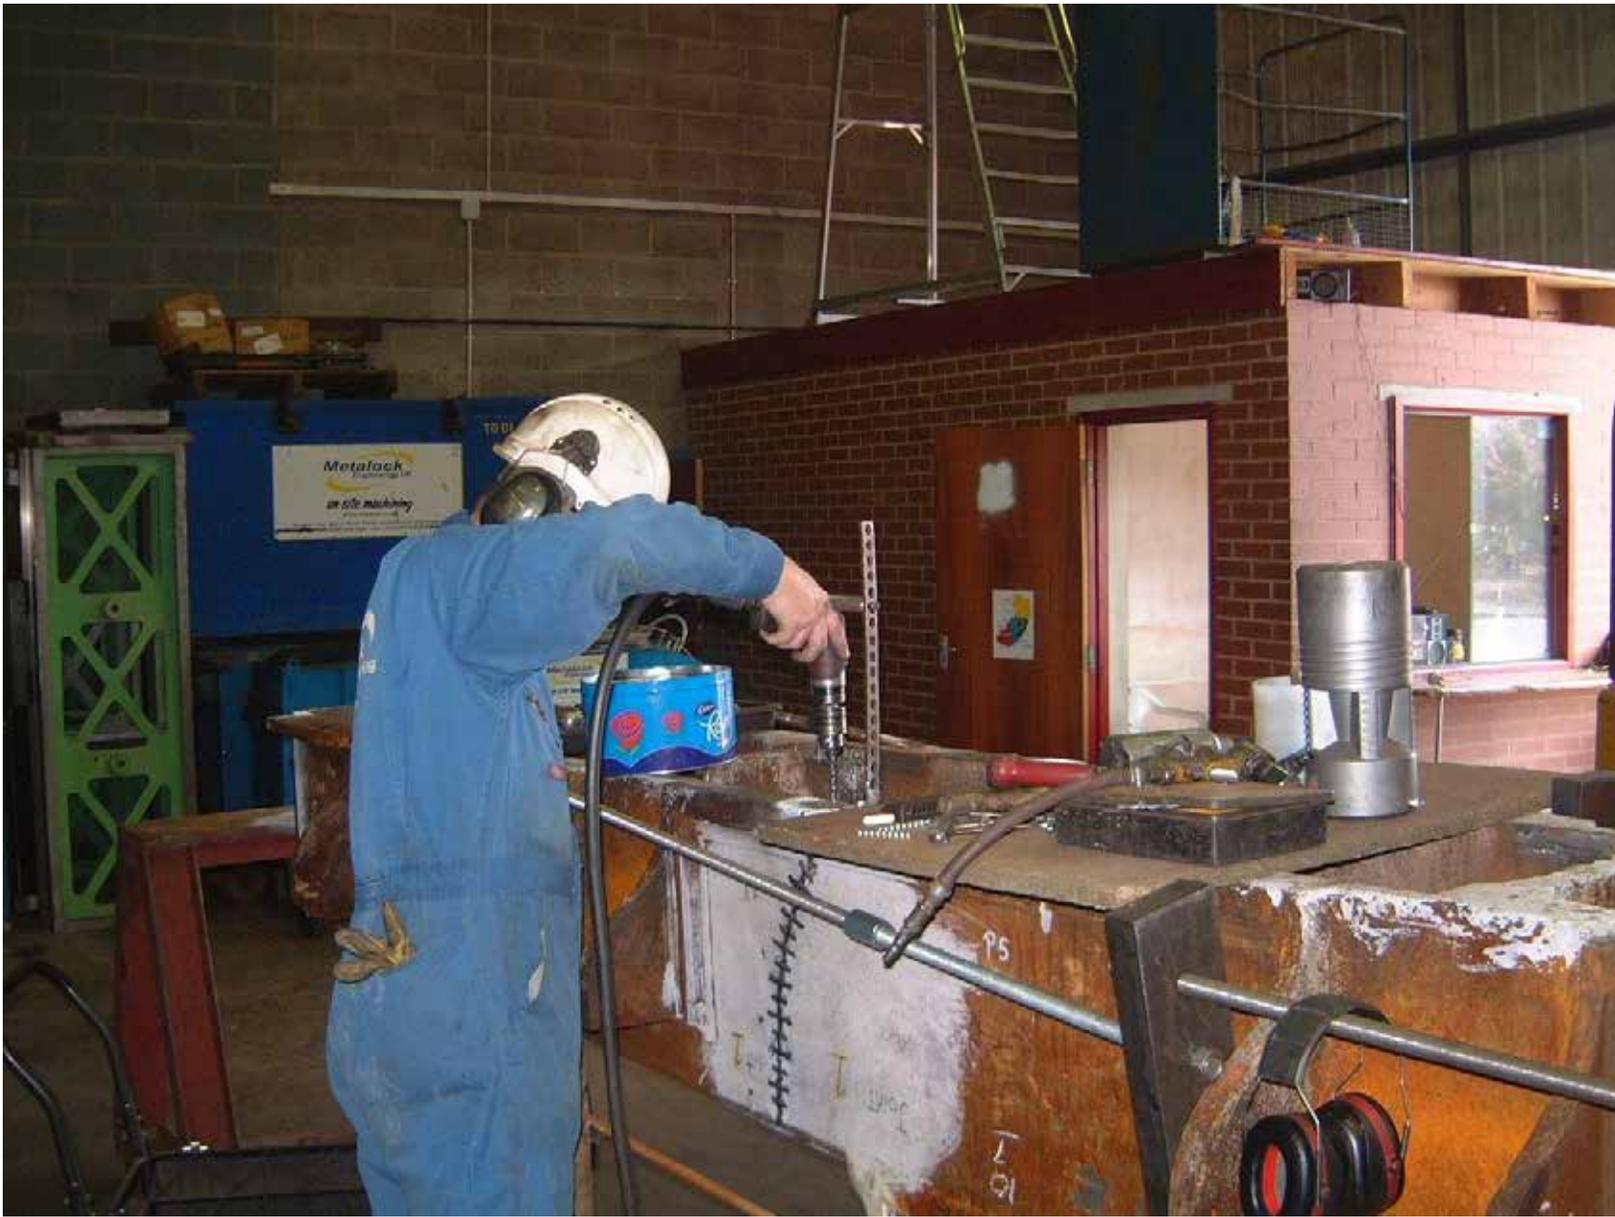
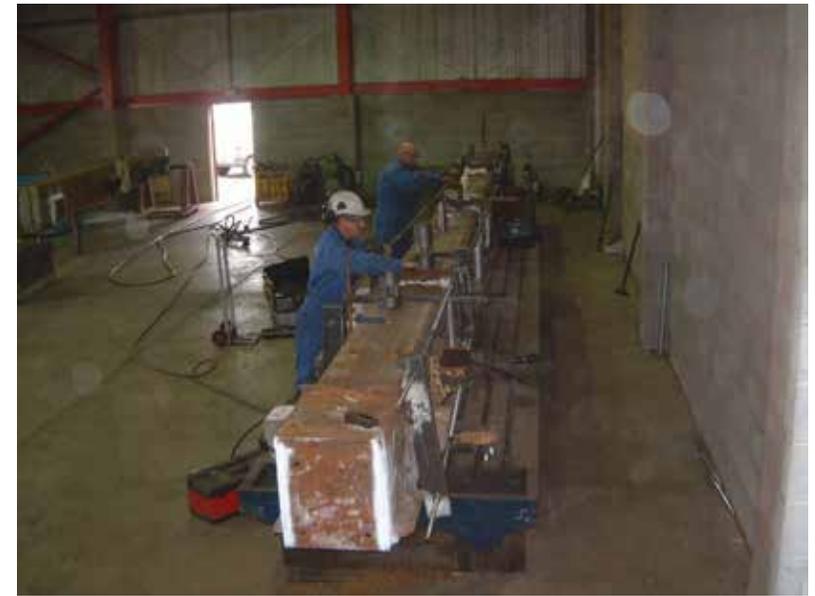
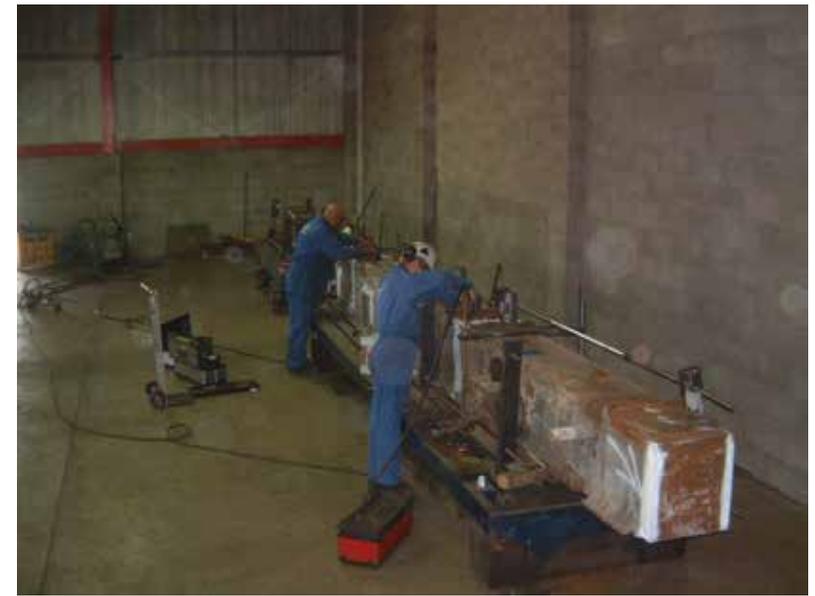
**Clamped, Optically Aligned and then verified
by the Bridge Consultants before repairs begin**
